**Virginia Commonwealth University  
Transportation Safety Training Center  
Crash Investigation Team**

Report Number 190 - May 2003

**SYNOPSIS-Case Study Number One**

**SYNOPSIS-Case Study Number Two**

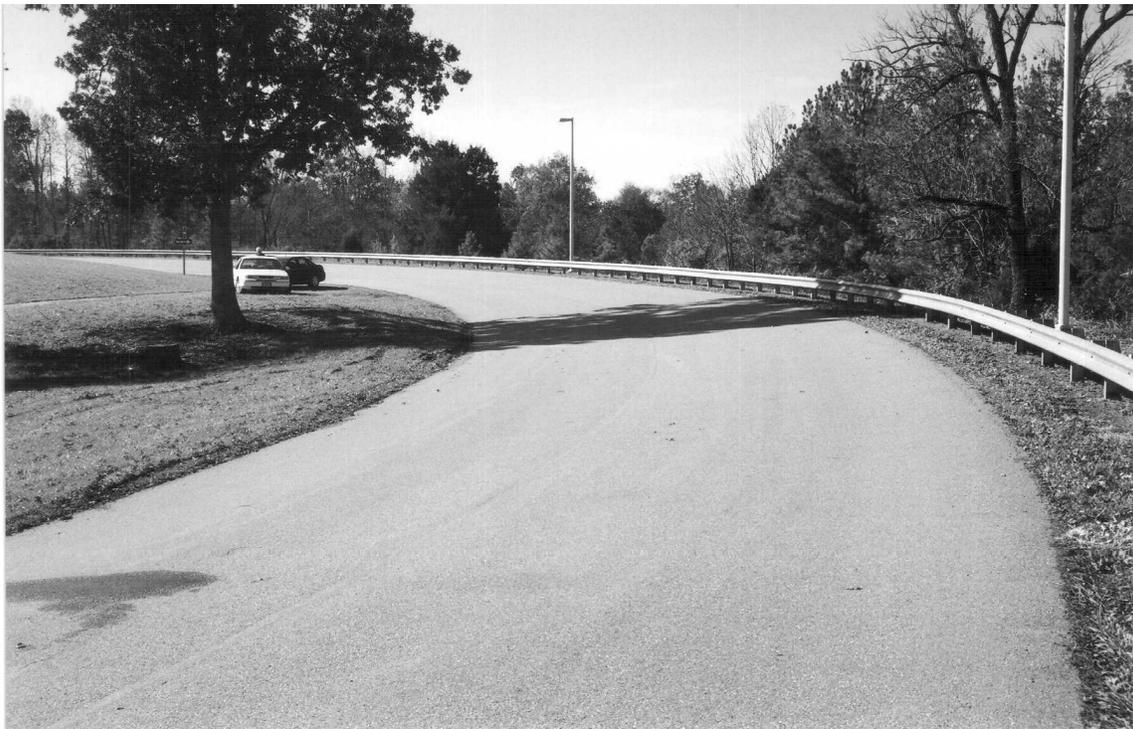
***Photo #1- View looking east in the direction the Acura was originally traveling. Photo was taken about 150 feet prior to where the car ran-off-the-road on the right and 250 feet before the point of impact. Note the excellent road conditions for this school access facility posted for 25 mph. The weather was mist and the pavement was wet at the time of the crash.***

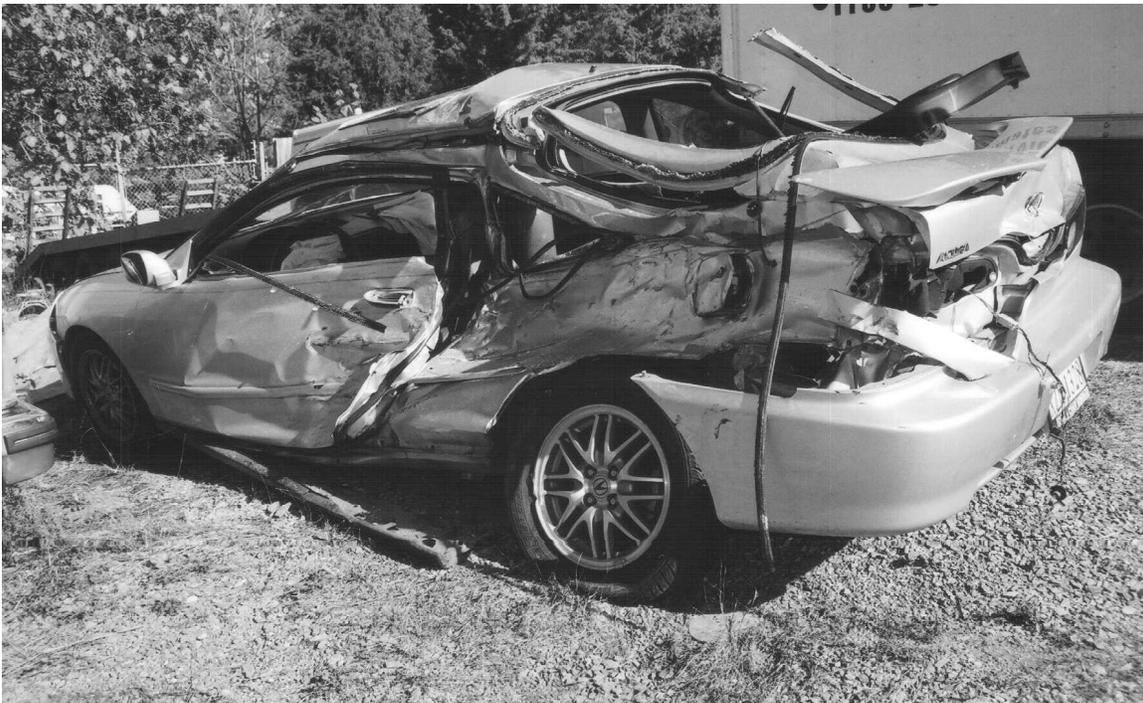
***Photo #2- Left rear side view of the 1998 Acura Integra showing the nearly 26 inches of collapse and 7 feet wide damage area.***

research sites. The Acura incurred nearly 26 inches of static crush or penetration to its left side. The left rear wheel and axle was also broken. The length of the damage was just under seven feet, matching the frontal width of the school bus. The bus sustained seven inches of crush damage to its heavy, rigid bumper. Its grille was also pushed backwards near the radiator. Upon disengagement, the car spun around the front of the bus about 25 feet, striking the bus a second time causing additional damage to both vehicles. Based on both vehicles' damage patterns combined with the post-impact travel distance of the car, the Team calculated that the Acura was traveling at least 45 mph at the time of impact. However, the car slid some distance on the wet pavement prior to impact, which, if known and combined with the calculated speed, would raise the initial speed. Due to the lack of physical evidence on the road, this distance is unknown. It is likely, however, that this young driver was exceeding the posted 25 mph limit for this road by at least 20 mph.

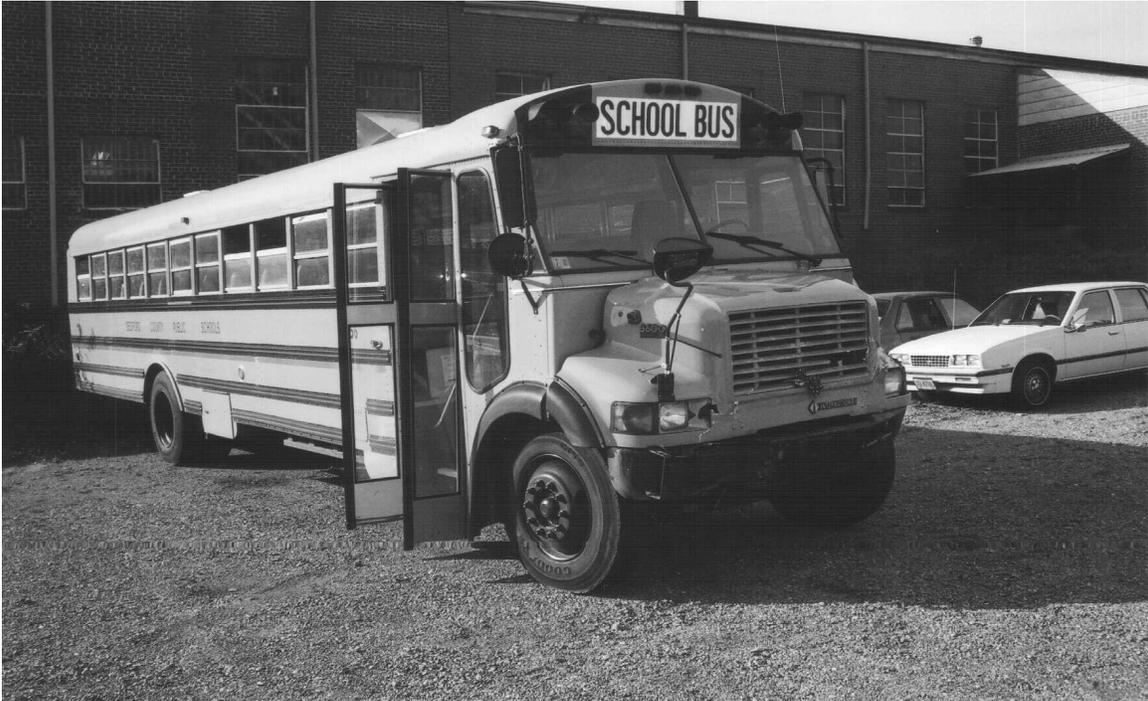
All the students on the school bus were able to exit through the right front service door and rear emergency door without mishap. The eight students who were taken to hospitals for observation were seated in the first rows directly behind the driver. This area was nearest the collision point and experienced the higher energy loads. The structural integrity of the school bus was not compromised, including its interior. None of the seat

*Photo #3- View of the 1997 International full size school bus from its front and right side. The entire front was damaged with the left front corner sustaining over 7 inches of collapse from being struck by the Acura. The belted bus driver and the unbelted students sustained only minor physical injuries.*

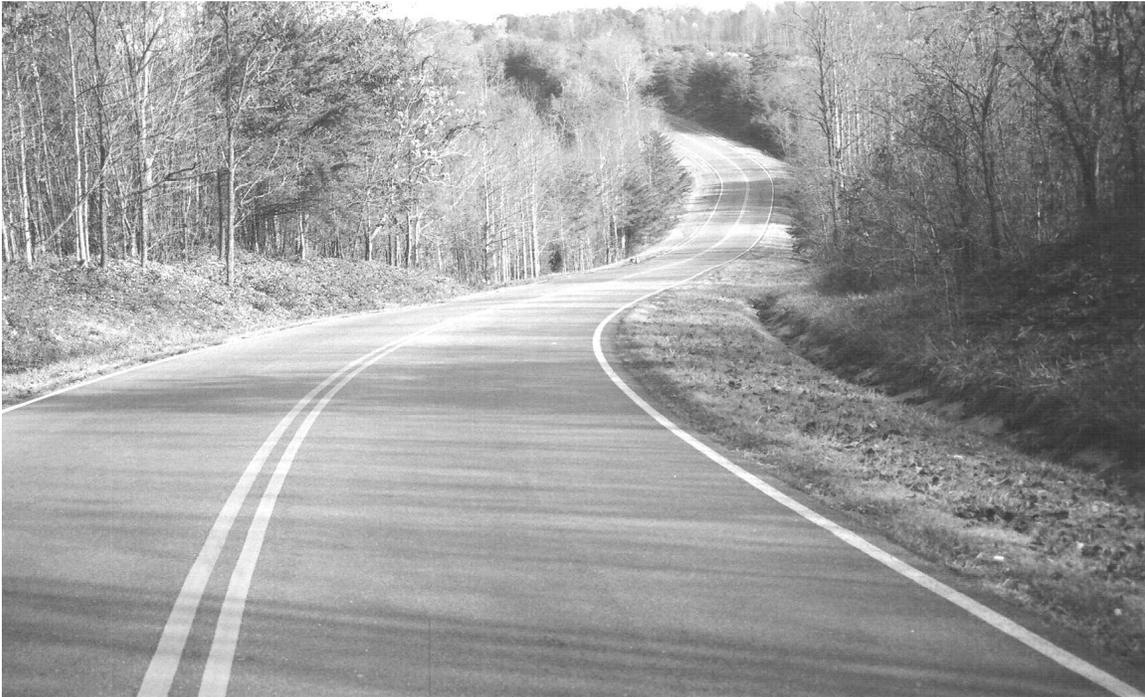
***Photo #4- View looking east in the direction the Ford pickup was originally traveling. Photo was taken about 400 feet before impact point. Note the highway grade and curve on this secondary road posted for 35 mph, which serves as a high school access road. The weather was mist and the pavement was wet at the time of the crash.***

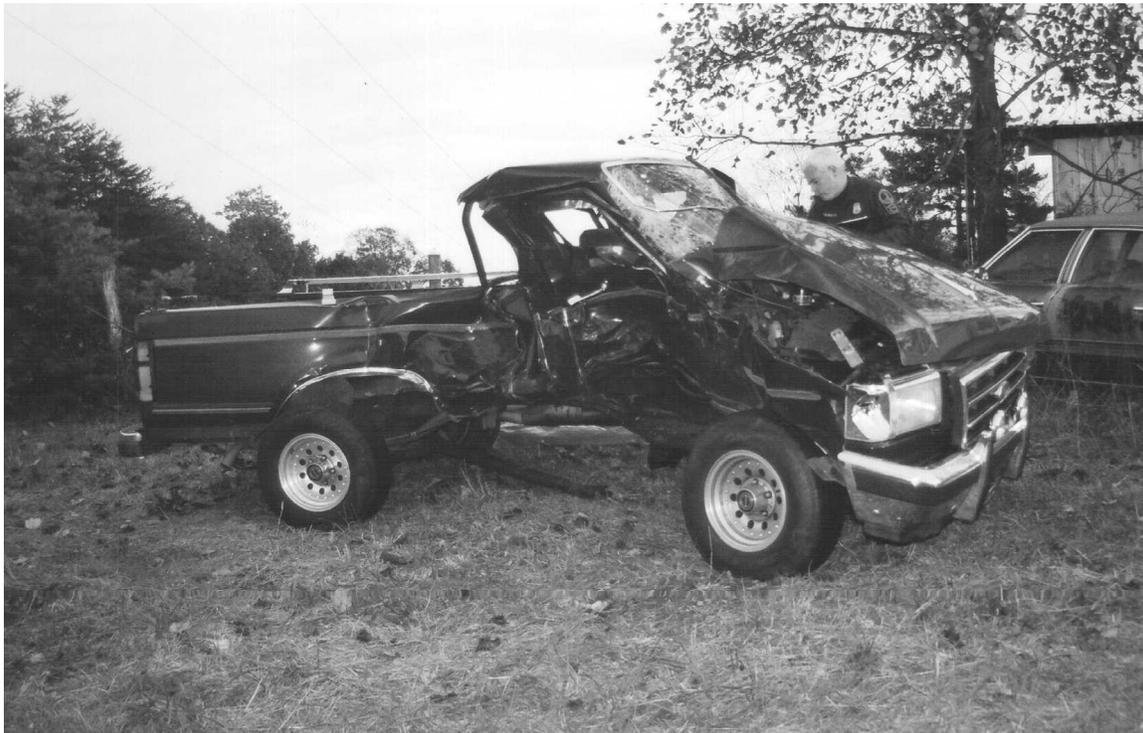
Based on the collapse damages sustained to both vehicles, a minimum speed for the striking pickup can be estimated. The total combined static crush from both vehicles was measured at 69 inches (40 inches on the pickup and 29 inches on the SUV). If the suburban was indeed stopped just prior to impact, all of the crush damages were produced by the pickup's speed. Based on the best evidence available by using several different vehicle damage/crush equations, the likely speed of the pickup at impact was calculated at 56 mph. The investigating Trooper estimated that the pickup was initially traveling 65 mph before impact.

***Photo #5- Right side view of 1991 full size Ford F-150 pickup truck, weighing nearly 3800lbs. Contact damage measured 40 inches deep and 72 inches wide. The truck's frame was severely bent causing the pickup to distort in a classic U-shape pattern while the Suburban was embedded into the Ford's side. The Ford's interior was reduced in size by over one half its normal width.***

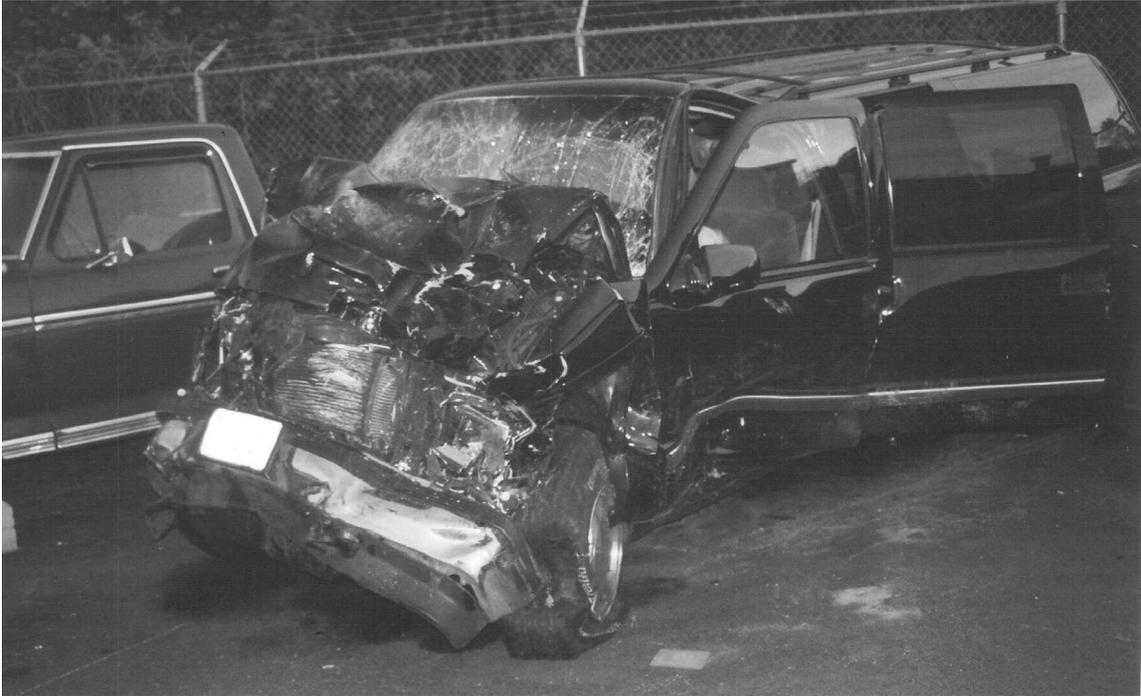
The 44-year-old driver of the SUV survived the collision with contusions to her upper body. However, she incurred multiple serious fractures to her right foot, ankle and heel. These impact injuries were sustained when she had her foot positioned on the brake pedal at the time of collision. The impact forces were so great that the floorboard collapsed and was pushed back against her feet and lower legs. Due to the seriousness of

***Photo #6- Right front view of the 1999 Chevrolet Suburban 1500 weighing 4700lbs. The SUV's front end was pushed rearward into the engine and occupant compartments nearly 30 inches. The left and right side wheel base lengths were reduced 33 inches and 24 inches respectively. The driver's side floor area at the foot controls was collapsed inward about 6 inches from its normal measurement.***
