**Virginia Commonwealth University  
Transportation Safety Training Center  
Crash Investigation Team**

Report Number 192 – July 2004

**SYNOPSIS – Case Study Number One**

**SYNOPSIS – Case Study Number Two**

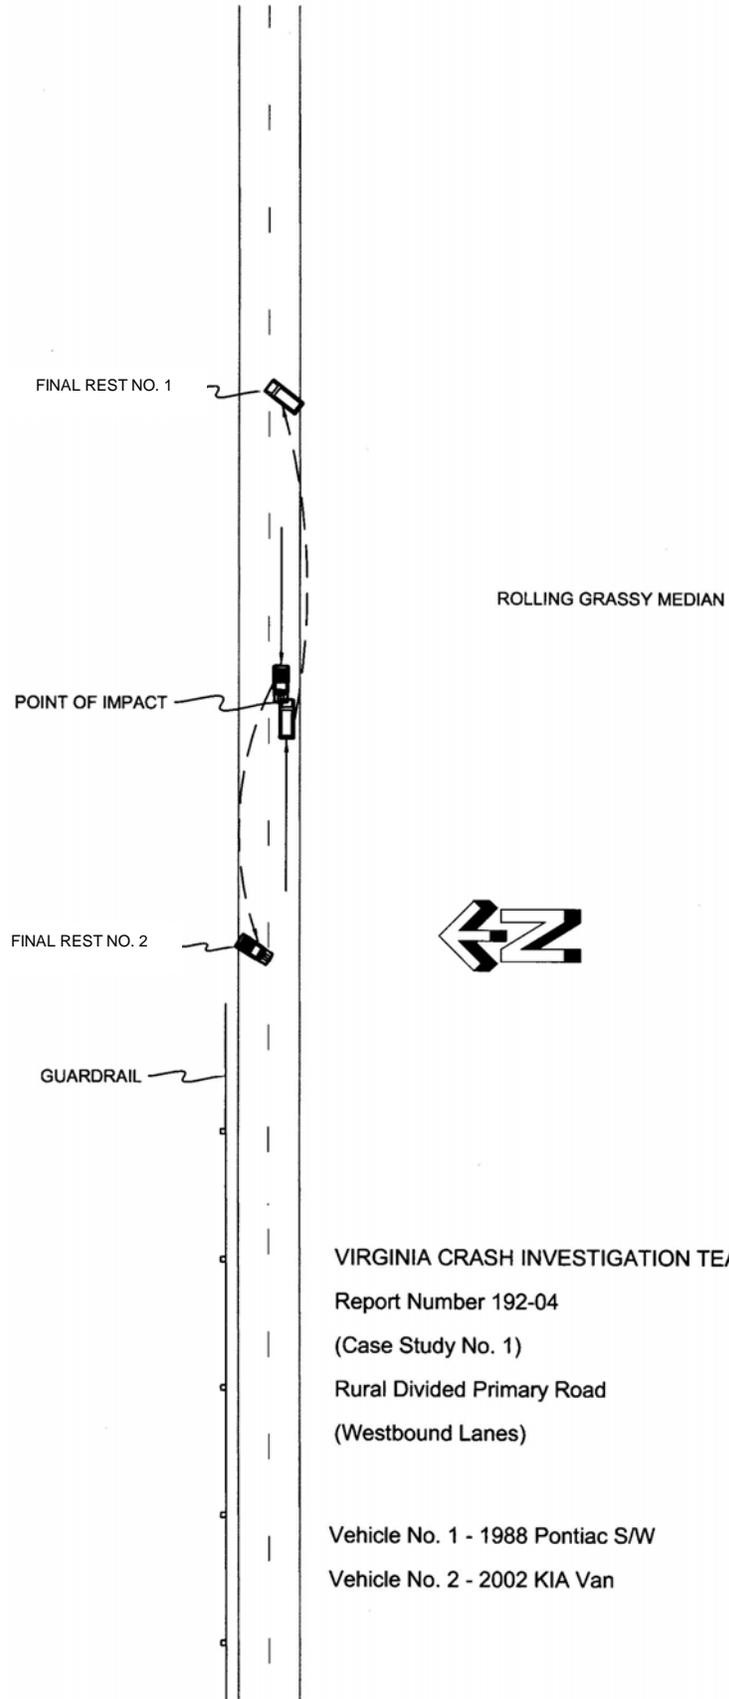
VIRGINIA CRASH INVESTIGATION TEAM  
Report Number 192-04  
(Case Study No. 1)  
Rural Divided Primary Road  
(Westbound Lanes)

Vehicle No. 1 - 1988 Pontiac S/W  
Vehicle No. 2 - 2002 KIA Van

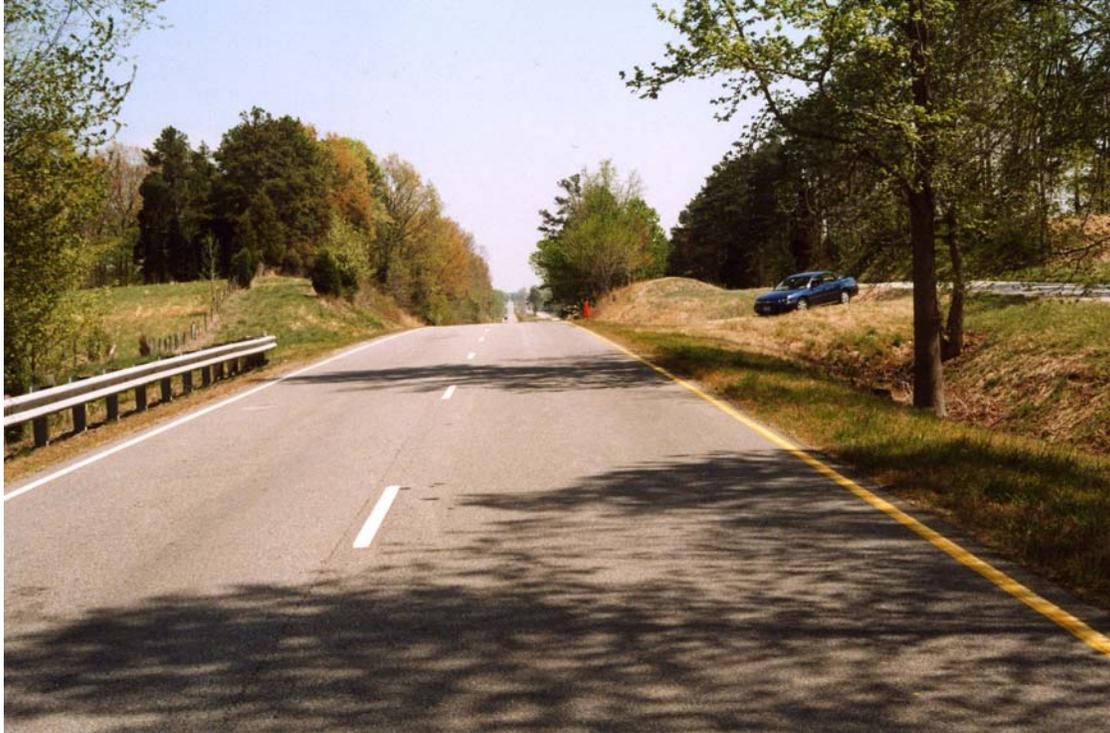
***Photo 1. View looking east from the left inside westbound lane. The wrong way Pontiac was traveling in this lane. Photo was taken about 150 feet before the impact point.***

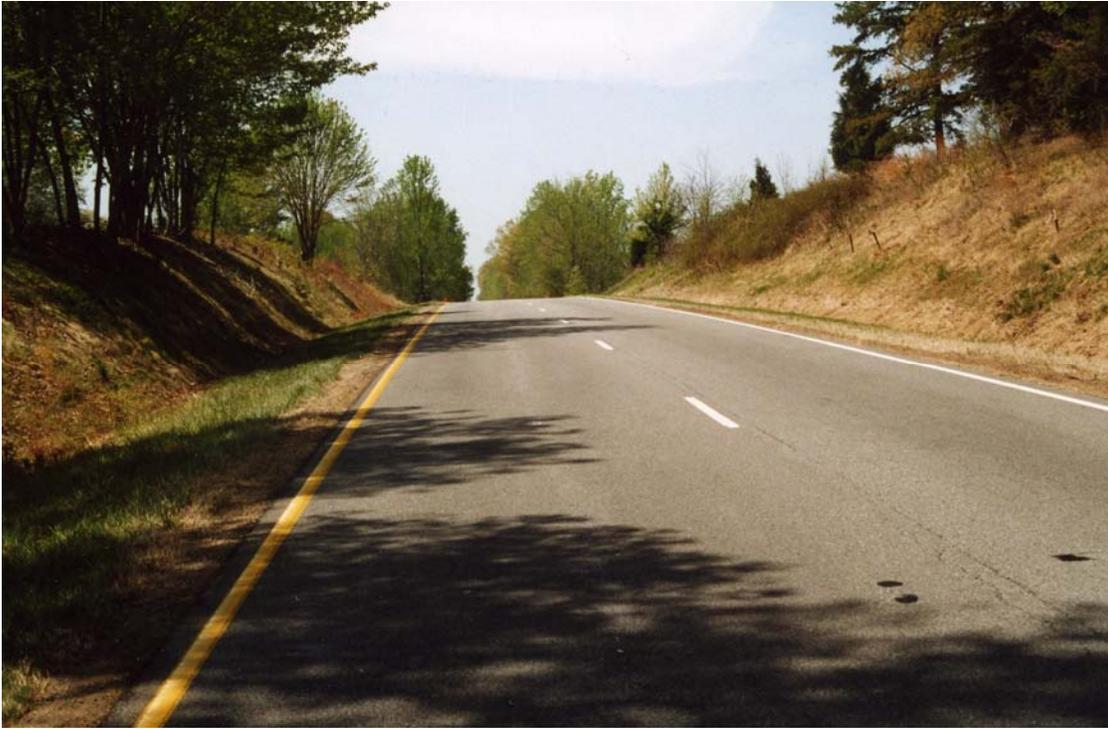
*Photo 2. View looking west from the left inside westbound lane. The van was properly traveling in this lane. Photo was taken about 300 feet before the impact point. Note the hillcrest and roadway design in the vicinity.*

The crash location is situated on a hillcrest that naturally limits approaching sight distance. The nearest crossover that the driver would have passed was in a curve about .8 of a mile west of the crash site. The two motorists who were traveling ahead of the westbound van in the right outside lane saw the wrong way Pontiac's lights approaching in the inside lane for nearly ½ mile. The Pontiac did not veer out of its lane or alter its direction of travel at any time prior to the collision. By the time the van's driver crested the hill and saw the Pontiac's headlights in her lane of travel, she had little time to react. Based on their impact damages and where they came to rest, both vehicles were traveling about 50 mph when they collided. Given the nearly 400 feet of approaching sight distance, the van driver had about 3 seconds in which to respond after seeing the Pontiac's headlights in front of her. Since she would not have been expecting a wrong way car in her lane, once she saw the lights and realized what was happening, her response time was exhausted. Although she says she steered to her right just at the last instance, it was not detected by the Pontiac driver who did not attempt to swerve or brake during the same driver decision time period. Had more sight distance been available and/or had this situation occurred on a long flat section of highway, successful evasive action may have been executed by the van driver and perhaps the Pontiac driver.

3. In an attempt to improve the future highway safety environment for all drivers, The Virginia Department of Transportation is encouraged to continue the widespread use of embedded centerline delineators with reflectors of different colors (white for the correct traffic and red for wrong way traffic), particularly on divided roadways. Educational programs to reinforce the correct interpretation of these color delineators and color pavement markings (yellow painted lines versus white lines) would be valuable as well.

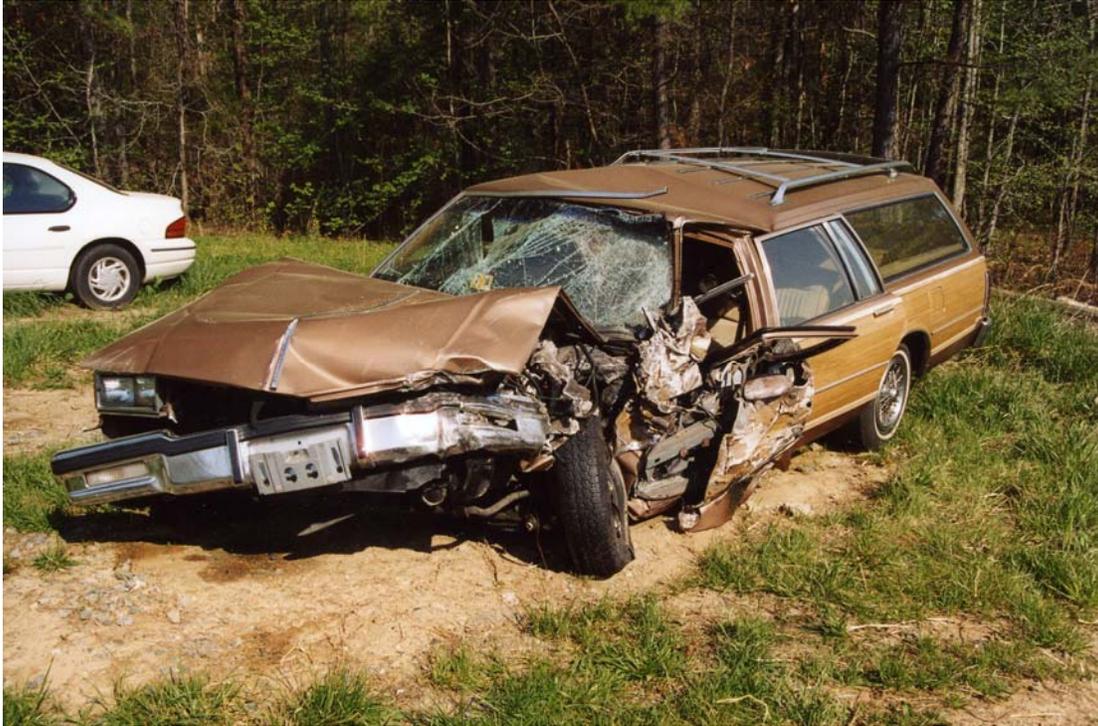
The Pontiac collided with the van at a nearly straight-ahead alignment. No evidence exists to show that the driver either steered or braked in any evasive action before the collision. The Pontiac's left front incurred contact damage 25 inches wide, 19 inches deep at the drivers "A"-post and extended along the left front side about 5-1/2 feet. The Pontiac kept going eastward after the collision and continued partially onto the grassy median, where its right side tires furrowed through the sod. The left front wheel collapsed into the firewall and frame and the right front wheel was bent to the left. This caused the car to rotate counterclockwise and travel back entirely into the inside lane. It came to rest 59 feet from the impact point, positioned diagonally across the left inside westbound lane. The Pontiac rotated nearly 80 degrees from its original heading. Because of the severe damage to its left front corner, it too lost all power, including its electrical system.

The unbelted Pontiac driver was thrown forward into the steering wheel, dashboard and windshield as they collapsed rearward into him. He sustained massive head and chest injuries and died instantly in the collision. He came to rest slumped over into the right front half of the bench seat. His legs and feet were pinned by the collapsed floorboard and dash areas and he had to be extricated from the vehicle. Due to his age, the amount of impact forces on his chest, and the amount of destruction to the car's front, the Pontiac driver likely would have still received fatal injuries had he been belted.

***Photo 3. Damage to the 1988 Pontiac station wagon from impact with the van. The 89-year-old unbelted driver died in this collision.***

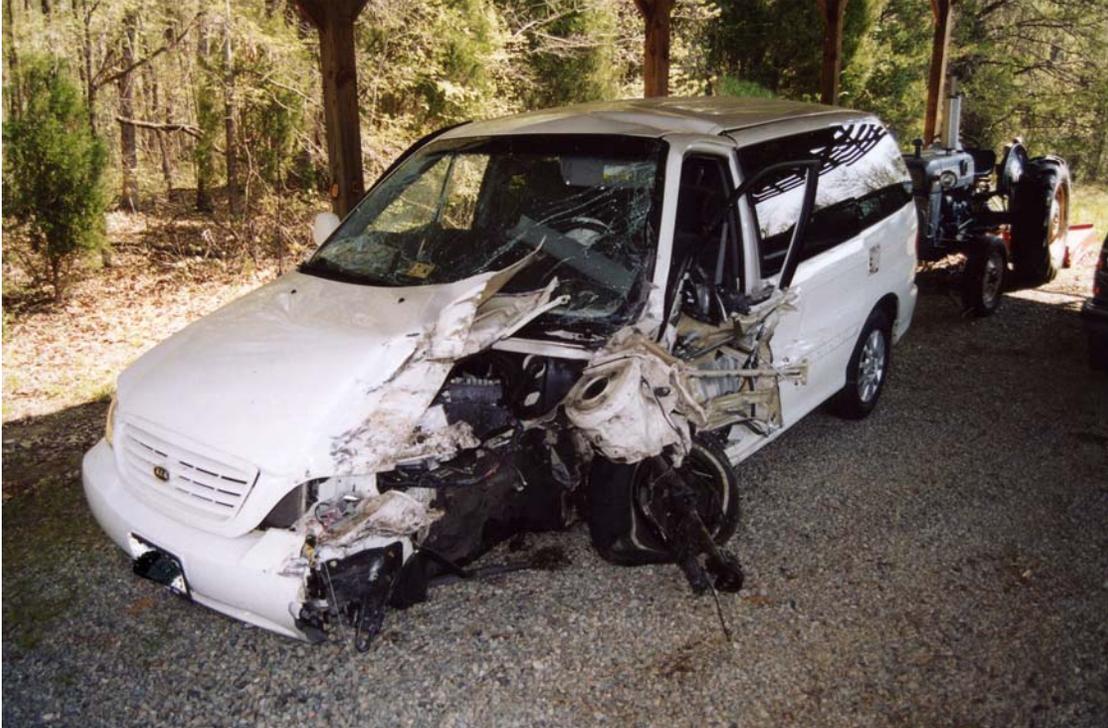
approaching car. The impact occurred near the center of the left inside westbound lane just as she began steering in an emergency evasive action to her right. At impact, the van's airbags deployed as she moved forward in her seat. Her safety lap and shoulder belt system kept her upright behind the steering wheel as her van's left front collapsed inward onto her. After impact, the van traveled into the right lane while simultaneously rotating counterclockwise. The Kia traveled about 35 feet west of the collision point and came to rest diagonally straddling the right outside lane, facing southwest. It had rotated about 85 degrees. The belted driver remained inside the van throughout the crash and post crash phases of the collision. The vehicle sustained major left front contact damage measuring 18 inches wide, 16 inches deep and 10 feet along its' left side. The two front tires were flat and the van's electrical system was destroyed, causing the lights to turn off. The driver sustained significant injuries to her lower legs and compression injuries to her head and chest. She remained inside the vehicle at final rest, trapped by the van's collapsed floorboard and dash/steering wheel areas. The safety belt use and deployment of the driver side airbag together saved the life of the van driver. Had she not been belted, she would have struck the deploying airbag, in addition to the collapsing interior and would have likely sustained fatal or near fatal injuries.

*Photo 4. Damage to the 2002 Kia van from impact with the Pontiac. The 29-year-old belted driver, protected by her safety belt and the van's air bag, survived this head-on collision*

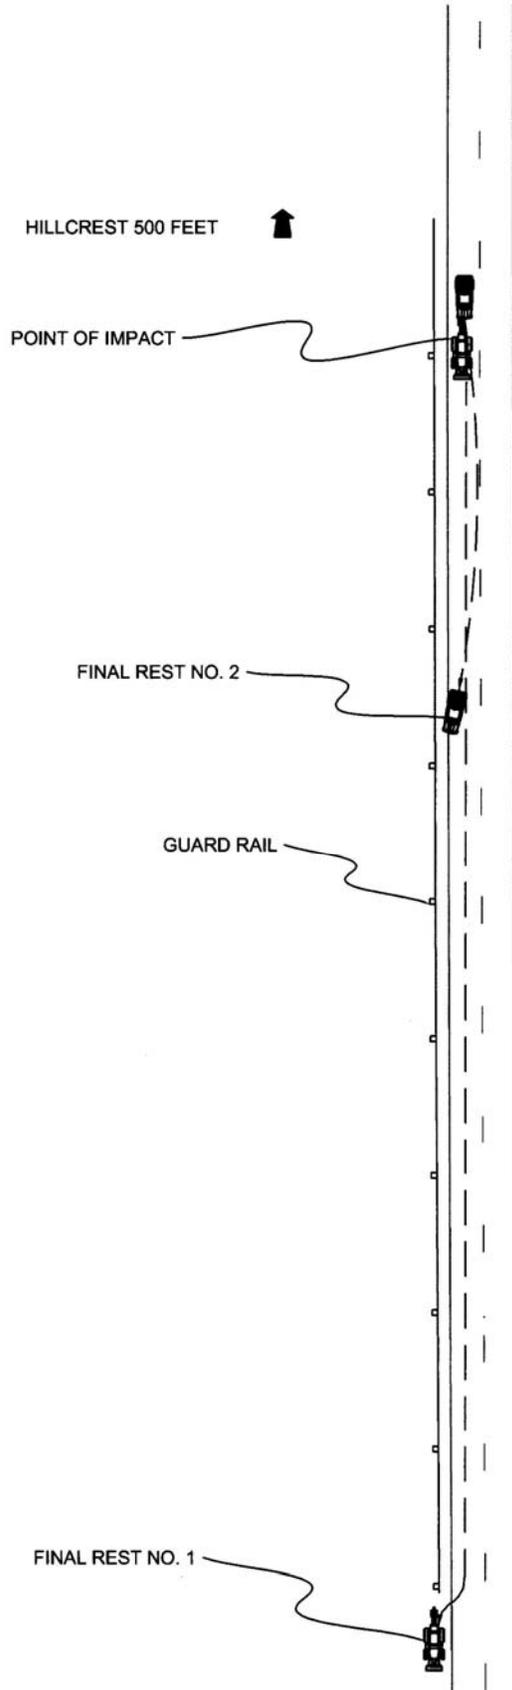
VIRGINIA CRASH INVESTIGATION TEAM

Report Number 192-04

(Case Study No. 2)

Rural Divided Primary Road

(Westbound Lanes)

Vehicle No. 1 - 1997 Case Backhoe

Vehicle No. 2 - 1988 Chevrolet Pickup

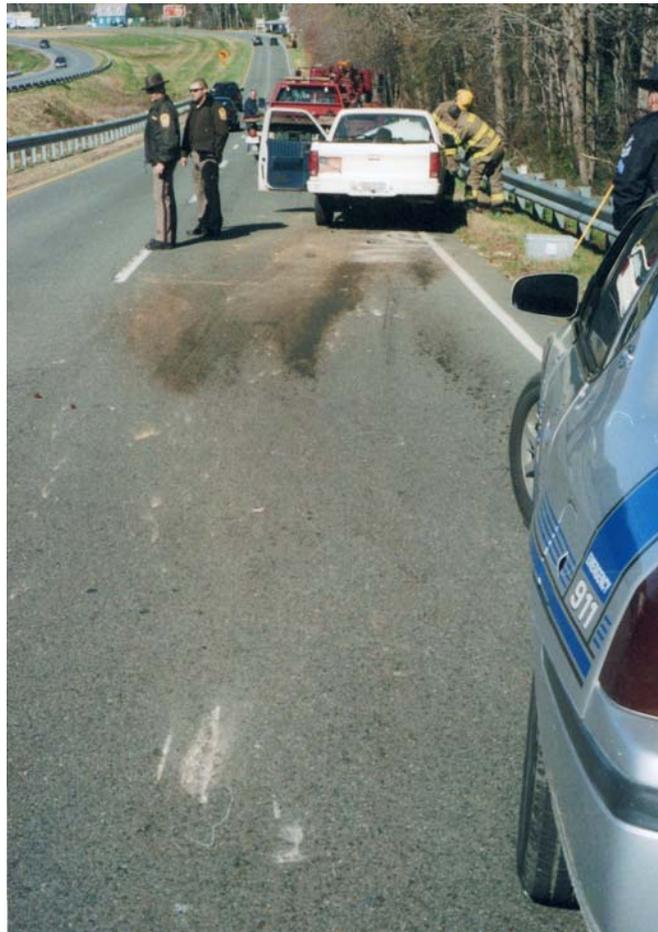
***Photo 1. View looking west from the impact point showing final rest of pickup truck and backhoe in distant background. Note the gouge mark in the center of the right lane, the subsequent solid and liquid debris as well as the scuff marks made from the pickup's front tires.***

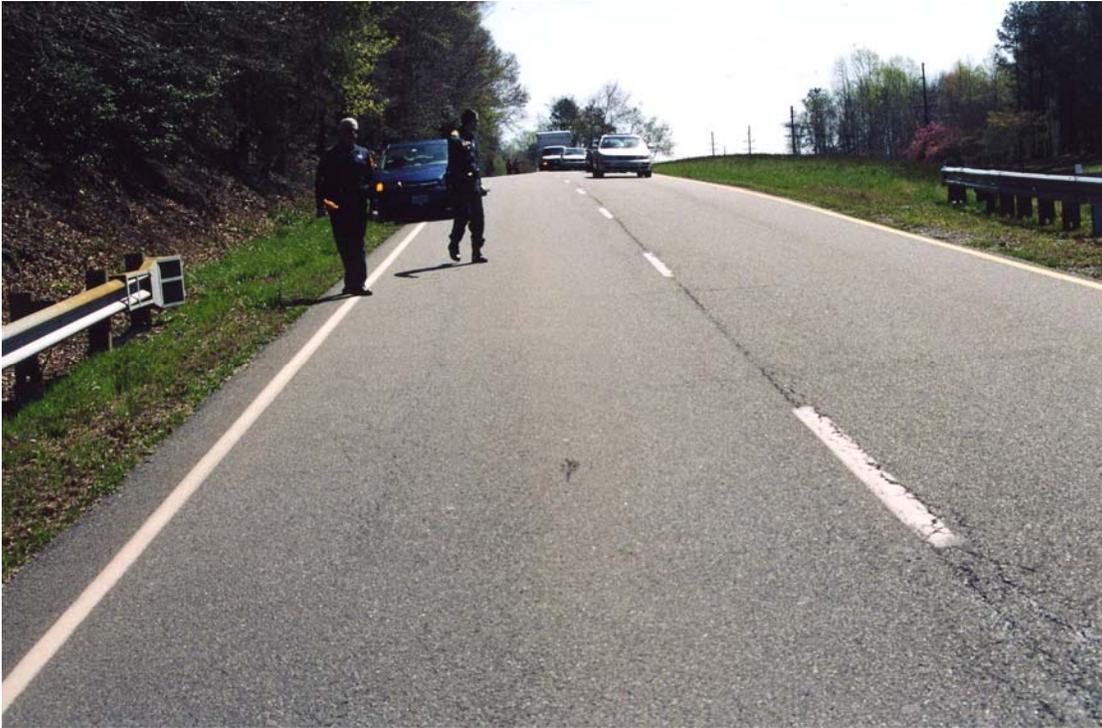
*Photo 2. View looking east from the impact point showing the gouge mark and the roadway leading up to the crash site. Note the hillcrest in the background and the downgrade at this point.*

The cause of this tragic crash was the apparent failure of the pickup driver to see the backhoe's flashing lights and to correctly assess the difference in closing speeds between the two vehicles. The approaching site distance looking along the westbound lanes and down the grade to the impact point was about 600 feet. Traveling at 30 mph and 50 mph for the backhoe and pickup respectively, the backhoe should have been constantly visible to the Chevy driver for about the last 8 seconds over this distance. This amount of time and distance was more than sufficient for a normal driver who is paying attention to his/her driving task to see the backhoe and react accordingly. The backhoe driver said that several cars had passed him with no difficulty within minutes prior to the crash. As far as he could recall, the last car to pass was about one minute before impact.

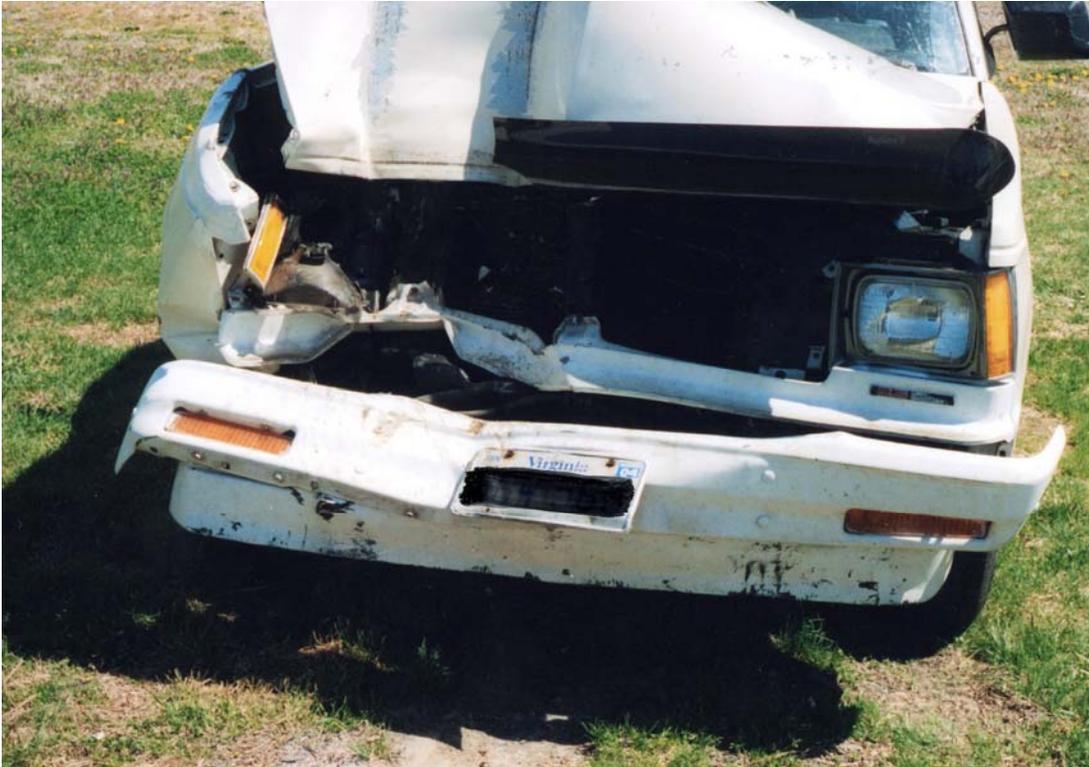
Upon impact, the pickup's front end collapsed from contact with the larger, heavier and slower moving backhoe. Its' front bumper, grille, hood and engine areas collapsed inward about 17 inches. Because it struck the backhoe's narrow "dump-arm," the width of the damage on the pickup's front measured only about two feet wide and was located just right of its' center front. The collision, compounded by the speed difference between the two vehicles, caused the Chevy's front undercarriage to contact the pavement at impact. This contact left a noticeable gouge mark near the center of the right lane that was parallel to the lane. This gouge mark, surrounded by several smaller and lighter scratches, indicates the point of impact. Approximately three feet beyond the gouge was solid debris (dirt) that had become dislodged from underneath the vehicles, followed by a liquid debris trail (radiator fluid) from the Chevy. Two short collision tire scuffmarks made after impact by the pickup's front tires were noticeable on the pavement several feet beyond the gouge marks. The pickup stopped about 50 feet beyond the impact point facing west near the edge of the right lane with its right front tire resting just off the pavements' edge.

At impact, the unbelted Chevy driver came forward and traveled into and over the steering wheel. His head struck the windshield violently, producing a "spider web" type impact pattern. These interior impacts (steering wheel and windshield) produced traumatic injuries that would later prove fatal. The driver was knocked unconscious and he rebounded back into his seat where he was found moments later by passing motorists.

***Photo 3. Damage to the 1988 Chevrolet S-10 pickup truck from impact with the backhoe. The 86-year-old unbelted driver died in this frontal collision.***

The Chevrolet driver was not wearing his safety belt at the time of the crash. He died of multiple impact injuries from striking the steering wheel and windshield. The impact speed between the Chevrolet and the backhoe is estimated at about 20 mph. This collision speed is survivable in most instances if motor vehicle occupants are properly belted. Even when considering the driver's advanced age, and natural frailty, had he

7. All motorists are encouraged to use their safety belts when in transit.

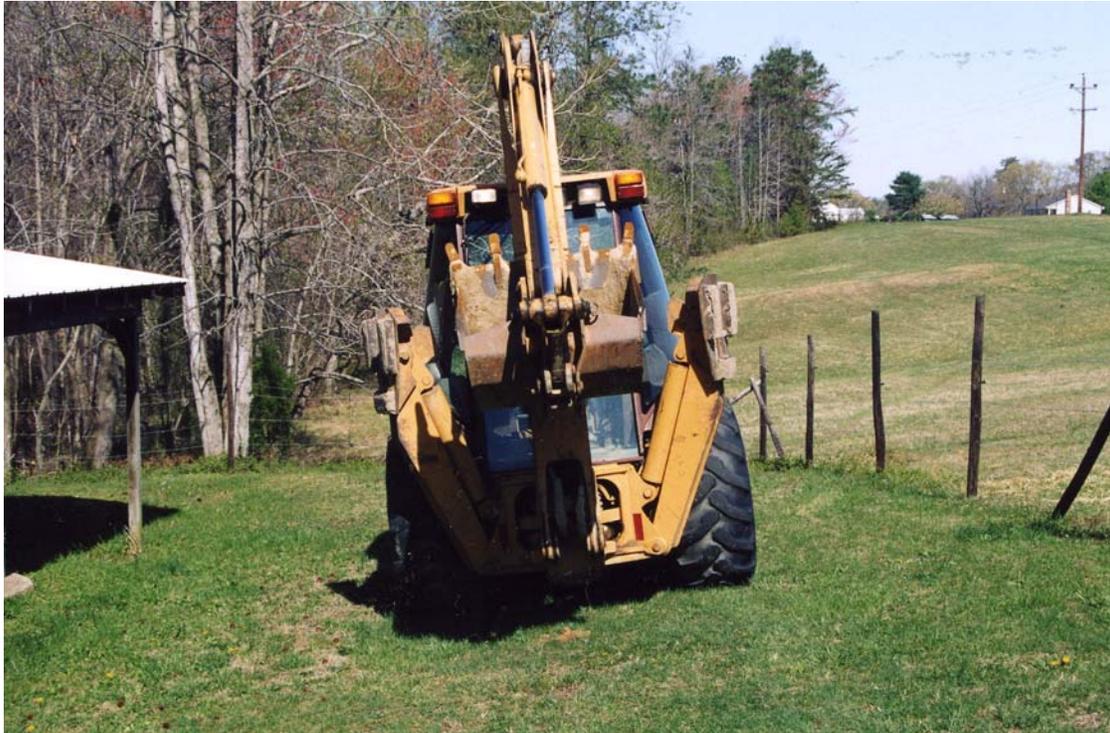
After examining the rear amber flashing lights, the taillights and the auxiliary lights on the backhoe in identical lighting conditions as those on the morning of the crash,

the Team determined that the lights were not particularly bright or detectable. Their intensity tended to fade out in the bright, sunny conditions prevailing at the time. (Had the ambient lighting been darker for instance, the flashing amber lights in particular would have been more conspicuous and noticeable). Given the pickup driver's age and the normal visual degeneration of a driver of his 86 years, it is probable he never saw the lights. However, he certainly should have seen the large backhoe traveling directly in front of him before impact. Due to its' huge size (7 feet 3 inches wide and 8 feet 7 inches tall) and its relatively conspicuous color scheme (yellow and black), the backhoe could be detected several hundreds of feet in advance. It is likely that the Chevy driver did in fact see the backhoe in the distance but he failed to realize that the vehicle was traveling much slower than he. Part of this could be a result of the pickup driver not expecting to encounter a slower moving vehicle. Determining the closing speed between vehicles can be difficult for any driver but for older drivers, such mental processing may be much slower, especially in unusual or unexpected circumstances. It is unknown what the pickup driver was doing the last seconds before the crash. Although he should have been paying attention, he may have been looking at the highway scenery, thinking about his banking transaction and/or distracted by something inside his vehicle. Under normal driving conditions, the average driver perception/reaction time to external stimuli is generally about 1.5 seconds. It has been proven that many older drivers (like impaired drivers) have longer driver perception/reaction times than younger drivers. Whereas a younger driver would have seen and reacted to the presence of the backhoe in ample time to avoid it, this older driver did not.

The backhoe driver was charged and convicted of failing to display a slow moving vehicle emblem in the rear of the backhoe (46.2-1081). Since this crash, the Team has seen many backhoes on the roadways across the Commonwealth and about half of them were displaying these emblems. The emblem is intended to be displayed on vehicles designed for operation at speeds not in excess of 25 mph. The purpose of the law is to increase the visibility of that vehicle and to convey to approaching motorists that it is in fact going slow. By having such a warning, a prudent motorist can assess his/her driving situation and react accordingly. The reason this backhoe was not displaying the emblem, according to its' owner, was because the vehicle could obtain speeds of about 30

mph. The Team feels that although this backhoe could travel at a speed greater than 25 mph on downgrade sections of roadway, it is doubtful that it could maintain those speeds on level surfaces and upgrades, thus necessitating the need for such an emblem. Although speculative, had this backhoe been equipped with such an emblem, (which is triangular shaped and a high intensity orange-pink color) the 86-year-old Chevy driver may have seen it and reacted safely, whereby this crash may have been avoided.

***Photo 4. Rear view of the 1997 Case 690 backhoe. The vehicle in this photo is facing west and its two amber flashing hazard lights, two red tail lights and two clear auxiliary lights are all activated in this shot. The physical size of the vehicle is more conspicuous than its lights during bright, sunny conditions. Note the absence of a slow moving vehicle emblem. The backhoe, due to its large size and heavy metal construction, incurred no damage in the collision and its driver was not injured.***

5. Backhoes and other similar special vehicles that normally travel at speeds under 25 mph on all types and grades of roadways should be equipped with slow moving emblems as required by law. Not only should the emblems be properly displayed, they should be clean and clearly discernable at all times. Consideration should also be given to the use of high intensity, flashing strobe lights on slow moving vehicles.
