**Virginia Commonwealth University  
Transportation Safety Training Center  
Crash Investigation Team**

Report Number 195 – November 2005

VIRGINIA CRASH INVESTIGATION  
TEAM  
REPORT NUMBER 195  
Rural Secondary Road  
1997 International School Bus

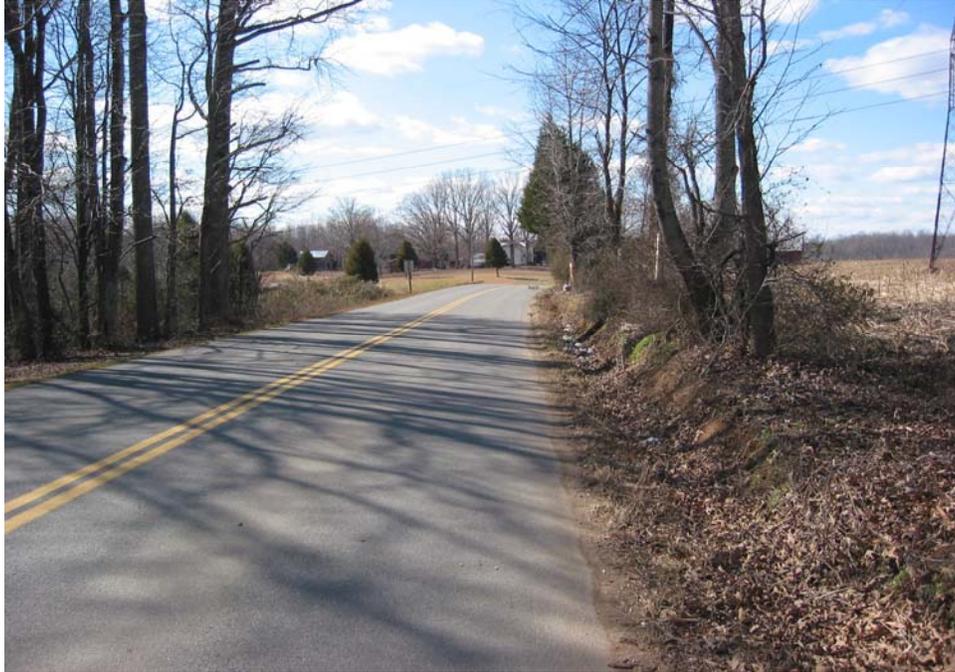
*Photo#1 View looking west in the direction the bus was traveling. Photo was taken prior to the point where the bus ran off the road. Note the narrow shoulders and the proximity of the trees and embankment to the road. Also, note that visibility around the corner is obscured.*

- B. Motor vehicle operators driving on narrow secondary roads should be constantly vigilant for off-road hazards, such as ditches and fixed objects close to the pavement, as well as for on-coming vehicles.

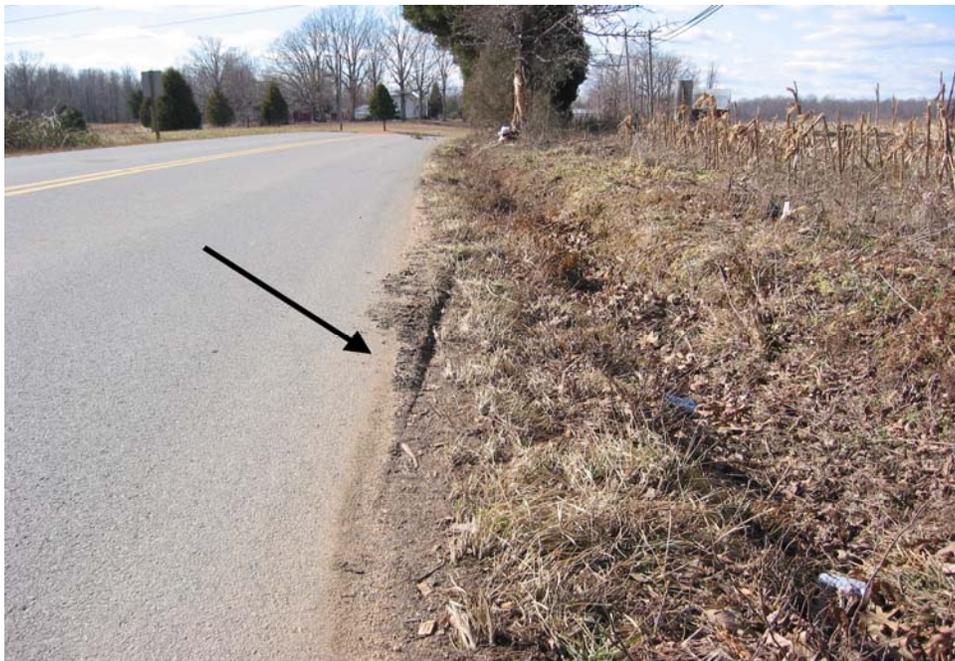
*Photo #2 A closer view of the path the bus was traveling. Note the shallow angle of the impression made by the right front tire as the bus left the pavement.*

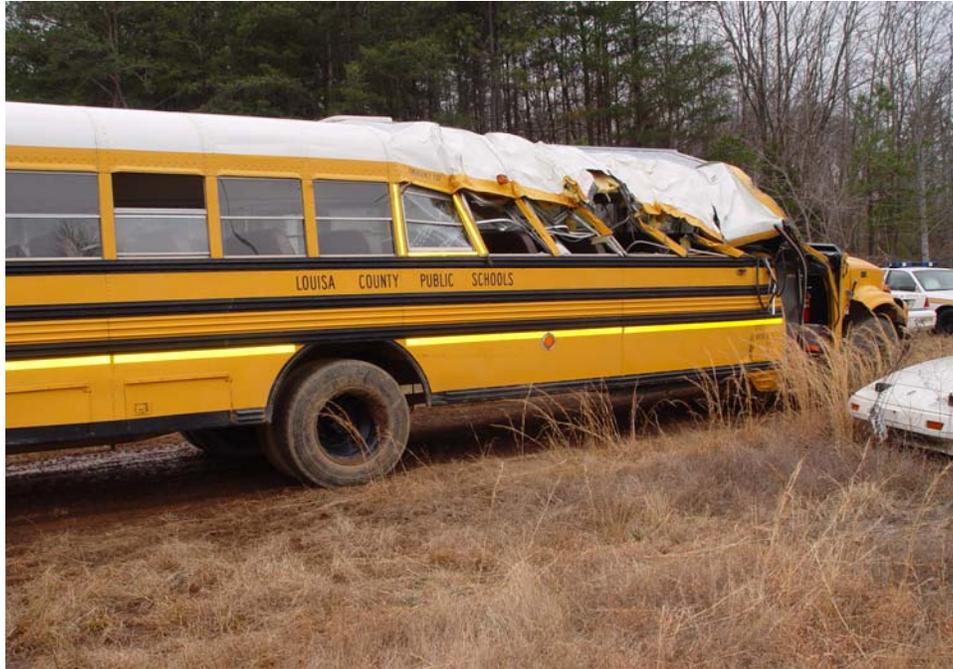
The top corner of the bus began to collapse upon impact with the tree. The windshield of the bus is composed of two independent glass segments; the right half dislodged from its mounting and was found in the ditch. The left segment cracked but remained in place. The bus continued its forward movement, the tree and its branches continuing to encroach into the right bus wall. The roof area began buckling toward the rear and downward into the passenger compartment as the crash progressed. The normal entry door was compressed and deformed, rendering it inoperable. The right side windows of the bus shattered and fragmented in sequence from the first through the fourth seat, spraying glass shards into the passenger compartment, where they struck some of the students. The roof continued to buckle, exposing jagged pieces of metal into the interior and causing the roof-mounted emergency hatch to pop out. The hatch was found in the ditch between the struck tree and the final resting place of the bus. The bus continued west an additional 100 feet, brushing against evergreen trees, before coming to rest facing west, its left tires in the road and both right wheels in the ditch.

***Photo #3 Right side view of the bus showing the damage to the roof, door and right windows near the front.***

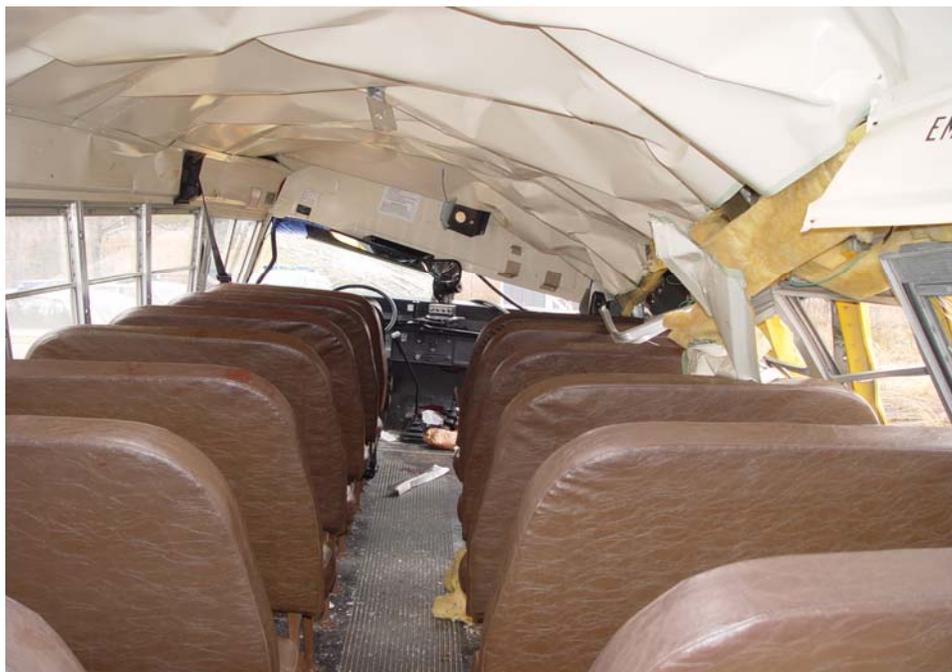
The bus involved in this crash was a 1997 International with a conventional style cab. The tires and brakes were examined and appeared to be well within inspection and code specifications. The vehicle displayed a current inspection approval sticker. The tires on the rear axle were retreads. The top right front corner was the initial point of impact with the tree; the resulting collision compressed the body to the rear and downward, buckling the roof both inside and out. The right half of the windshield had popped out and the doorframe had collapsed, rendering the bi-fold door inoperable. The glass in the first four side windows on the right side had broken and fragmented, and the fragments were strewn about the interior of the bus. Despite the crush damage to the front of the bus and even with part of the ceiling intruding into the right interior compartment, most of the passenger space remained intact and open. Even the driver's compartment was relatively unaffected.

*Photo #4 Interior of the front half of the bus. Note the angled buckling of the ceiling and the exposed metal on the right side.*

struck by an ejected student, and a laceration of the scalp (I). This injured student was seated in an area where the metal ceiling of the bus buckled and intruded down into the passenger compartment; however, the specific cause of the cut could not be matched to his injury.

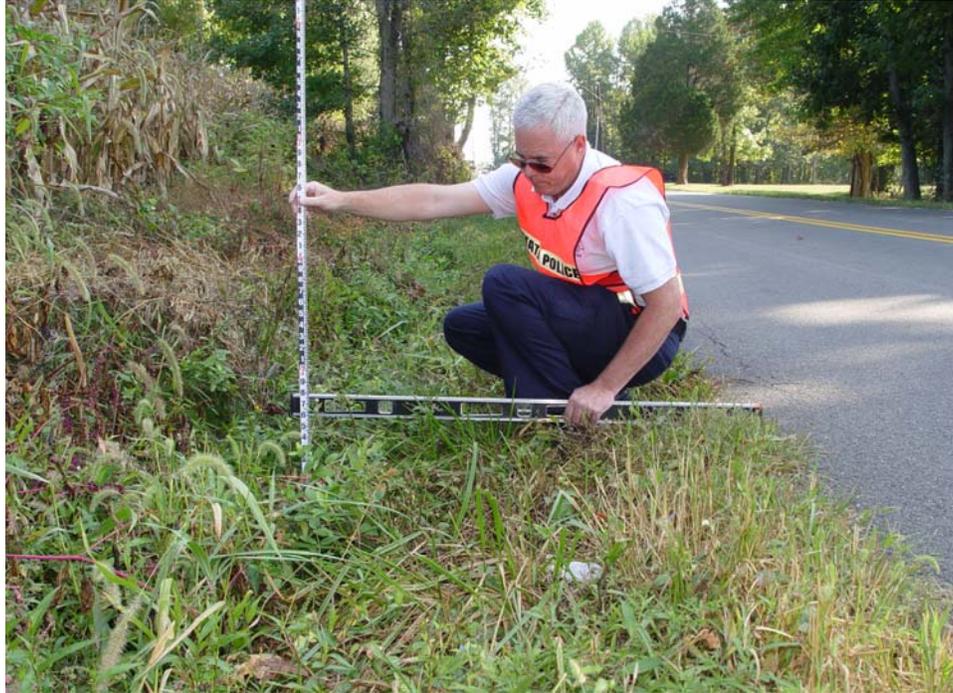
Rural roads often fail to allow much room for error on the part of drivers. While the drainage ditch beside this road is an important feature to assure that the road remains clear of running or standing water during and after storms, it can become a hazard as well. The depth of the ditch, combined with the narrow shoulders along this stretch of road, increase the risk of damage and injury for those who drift off the pavement. If not for the embankment, the bus would have tipped over onto its side prior to hitting the trees. The trees and their proximity to the shoulder are a second, potentially destructive hazard common to rural roads. As the bus continued forward, beginning to right itself as the ditch became shallower, the driver had the opportunity to regain control. The trees, dense and unforgiving fixed objects, blocked her path and caused the energy of the forward momentum to be transferred to the occupants inside. There are no “narrow shoulder” signs or other warnings along this area of road to advise drivers of any possible hazard, although individuals familiar with the rural area know that such conditions are common. As testimony to their safety practices and driving skills, school bus drivers in the Commonwealth log hundreds of thousands of miles on rural roads each year with only rare instances of problems. Although not a factor at the time of this crash, a few months later this ditch was covered in a dense growth of grass and brush, obscuring its true depth from drivers.

***Photo #5 The drainage ditch had a depth of 3-1/2 feet where it intersects with a drainage pipe that passes beneath the road. This picture was taken several months after the crash. Note how grass and brush hide the ditch from view.***

3. The Virginia Department of Transportation should continue upgrading secondary roads through highway construction and rehabilitation.
