**Virginia Commonwealth University  
Transportation Safety Training Center  
Virginia Multi-disciplinary Crash Investigation Team**

Report Number 197 – May 2006

VIRGINIA  
MULTI-DISCIPLINARY  
CRASH INVESTIGATION TEAM  
REPORT NUMBER 197  
Rural Interstate Highway  
1998 Ford Expedition  
2005 Chevrolet Trailblazer

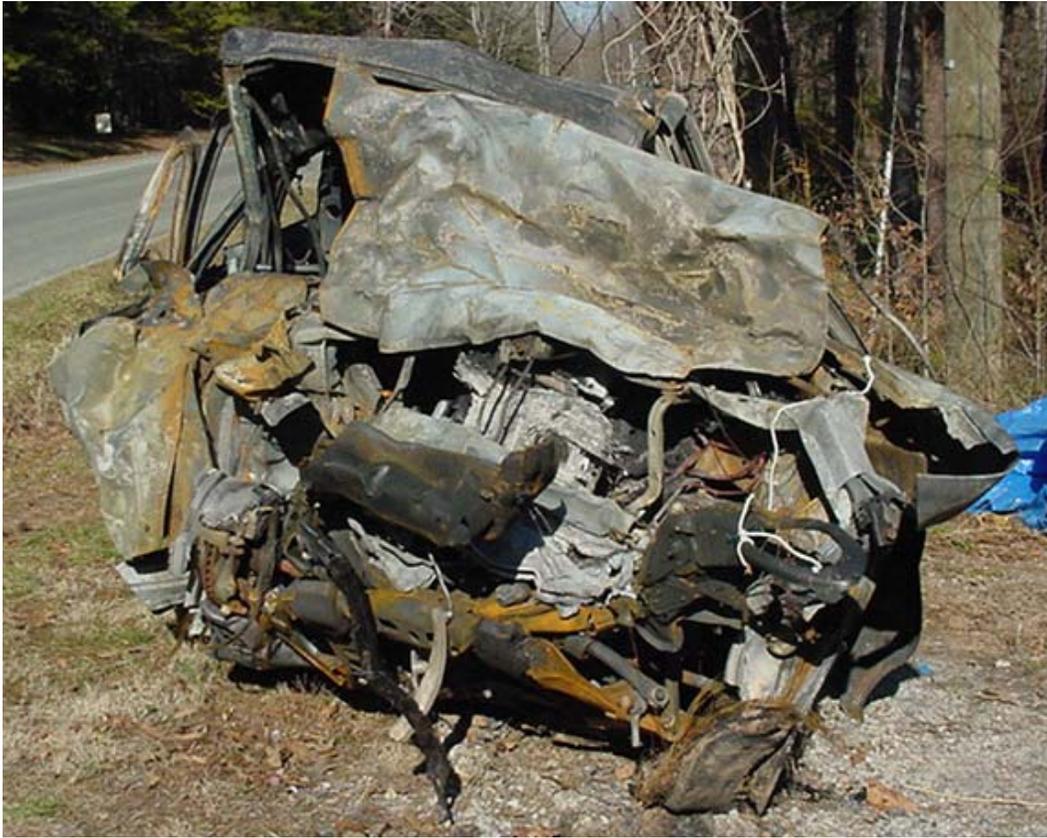
Upon impact, the two vehicles moved forward into each other, causing extensive crushing of the engine compartments and intrusion into the front occupant compartments for both SUVs. Although the damage occurred across the entire front of both vehicles, the heaviest penetration to the westbound Trailblazer was on the passenger side (see Photo 1 and 3). On the driver's side, the front of the vehicle was crushed in 2.9 feet; on the passenger side, the severe forces collapsed 5.2 feet of the engine compartment. For the Expedition, the driver's side received the greatest intrusion (see Photo 2 and 4). The front of this SUV was crushed in 3.2 feet on the driver's side, while the passenger side had 2.9 feet of collapse. After maximum engagement, the vehicles began to separate and rotate. Fire erupted as a result of the collision. Damage to the vehicles and the road made it impossible to determine specifically where and when the fire started, or its cause. The lighter Trailblazer was pushed backward, rapidly rotating nearly 360 degrees counter-clockwise. It came to rest in the median with its rear wheels in the ditch and the back bumper against the raised median. This vehicle burned extensively, destroying the white painted surfaces and leaving the metal exposed. The grass median caught fire and burned the area around the Trailblazer, as well. The Expedition continued forward slightly after impact, rotating clockwise approximately 165 degrees, and came to rest in the left travel lane. The red painted surfaces, tires and non-metallic components of the Expedition burned, including the spare tire mounted beneath the luggage compartment, which left an impression in the asphalt pavement.

**Photo 1: Front view of Trailblazer**

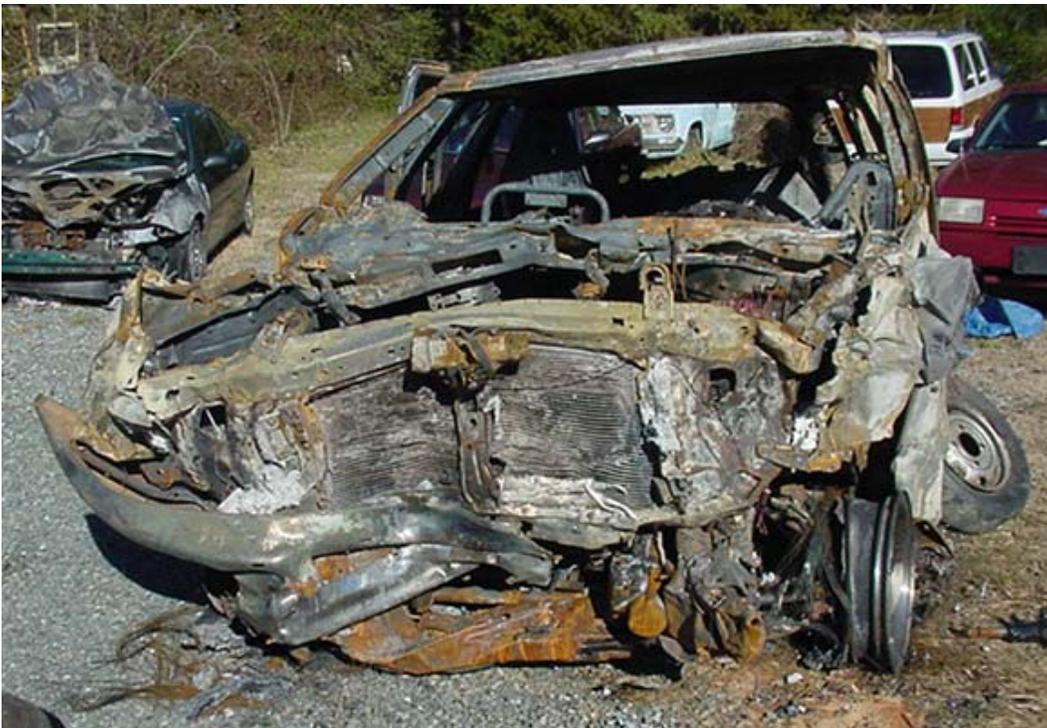
**Photo 2: Front view of Expedition**

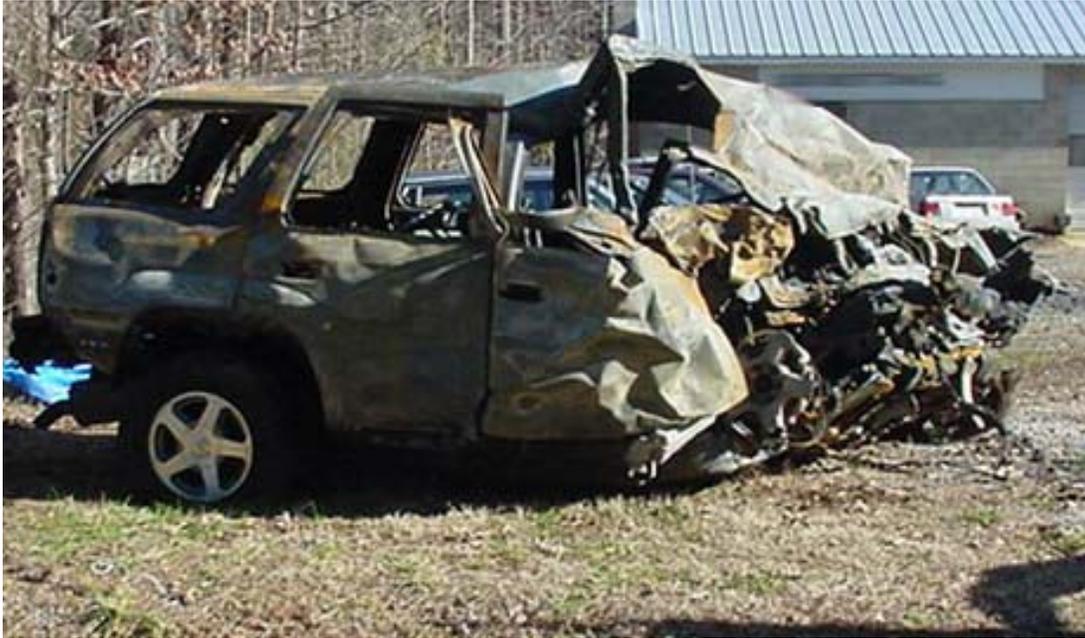
**Photo 3: Right side view of Trailblazer**

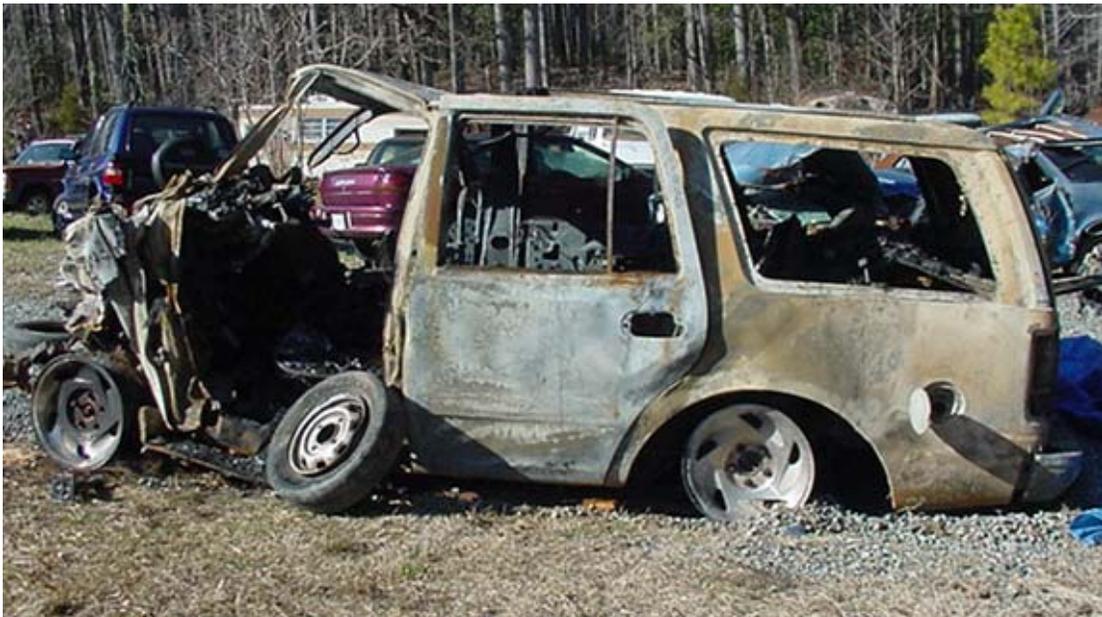
**Photo 4: Left side view of Expedition**

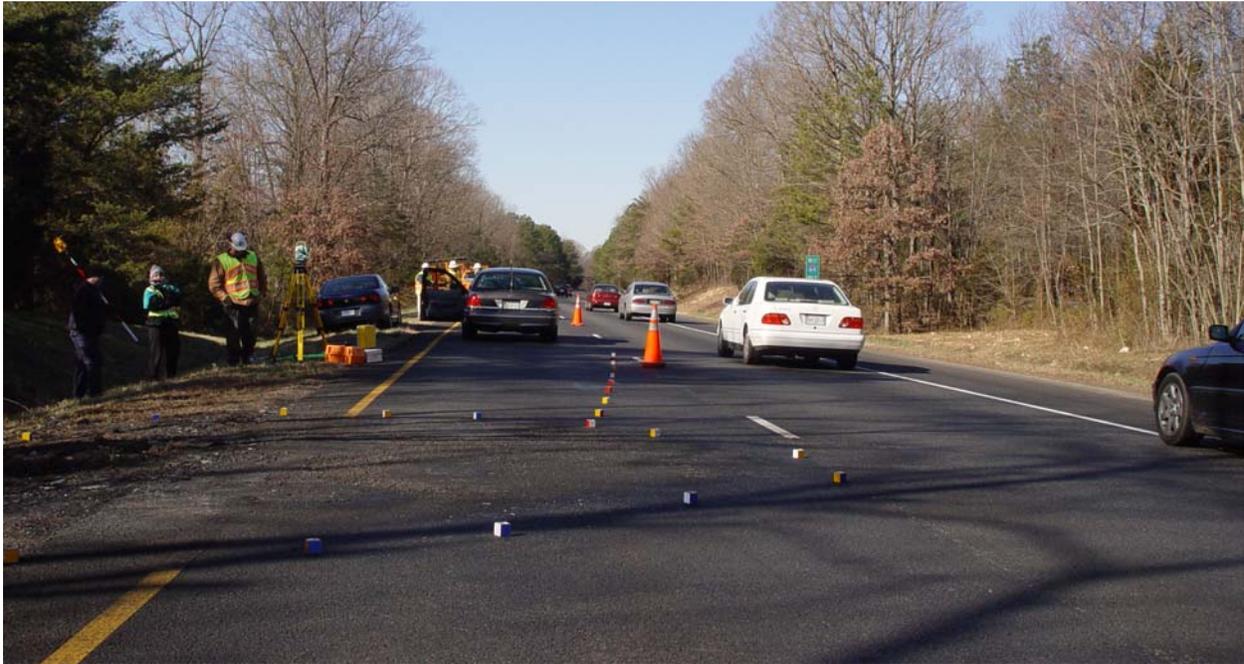
**Photo 5: View looking west with burned area in foreground. Note total station on left shoulder and cubes depicting remaining scuff mark and outlining the burned area.**

The scarred and burned areas of the road were noted and measurement of the remaining scuff mark was documented. According to the reconstruction trooper who had been on the scene, four scuff marks had been visible the night of the crash. These marks, which showed clear crossover of the tires and striations from their sliding during the abrupt steering maneuver, were not measured or photographed at that time. A week later, only one mark, 70 feet long, was visible (see Crash Diagram, page 3). Based on the reconstruction trooper’s identification, this mark was determined to be from the loaded steering tire, in this case, the left front tire of the wrong way vehicle. Two sets of chord and middle ordinate measurements were taken to determine speed from the remaining scuff mark. An initial speed of approximately 83 mph was calculated for the wrong way vehicle. The second set, taken closer to the point of impact,
