**Virginia Commonwealth University
Transportation Safety Training Center
Virginia Multi-disciplinary Crash Investigation Team**

Report Number 198 – December 2006

VIRGINIA
MULTI-DISCIPLINARY
CRASH INVESTIGATION TEAM
REPORT NUMBER 198
Urban Primary Road
1990 Ford Ranger
2005 Mercury Sable
1999 Plymouth Voyager

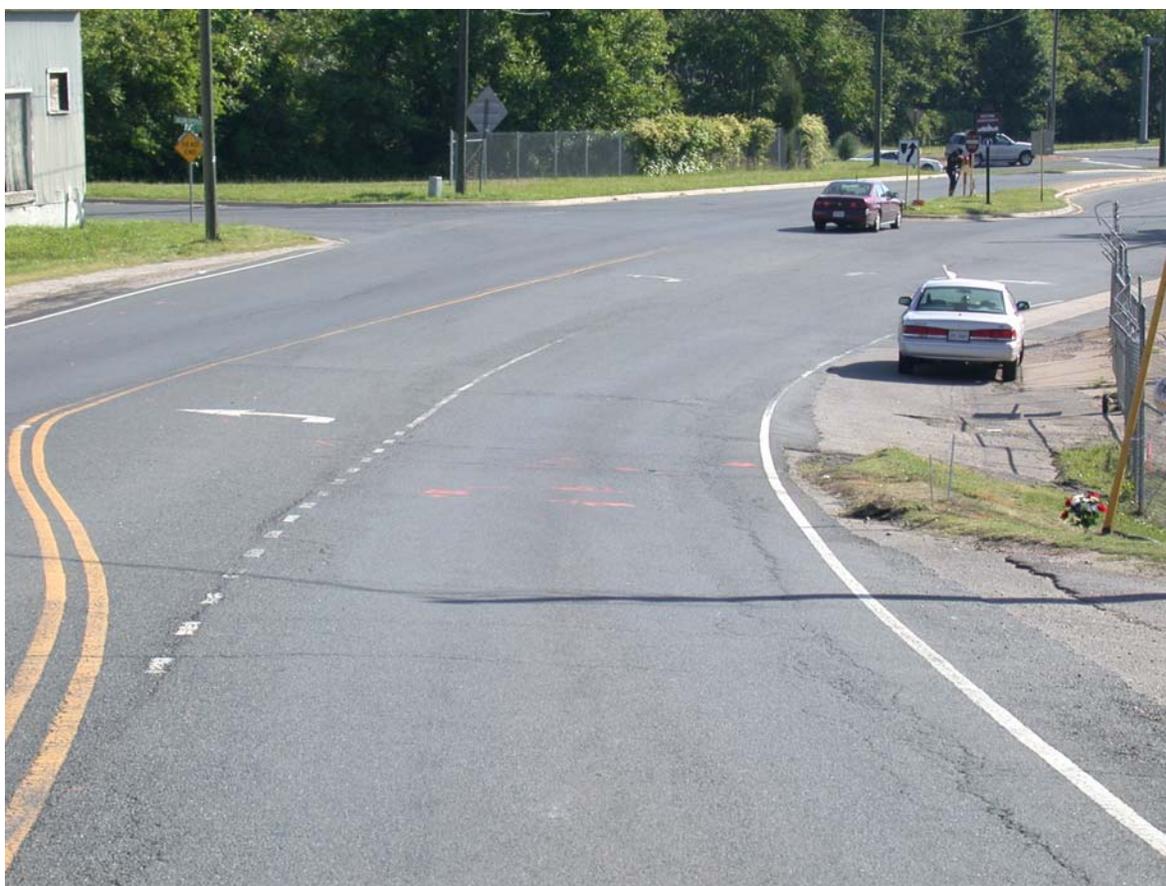
Photo 1: View looking north, direction the Voyager was traveling. Note the back of the sole advisory sign for southbound traffic, just north of the intersection on the left.

Upon viewing the scene just after the crash, the Trooper noted that the lane line markings for this primary business route were faded and worn from traffic volume. Due to population

increases in the area and changes in traffic patterns, the primary business route has experienced a high volume of traffic passing through the signalized intersection with the major east-west primary road. For vehicles turning onto the southbound lanes of the business route, there was only one warning sign advising motorists that the right lane ended within 100 feet. While drivers familiar with the intersection could plan ahead for the merge, those newer to the area could easily be caught off guard and have difficulty managing the merge in heavy traffic conditions while also watching for traffic from the eastbound merging lane and the intersection on the right.

After the crash, the city employed an engineering consulting firm to review the roadway and make recommendations. Some of the recommendations have already been implemented: 1) additional advance warning signs indicating the right lane ends 300 feet and 200 feet have been installed, 2) a speed limit “35 MPH” sign and a graphic warning “no U turn” sign have been installed.

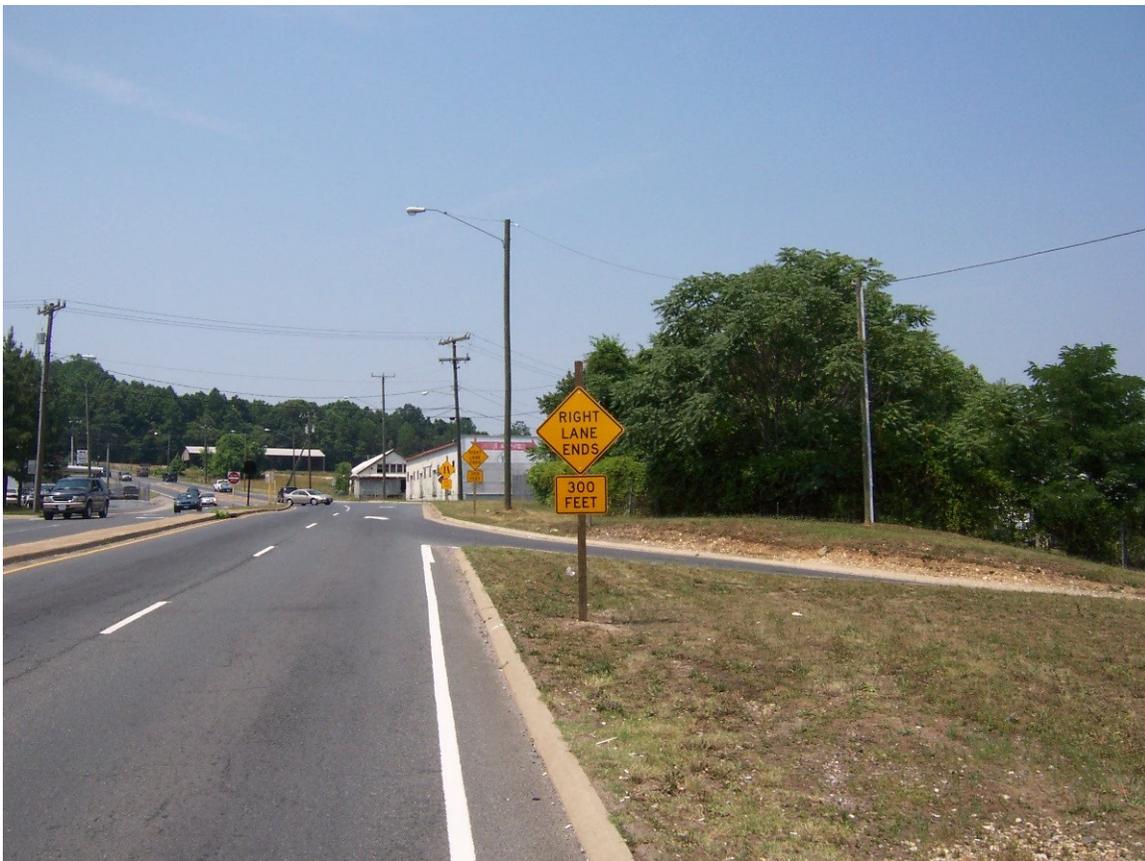
Photo 2: View looking south, after additional warning signs and repainted pavement markings were added.

The consultants also recommended two other changes: graphic “yield” pavement markings on the exit ramp from the eastbound primary road where it intersects with the primary business route and a stop bar on the city street at its intersection with the primary business route. These recommendations had not been implemented at the time of the VMCIT’s last visit to the site several months after the crash. On the other hand, the city recently repainted existing pavement markings and replaced the old warning sign for the merge at 100 feet with a new graphic one. The implemented changes have significantly improved the level of safety in this area by delineating the roadway and lanes more clearly and by alerting drivers with repetitive warnings to reinforce the merging action required.

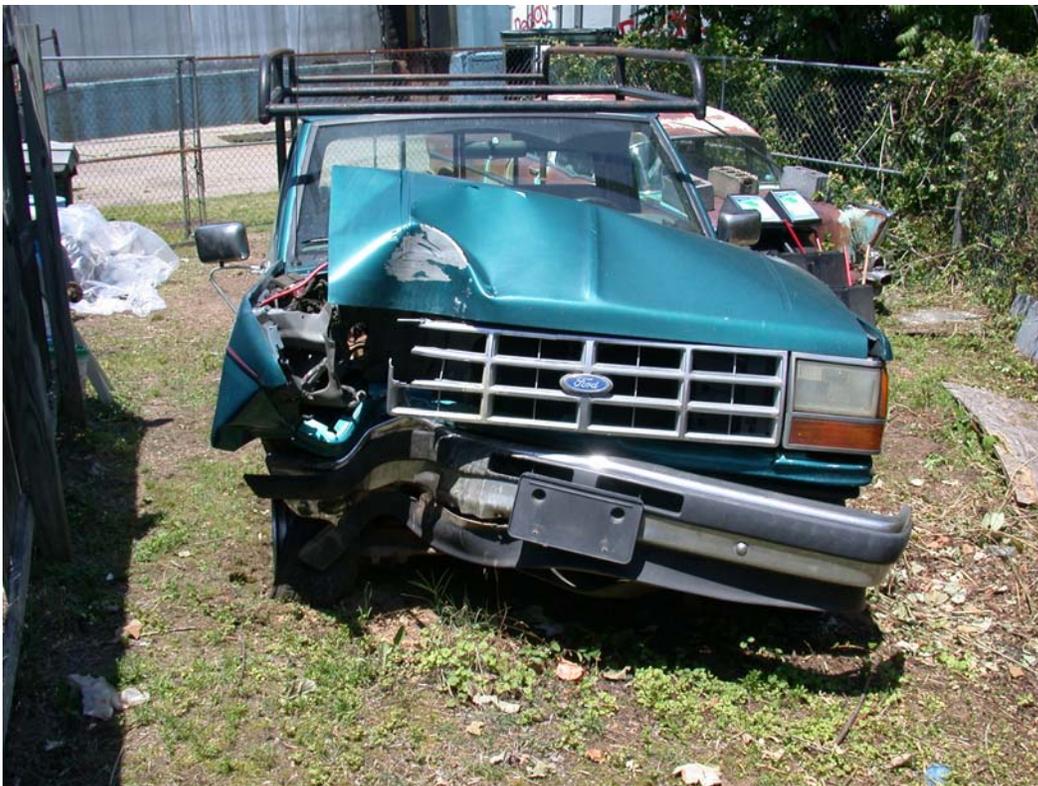
The Ranger was an older model vehicle that displayed a valid safety inspection approval sticker and appeared to be in sound mechanical condition. The license plates had been removed when a VMCIT member inspected it. No defects were noted during the post-crash inspection. Contact damage was noted on the right front corner with paint transfer from the Sable. There was also contact damage consistent with the pole on the right side of the front bumper between the center point and the right headlamp. The pole intruded into the front end of the vehicle almost 11 inches, at a width of over 8 inches.

Photo 3: Front bumper of Ranger

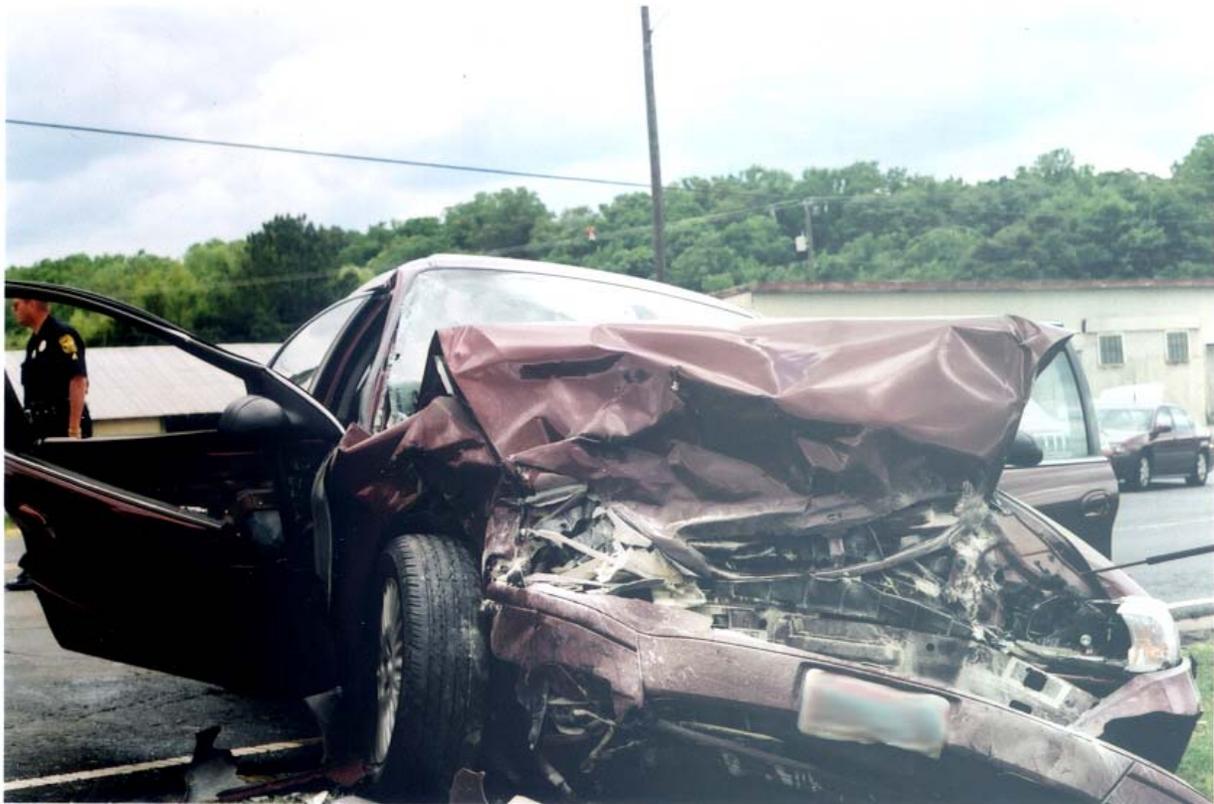
The Sable driver normally drove the car, which was registered to her husband. The safety inspection sticker was unreadable due to the collision damage to the windshield. The Sable was a newer model and the equipment was found to be in good working order. No apparent defects were noted during the post-crash inspection. Slight contact damage on the left rear quarter panel was noted along with paint transfer from the Ranger. Crash damage from the head on collision with the minivan extended across the entire front of the vehicle. The right side sustained almost two and a half feet of crush, while the left side had less intrusion, at just over a foot. The wheelbase of the Sable was shortened on both sides by over 10 inches and the damage configuration indicated that it under-rod the Voyager. The seat belts in both front occupant positions were routed behind the seat backs; then the latch plates were inserted into the buckles.

Photo 4: Front View of Sable

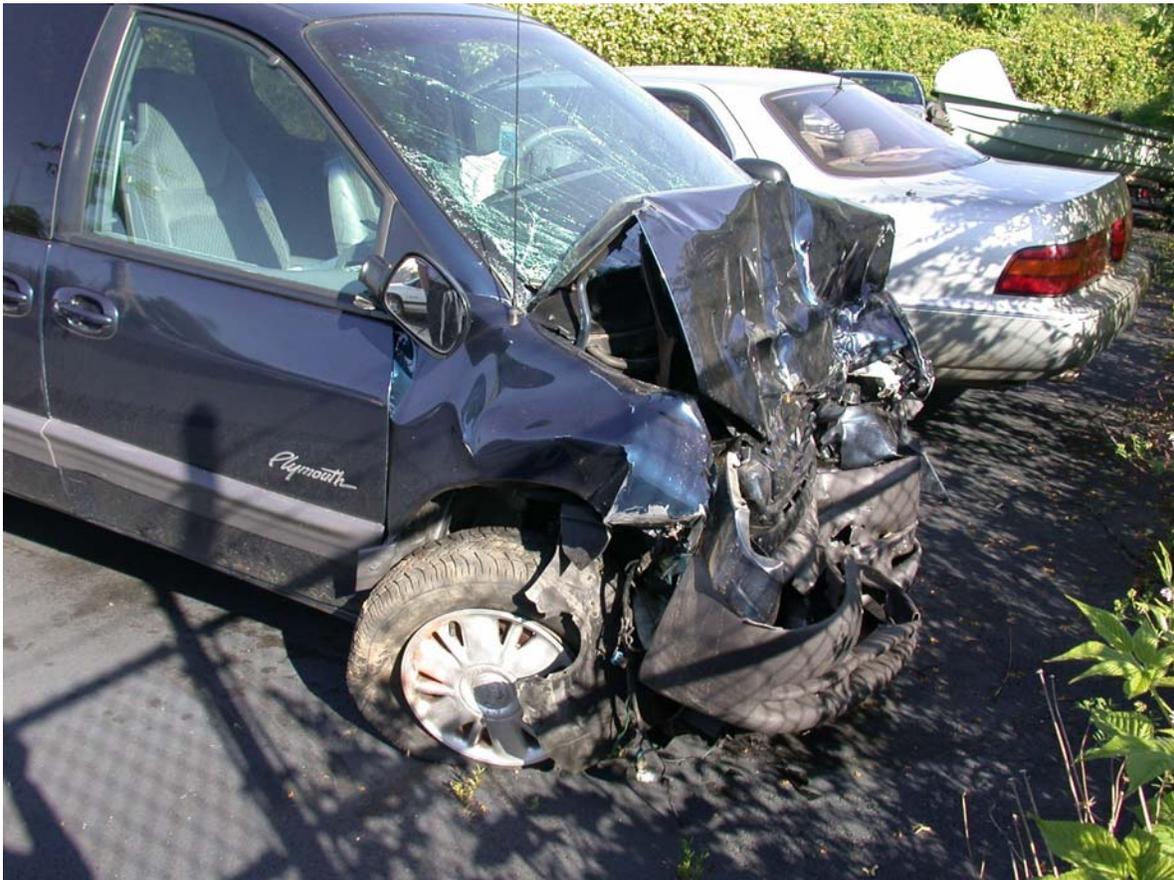
The Voyager, which was driven by its registered owner, displayed valid license plates and safety inspection approval sticker. There were no apparent defects noted during the post-crash inspection. The latch plate for the driver's seat belt was found still inserted in the buckle

and the belts had been cut. The minivan sustained contact damage across the entire front, with 12 inches of collapse on the right side and over nine inches of crush on the left side. The damage configuration was consistent with a slight over-ride of the Sable. The wheelbase, while not significantly altered on the left side, was shortened by over five inches on the right, when the intruding Sable struck the wheel.

Photo 5: Damage to Voyager

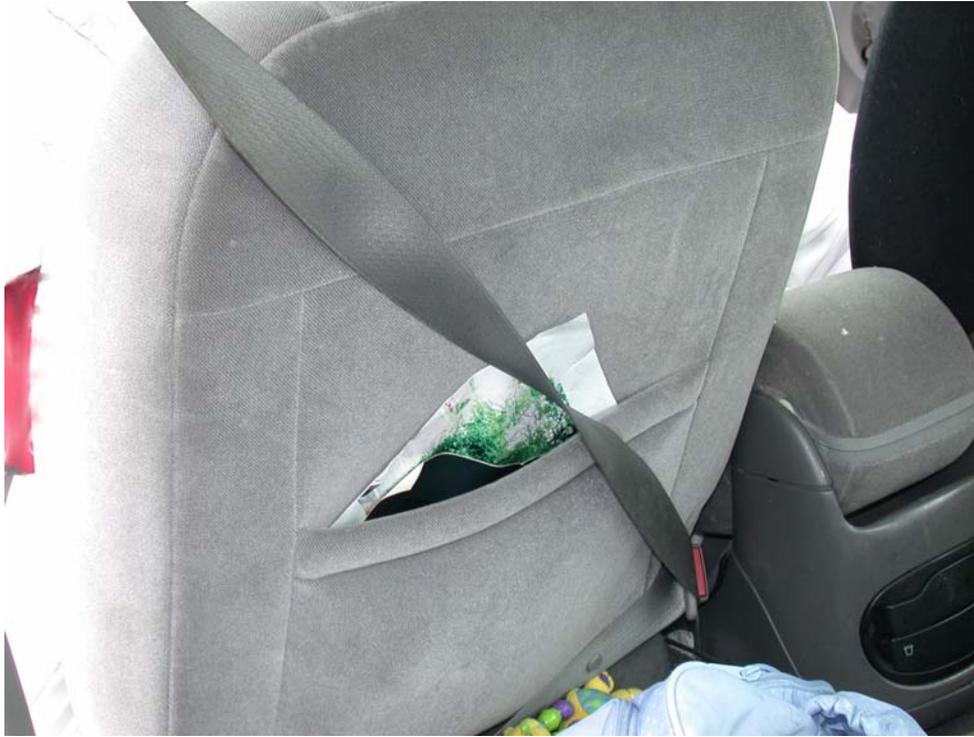
The pickup driver wore his lap/shoulder belt and consequently was not seriously injured during the initial collision or the secondary impact with the light pole. The front seat occupants of the Sable were in different circumstances. The driver was only 5 feet in height and she had her seat pulled close to the steering wheel and dash. Additionally, she was also overweight, weighing approximately 285 pounds. Her pregnant daughter-in-law was about 6 inches taller and weighed about 200 pounds. Both women had fastened their lap/shoulder restraints behind their respective seats. Their reason for declining to wear the belts is unknown, but the driver's husband reported that they fastened the belts behind the seat to keep the seat belt light and bell warnings from activating when the car was started and running. Their actions reveal a conscious decision to avoid using the restraints, rather than an unconscious forgetful act of omission. As a consequence, both were thrown to the left during the first collision and then forward with great force during the frontal collision with the minivan. Their bodies were in close proximity to the airbags as they deployed. While airbags can be life-saving devices during such collisions, they are designed to work in conjunction with belt systems, not alone. Injuries from sitting too close to airbags may be severe, especially to unbelted individuals, and airbags do not prevent occupants from being tossed around the interior of a vehicle during a crash sequence. In the Sable, neither woman had burns or abrasions on their faces from contact with the airbags; however, both died from blunt force trauma that occurred as their moving bodies contacted the rapidly inflating airbags and interior components of the vehicle. The driver also suffered fractures to her right thigh and left ankle from contact with the steering wheel and parts under the dash. Had they been belted, these women would not have been projected into the airbags and dash area with as much force, increasing their likelihood of survival.

Photo 6: Back of Sable driver's seat with belt routed behind seat and buckled.

2. Education and enforcement measures should be taken to increase the use of safety belts for all occupants of motor vehicles.
 - a. The Department of Motor Vehicles, the Department of Health, and agencies focused on public safety should continue to stress the life-saving and injury reducing capabilities of seat belts and actively promote safety belt use through media campaigns, training, and individual counseling.
 - b. The Department of State Police, local law enforcement agencies and the Department of Motor Vehicles should continue to develop, implement and assess enforcement programs designed to increase safety belt use (including programs like “Click it or Ticket” mobilizations).

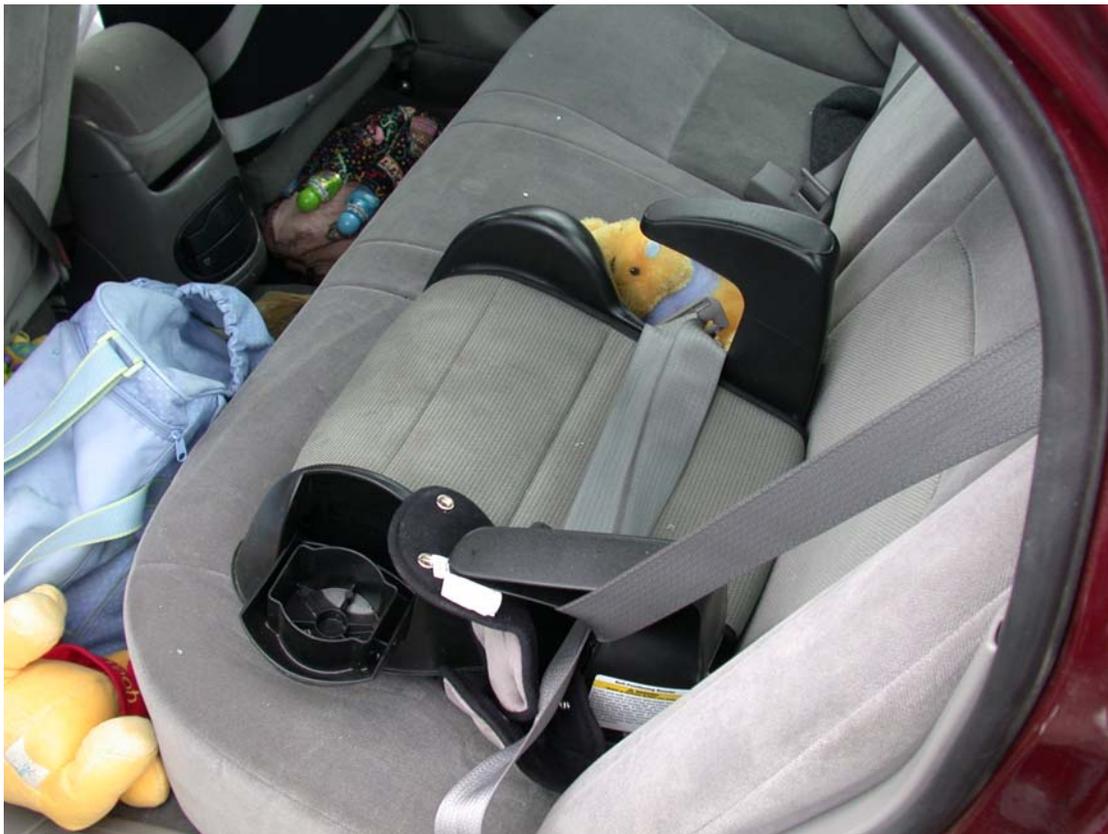
The 22 month old girl positioned behind the Sable driver was sitting in a belt-positioning backless booster seat. At her age and size, 28 pounds and 31 inches, she would have been safest in a forward facing convertible child safety seat or a high back booster seat with an internal harness. The five point restraint systems found in these types of seats would have provided much more energy dispersion across the upper and lower parts of her developing body. If the backless booster that was used had been installed correctly, she would have at least had a belt

passing across her chest from left to right, providing her some upper body protection. Tragically, both the shoulder and lap portions of her safety belt had been threaded through the lap belt guides molded into the seat. This left the child with only a lap restraint holding her in place. During the collision, that belt stretched some as she began to move forward. When the stretching stopped the forward movement of her pelvis, her head and torso snapped forward, while her legs and hips, below the belt, also continued forward. Her body dynamics resembled a jack-knife type of maneuver. She hit her head on the back of the driver's seat, causing a basilar skull fracture and a fracture of the first cervical vertebra, along with other spinal fractures. An internal harness would have prevented the intense forward movement and allowed the energy of the collision forces to be spread out over a greater area across her developing skeletal frame. She may well have survived this crash.

Photo 7: Backless booster seat with safety belts threaded through lap guides.

3. As recommended in the VMCIT’s *Special Report Number 20: Child Safety Restraint Study*:
 - a. The Virginia Department of Health, the Department of Motor Vehicles and the Department of State Police presently work with other state and local agencies to inform and educate those who transport children about appropriate child safety restraint use. Beyond stressing the importance of using restraints, these groups should continue to emphasize correct selection and installation of seats, along with proper use of internal harnesses and vehicle lap and shoulder belts. Methods for creating greater awareness and improving understanding as well as compliance across all populations should be explored, including working with pediatricians, child advocacy groups, and local communities.
