**Virginia Commonwealth University
Transportation Safety Training Center
Virginia Multi-disciplinary Crash Investigation Team**

Report Number 199 – March, 2007

VIRGINIA
MULTI-DISCIPLINARY
CRASH INVESTIGATION TEAM
REPORT NUMBER 199
Rural Primary Road

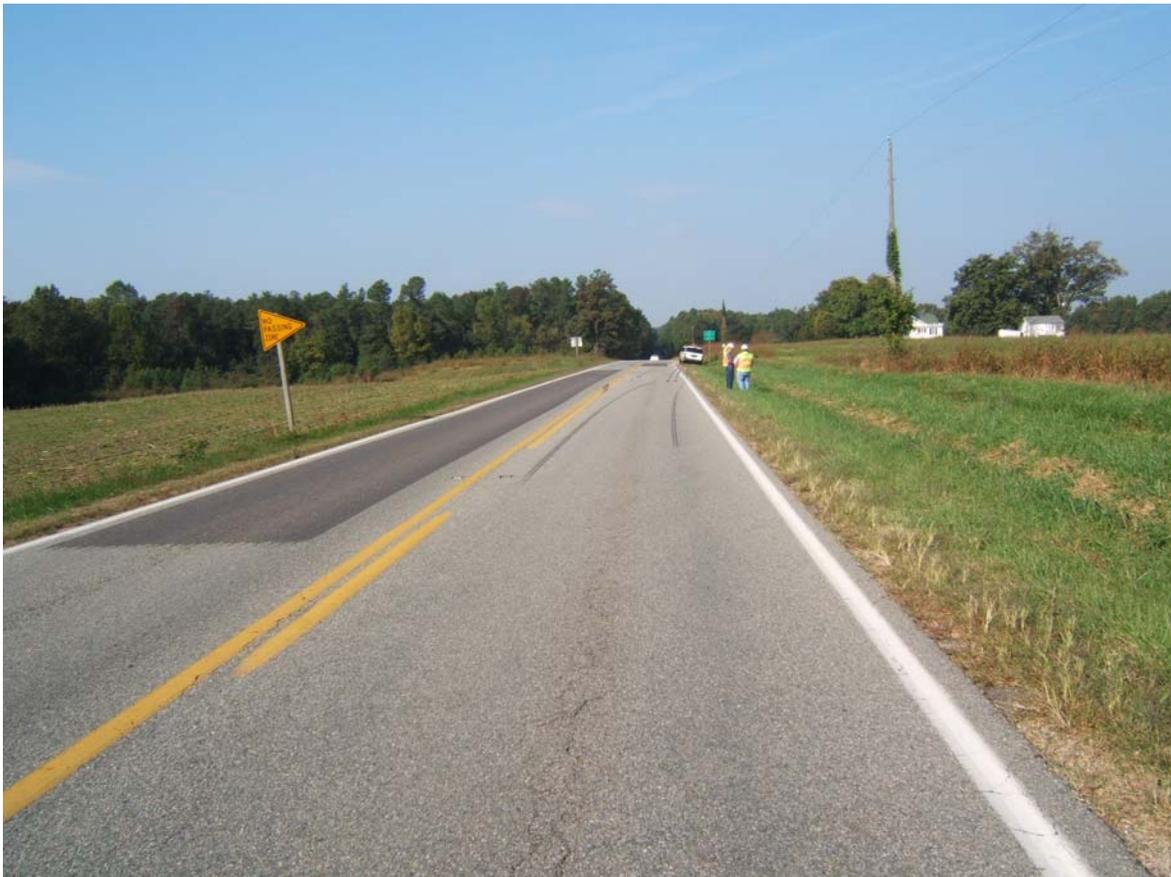
Photo 1: View facing west, showing tractor skid marks.

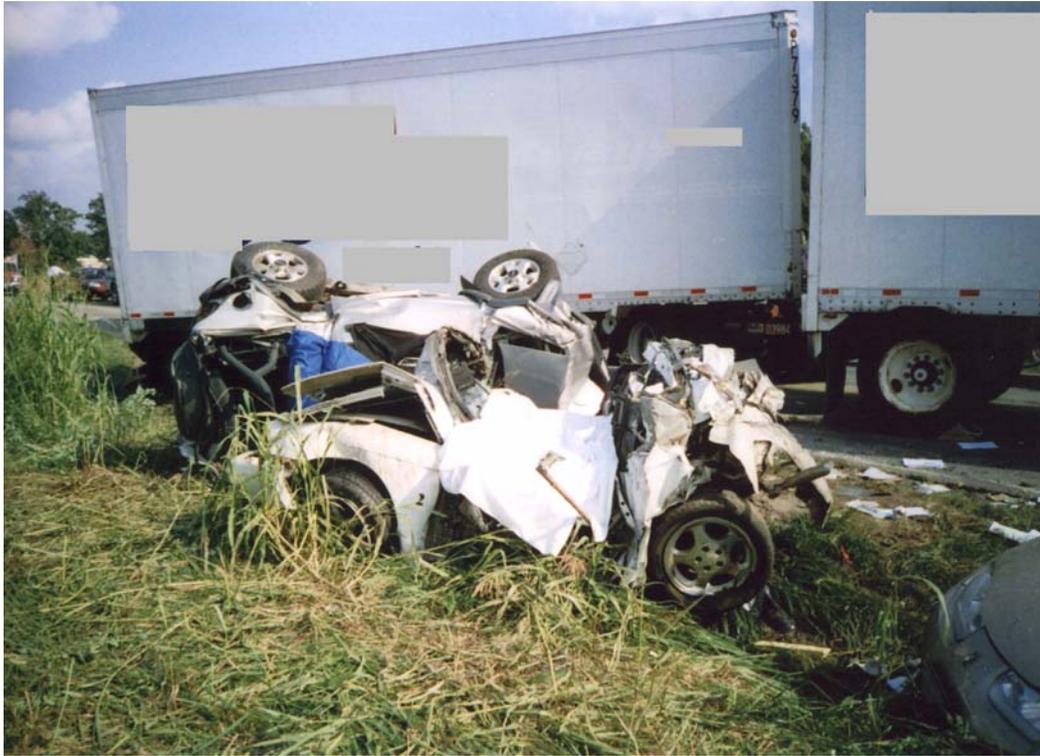
Photo 2: Final rest of the Mustang (foreground) and Amigo (wheels up beside Mustang) in relation to trailers.

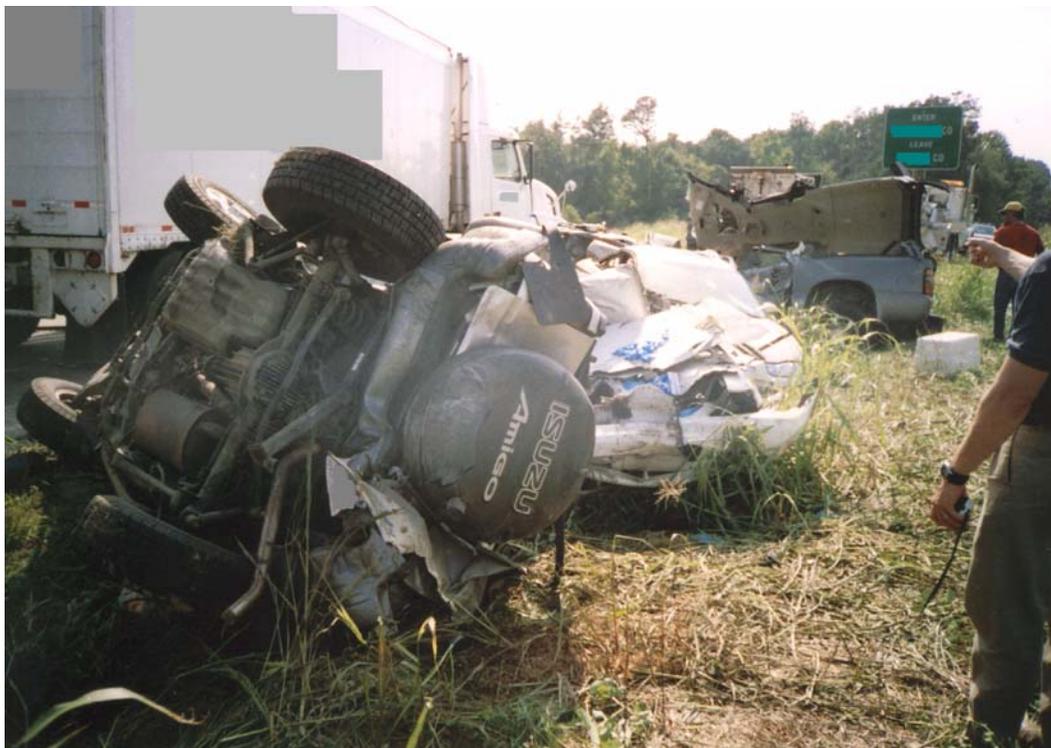
Photo 3: Final rest of the Mustang and Amigo from a perspective facing southwest.

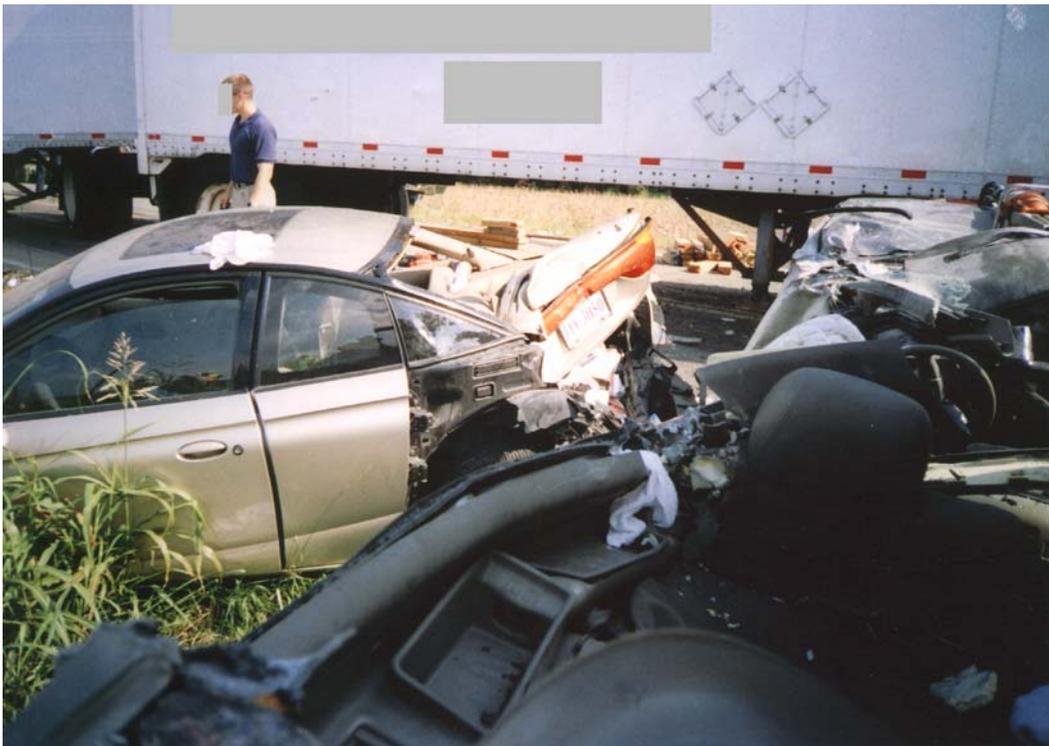
***Photo 4: Final rest of the Saturn. Driver's side view shows damage to the rear end.
The first trailer is in the background.***

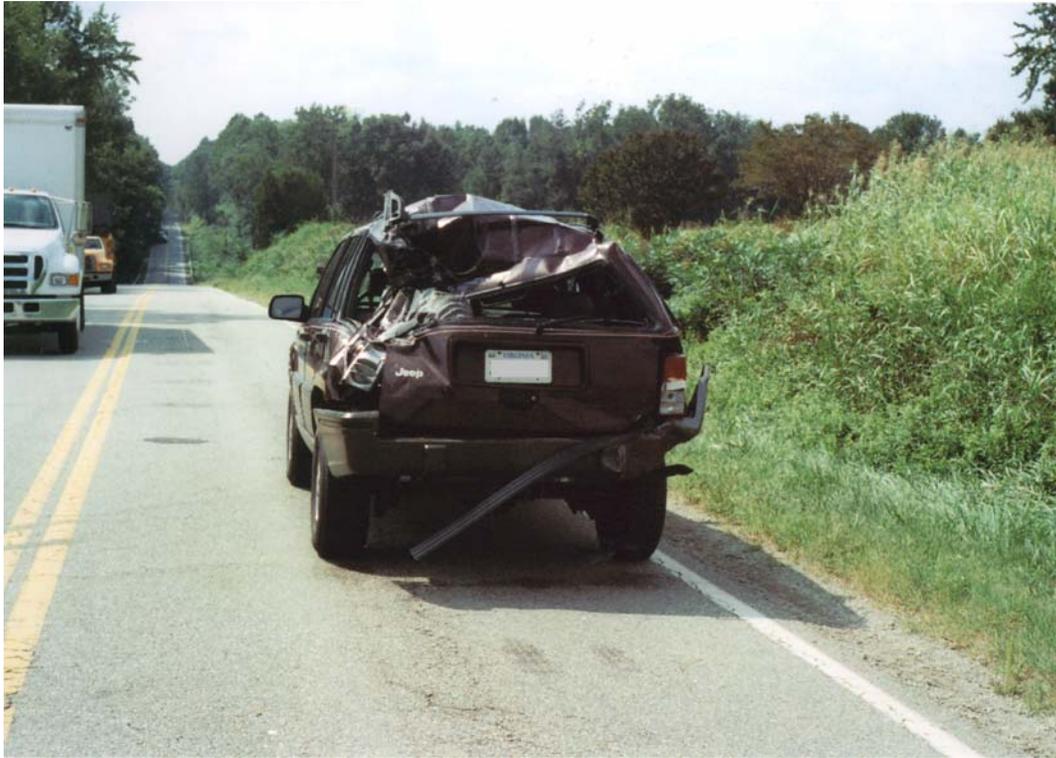
Photo 5: Jeep at final rest, west of impact site.

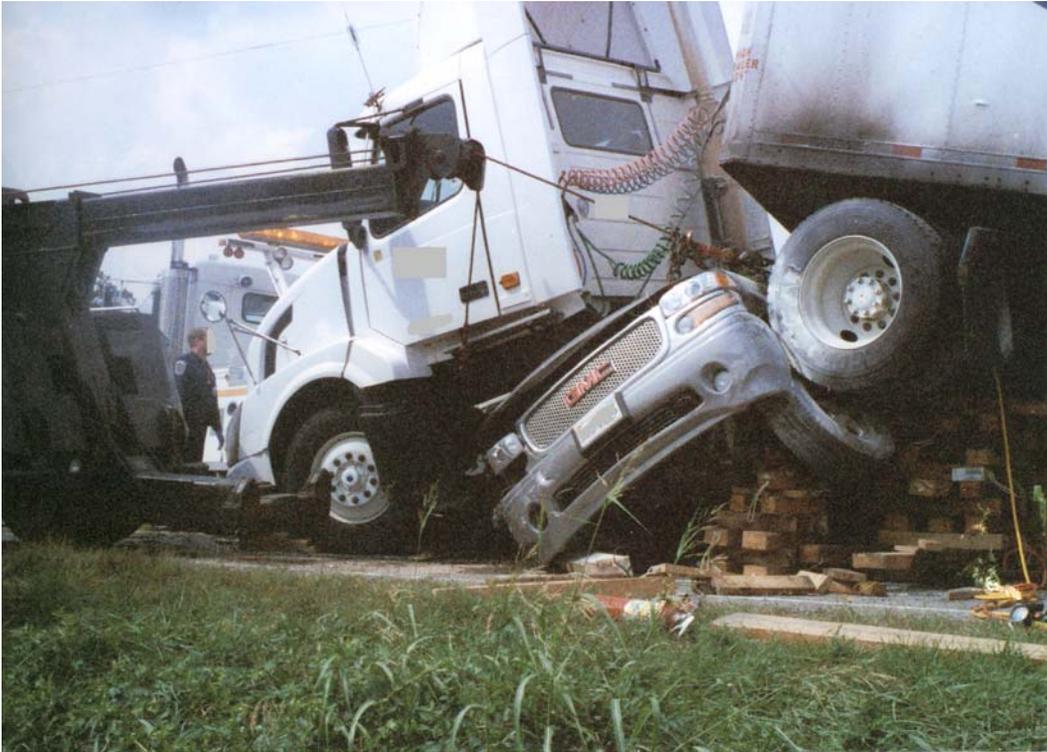
Photo 6: Yukon at final rest under tractor. Note scorch marks on bottom edge of trailer from fire.

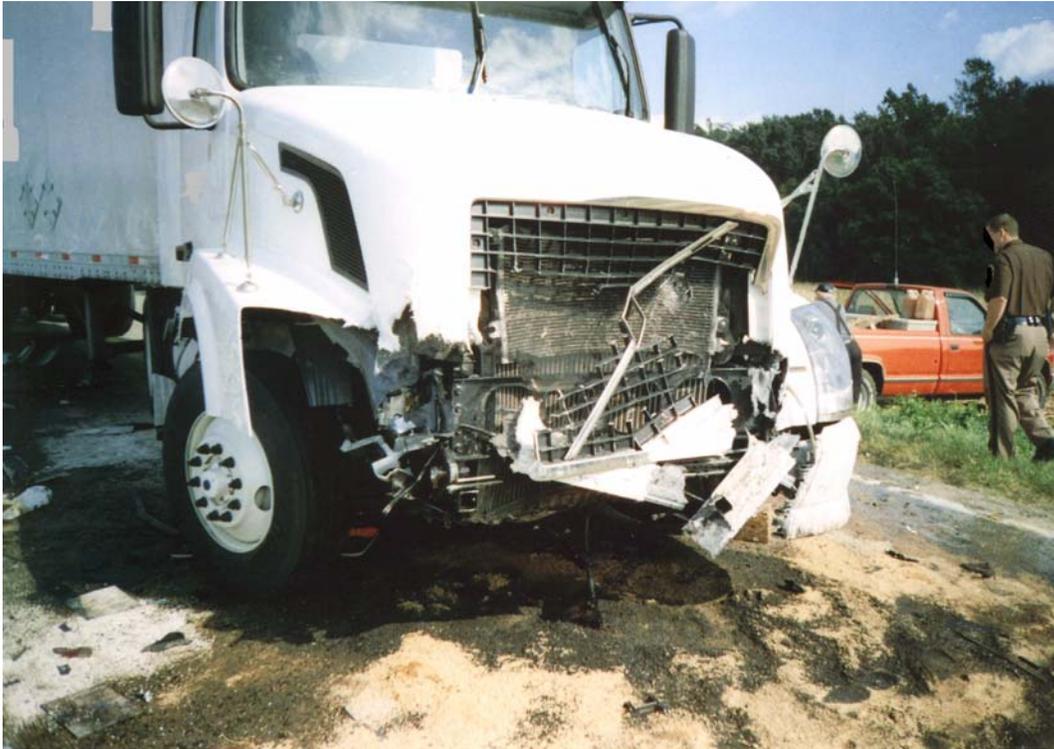
Photo 7: Damage to the front of the tractor.

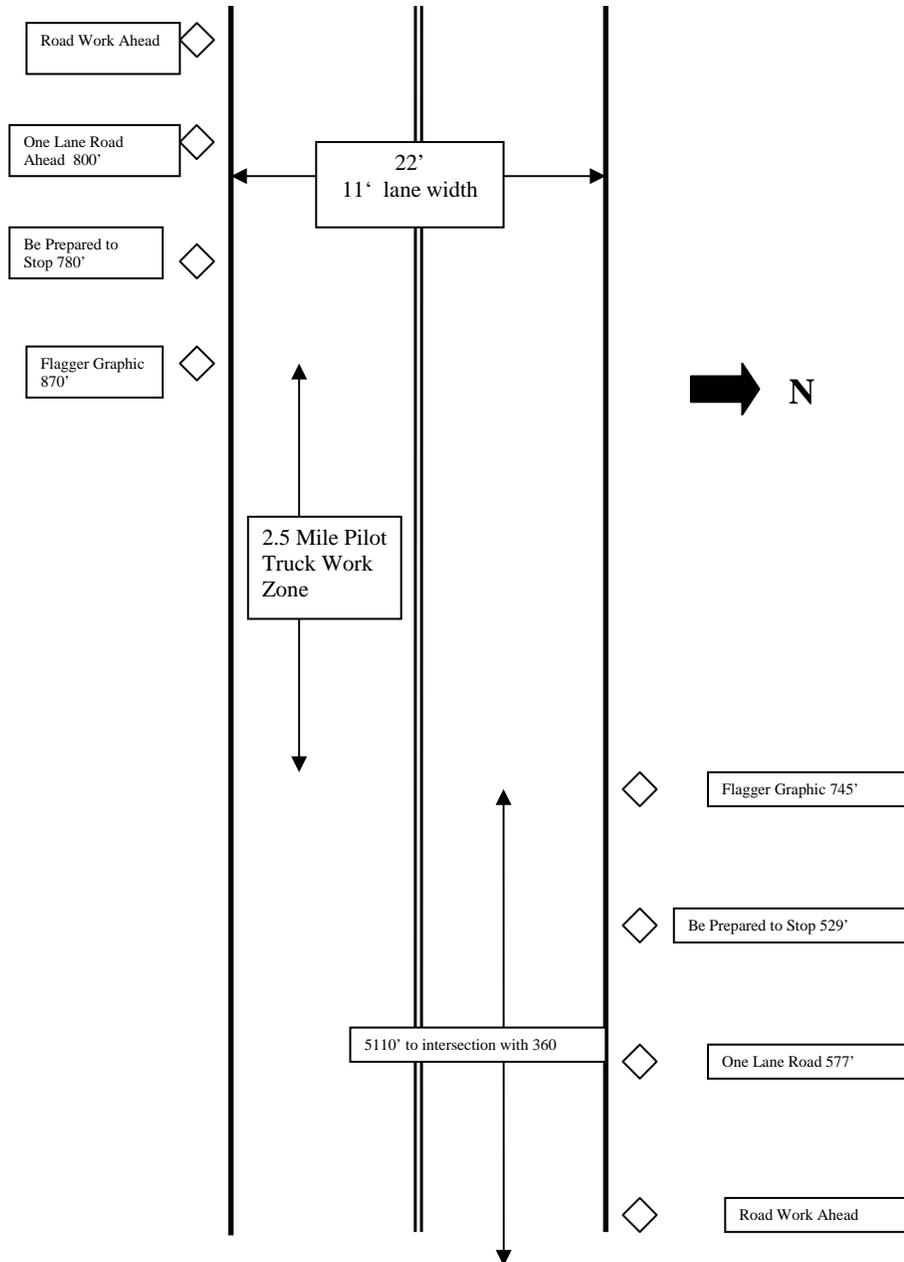
Figure 1: Work zone layout (Not to scale)

On the day of the crash, work crews were filling potholes and repairing pavement edges that had been damaged by a severe storm that has passed through the area the week prior. The layout of the work zone exceeded the minimum requirement of VDOT's work zone safety guidelines (VDOT, 2004). VDOT meets and generally exceeds requirements of the Federal Highway Administration. Due to the geometrics of the roadway, a pilot vehicle was used to guide traffic through the work zone to further enhance safety. In addition, truck mounted attenuators were used to protect the workers. The flaggers directing traffic at each end of the zone were state certified and wore appropriate hard hats and safety vests.

2. VDOT should study the feasibility of using portable rumble strips and/or other types of audible devices in work zones to warn motorists to increase their attentiveness and reduce speed.
