**Virginia Commonwealth University
Transportation Safety Training Center
Virginia Multi-disciplinary Crash Investigation Team**

Report Number 200 – May, 2007

SYNOPSIS

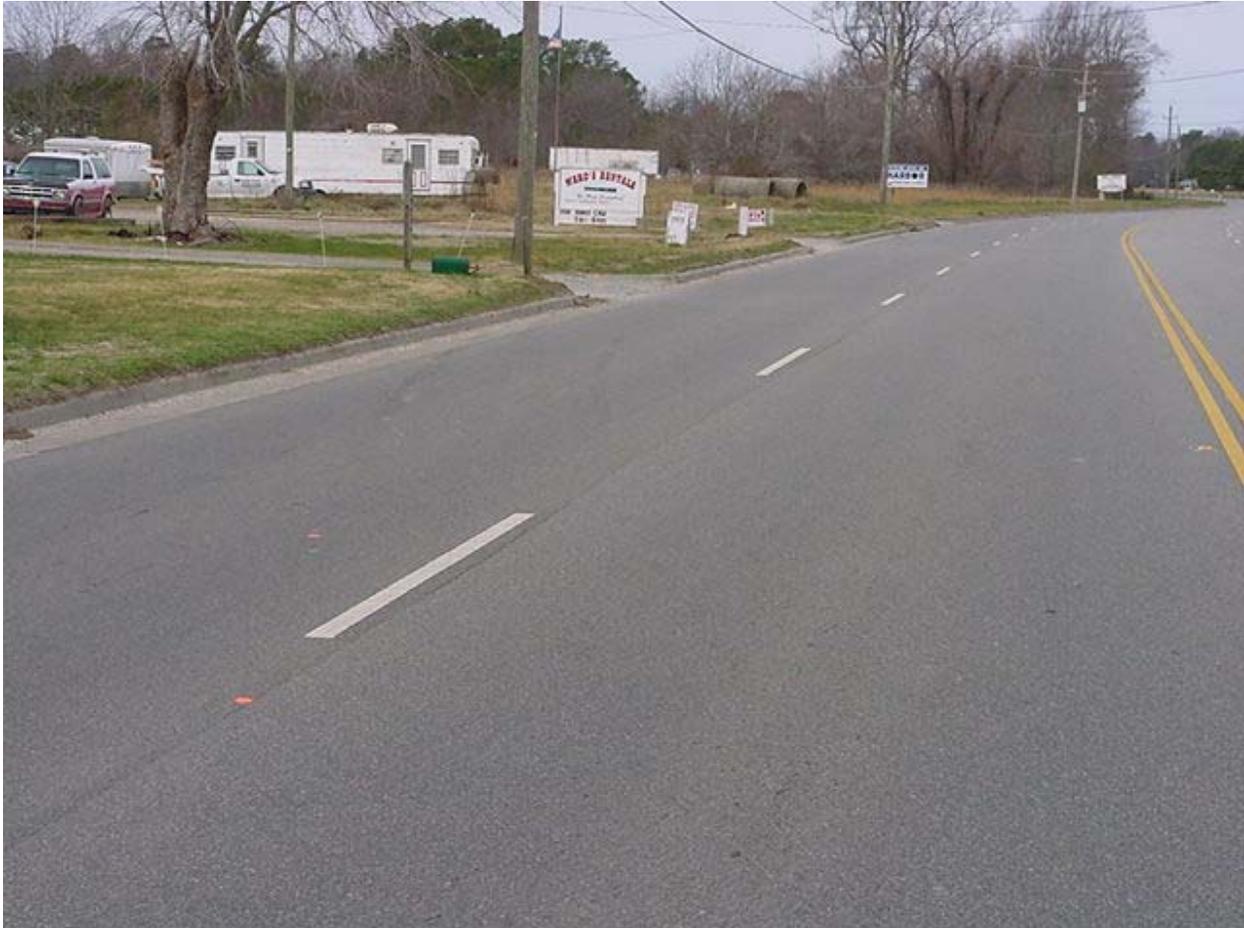
***Photo #1: View facing west, looking into area that the eastbound SUV had just traveled.
Yaw marks can be seen in the foreground crossing the eastbound lanes.***

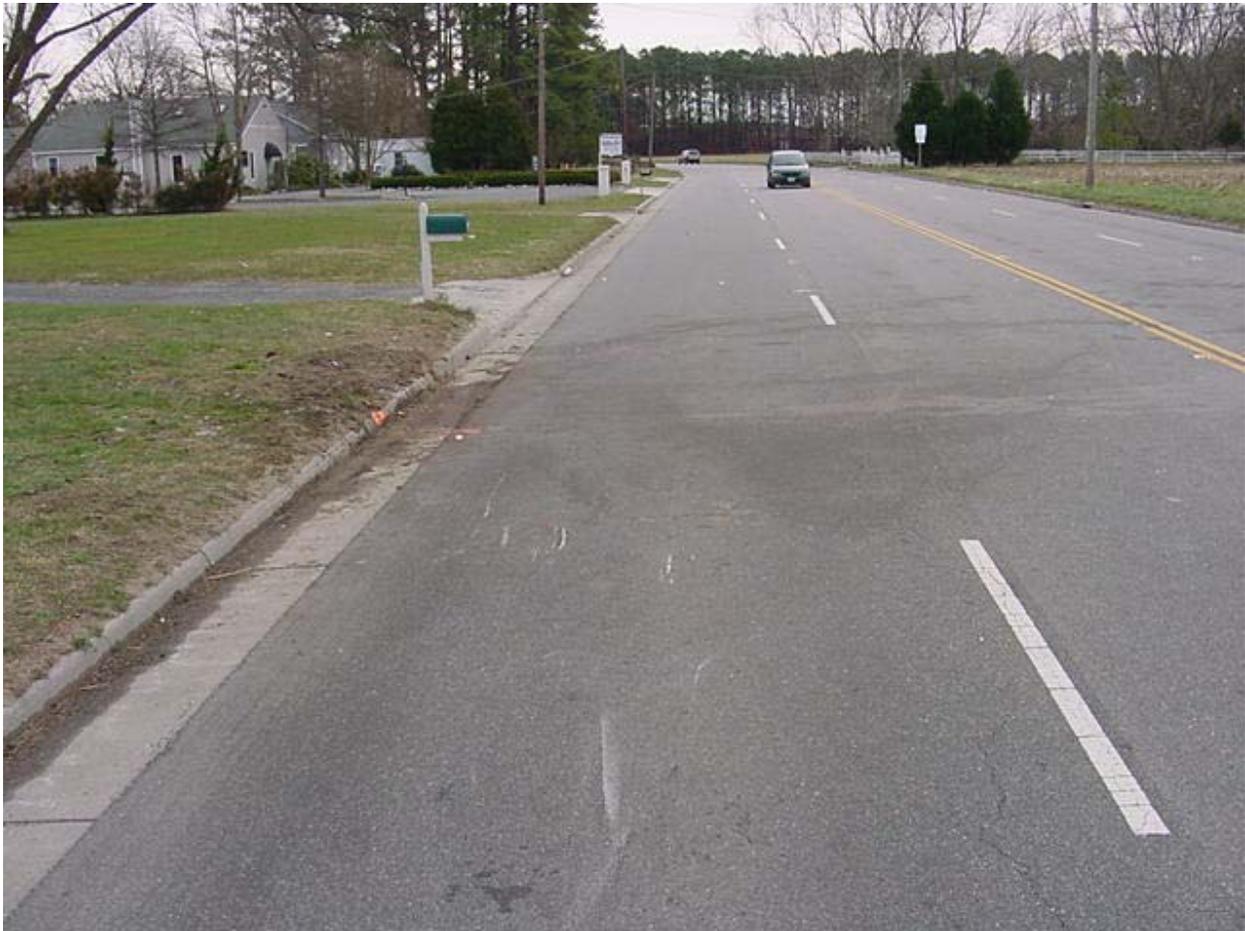
Photo # 2: View of approaching westbound lanes. Pickup had completed the curve and was traveling in the outside lane. The area of the collision can be identified in the foreground.

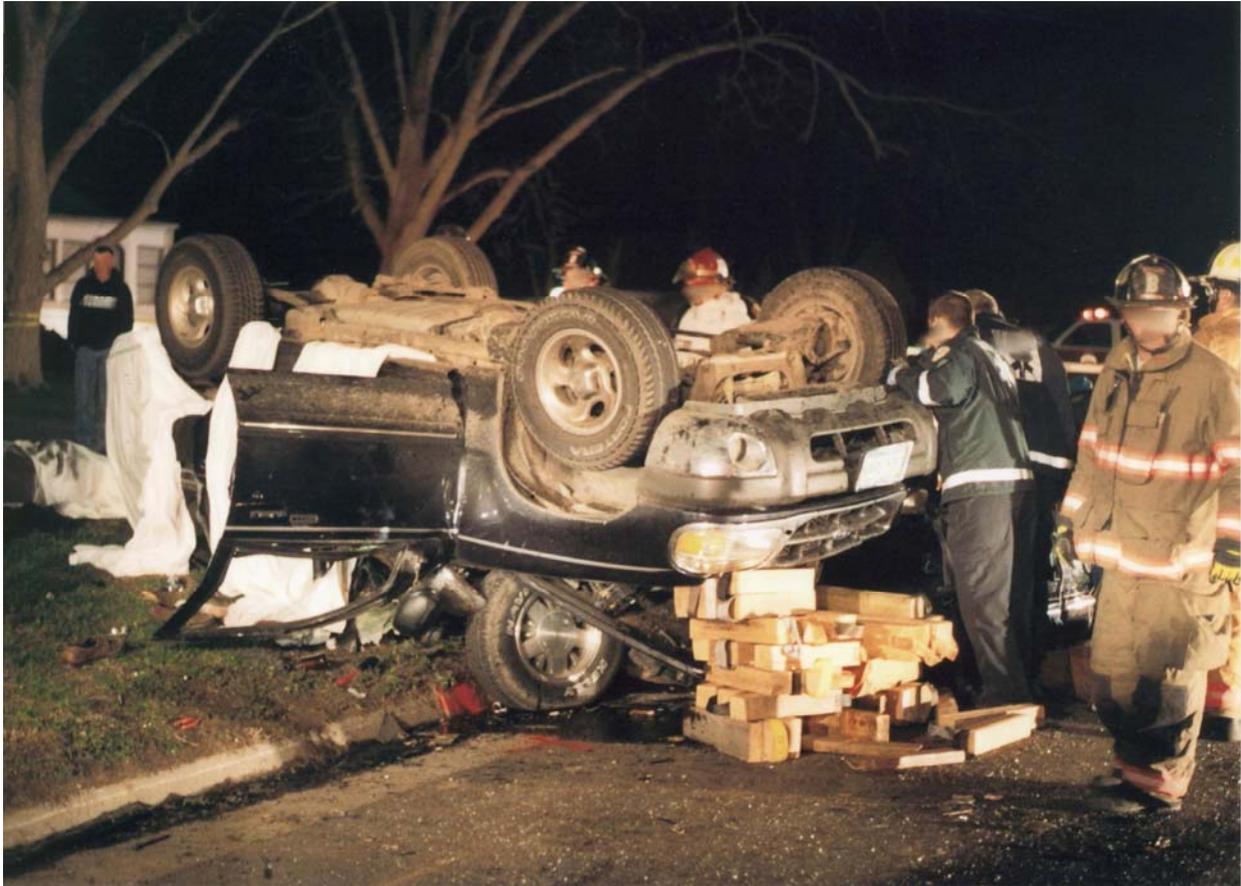
Photo #3: Vehicles at final rest

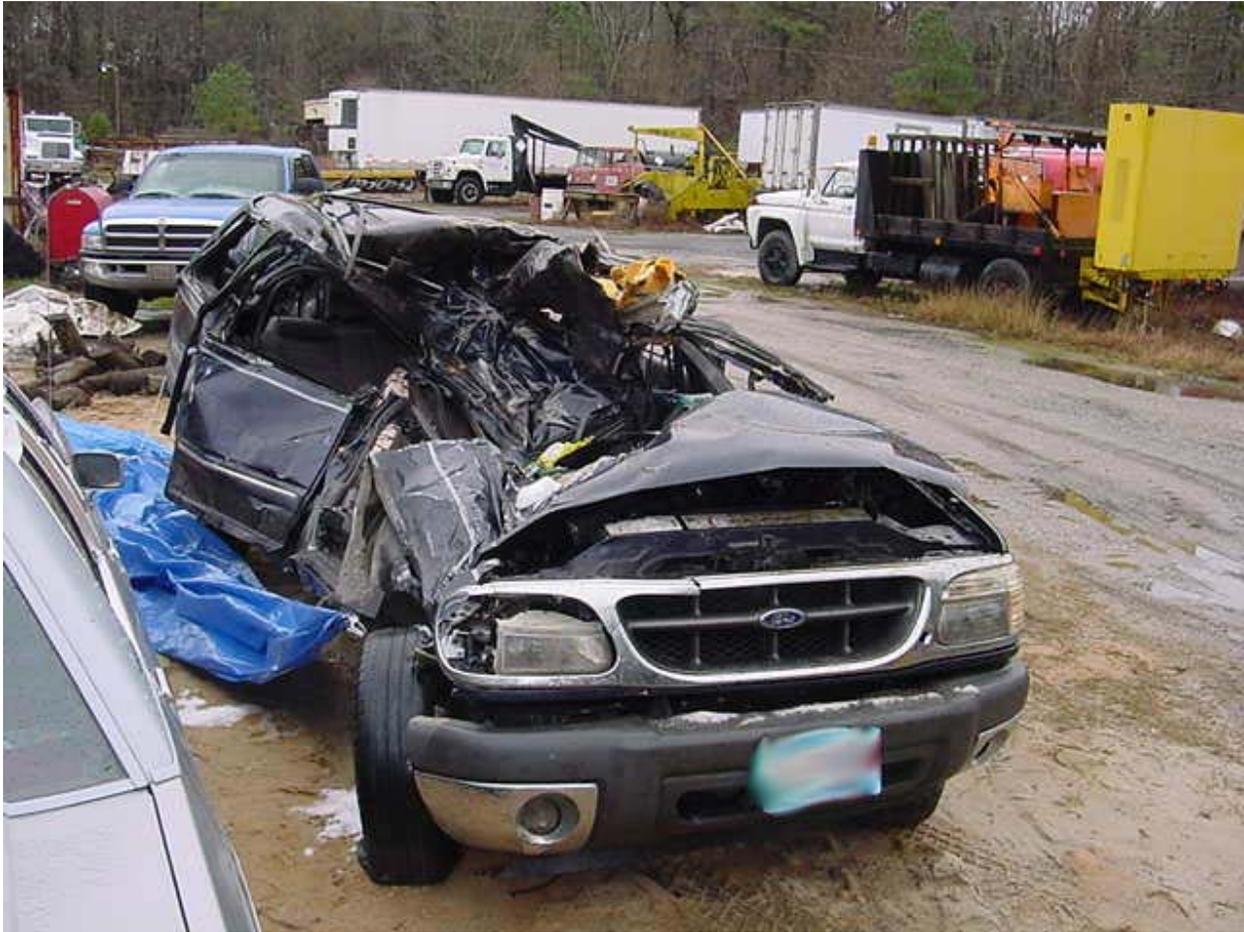
Photo #4: Front view of SUV.

Prior to the collision, this vehicle was destabilized upon mounting the 6 inch high curb. It continued forward with one set of wheels on the road and one set off. There was no evidence that the driver ever applied his brakes. The vehicle further destabilized when the driver first jerked the wheel to the left to avoid the utility pole. He then went through a second driveway

and struck adjacent mail boxes before dropping off the same curb. He regained the roadway and began rotating counter-clockwise as he crossed both eastbound lanes and the center lines. His next violent steering action, to the right, caused the vehicle's weight to transfer from one side of the vehicle to the other and the SUV began to rotate clockwise, which ultimately caused it to roll onto its left side. The SUV's roll was stopped when it struck the pickup and mounted its hood. A speed calculation from the scuff marks left by SUV just after it entered the westbound lanes was approximately 65 mph.

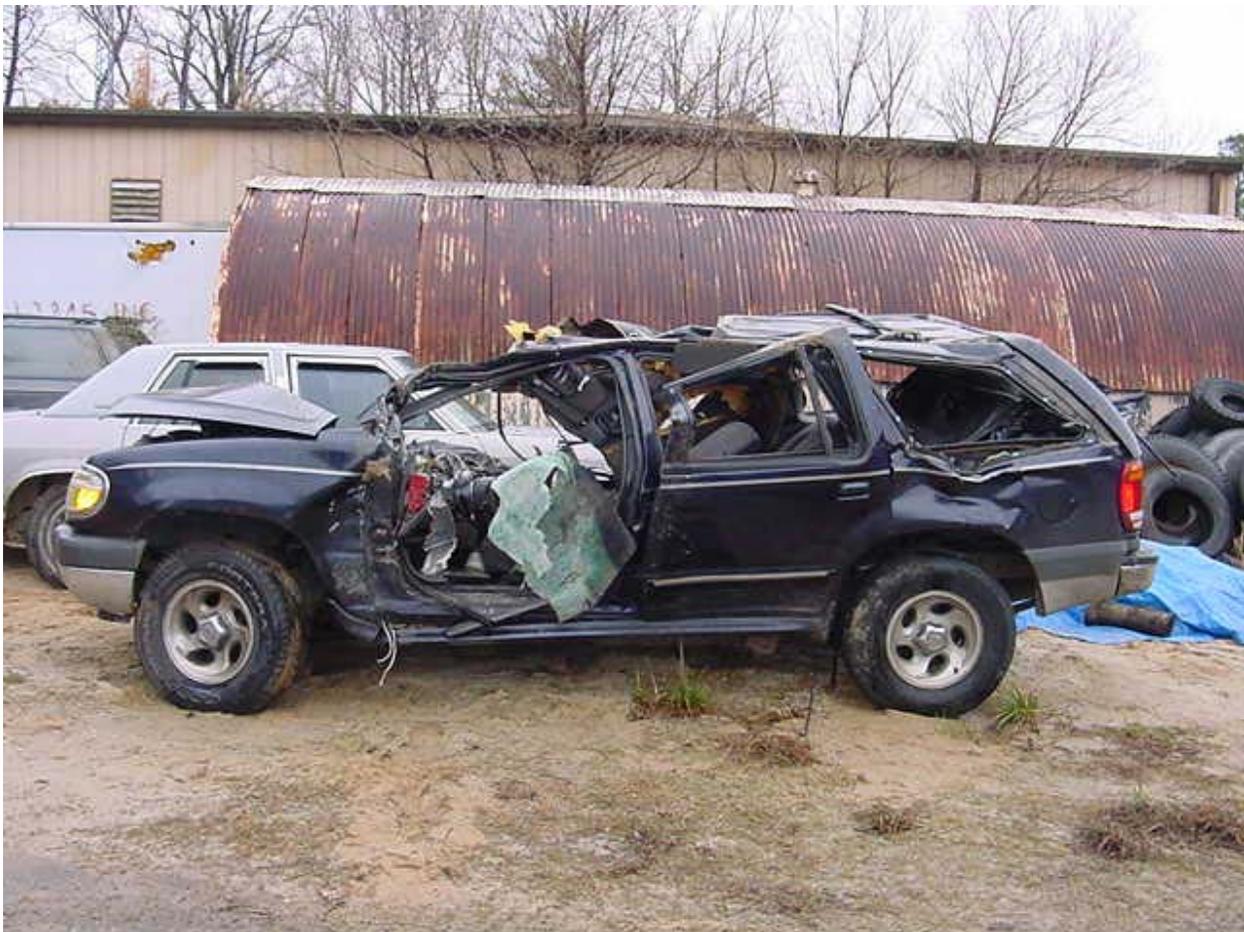
Photo #5: Side view of SUV.

Fatality rates (per million registered vehicle years) in Ford Explorer SUVs (model years 2000-2003) are higher than the average and the rate in single vehicle rollover crashes is significantly above the national average. This is in part due to the lower stability of the vehicle, which can be measured by its Static Stability Factor (SSF) and dynamic maneuvering tests. A vehicle's SSF is determined by measuring the track width (t) and dividing by 2 times the height

of the center of gravity above the road (2h). The higher the ratio, the more stable the vehicle. Generally, passenger cars have SSFs between 1.3 and 1.5 while SUV's and pickups, with higher centers of gravity and shorter track widths, often range between 1.0 and 1.3. Published reports of the SSFs for 4 door Ford Explorers released between 1995 and 2002 ranged from 1.07 to 1.14 (Walz, 2005). The National Highway Traffic Safety Administration (NHTSA) combines the SSF with a dynamic maneuvering test for tipping to arrive at a star safety rating for rollover chances in different vehicles. These ratings are reported in addition to the frontal and side impact safety ratings. Although the 2000 Ford Explorer SUV was not rated in this category, the 2001 model received a low two-star rating. Vehicles receiving this rating had a 30 to 40 percent chance of rollover during a single vehicle crash. Many manufacturers, including Ford, have redesigned their vehicles to improve their stability and their safety ratings, as well as adding electronic stability control systems for improving outcomes in dynamic maneuvering situations.

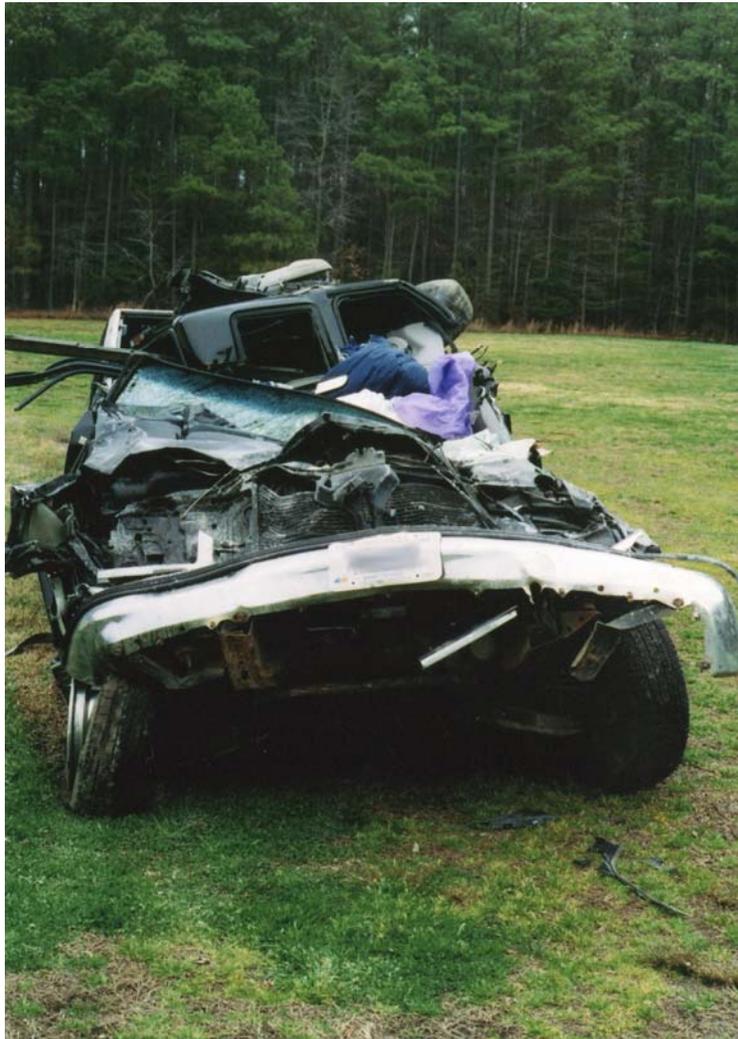
Photo #6: Front view of pickup.

While the pickup driver was negotiating the curve, she had over 600 feet of sight distance to what would become the point of impact. She could also see further down the road. However, the crash occurred well after dark and no street lights illuminated the area, so the edges of the roadway and the environment beyond the area illuminated by headlamps were not clearly visible. Additionally, the headlights of approaching vehicles would have created glare, which also decreases the conspicuity of objects in the visual field (like mailboxes and curbing). Consequently, many of the visual cues that would have normally enabled the pickup driver to determine that the oncoming vehicle was moving erratically and outside its lane may not have been available to the pickup driver. Since the Explorer was off the road to the right, the pickup driver was less likely to perceive it as a threat to her path of travel. Only when the SUV crossed the centerlines would the pickup driver have had her first decisive evidence that the Explorer was on a direct collision course. This occurred just 110 feet from the area of impact for the two vehicles. With the SUV traveling at about 65 mph, or 95 feet per second, the pickup driver

would have had just over a second to perceive and react to the danger. This amount of time was insufficient for her to perceive, process and respond defensively to the imminent collision.
