Virginia Commonwealth University
Transportation Safety Training Center
Virginia Multi-disciplinary Crash Investigation Team

Report Number 205 – August, 2008

VIRGINIA
MULTI-DISCIPLINARY
CRASH INVESTIGATION
TEAM
REPORT 205
2003 VOLVO TRACTOR
TRAILER VS PEDESTRIAN

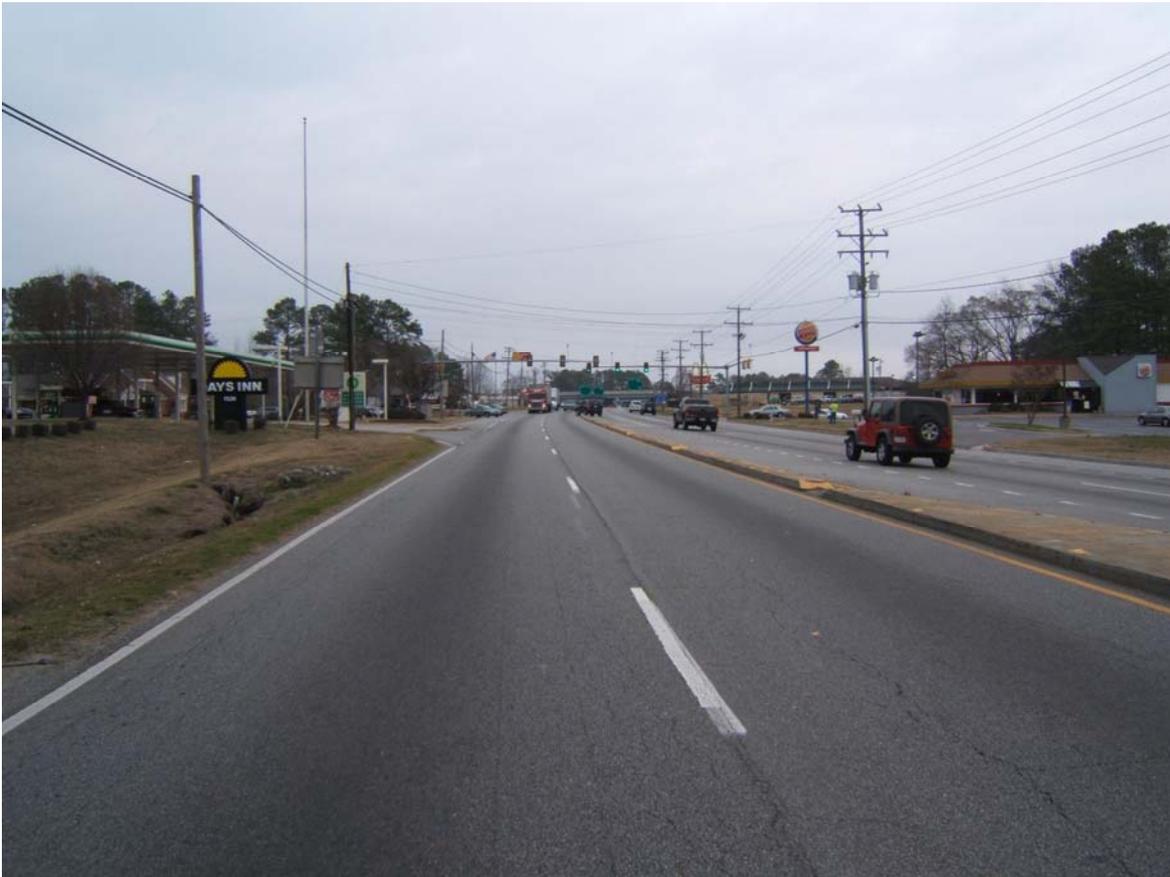
***Photo #1: View facing east, looking at approaching westbound traffic.
Tractor was in outside through lane.***

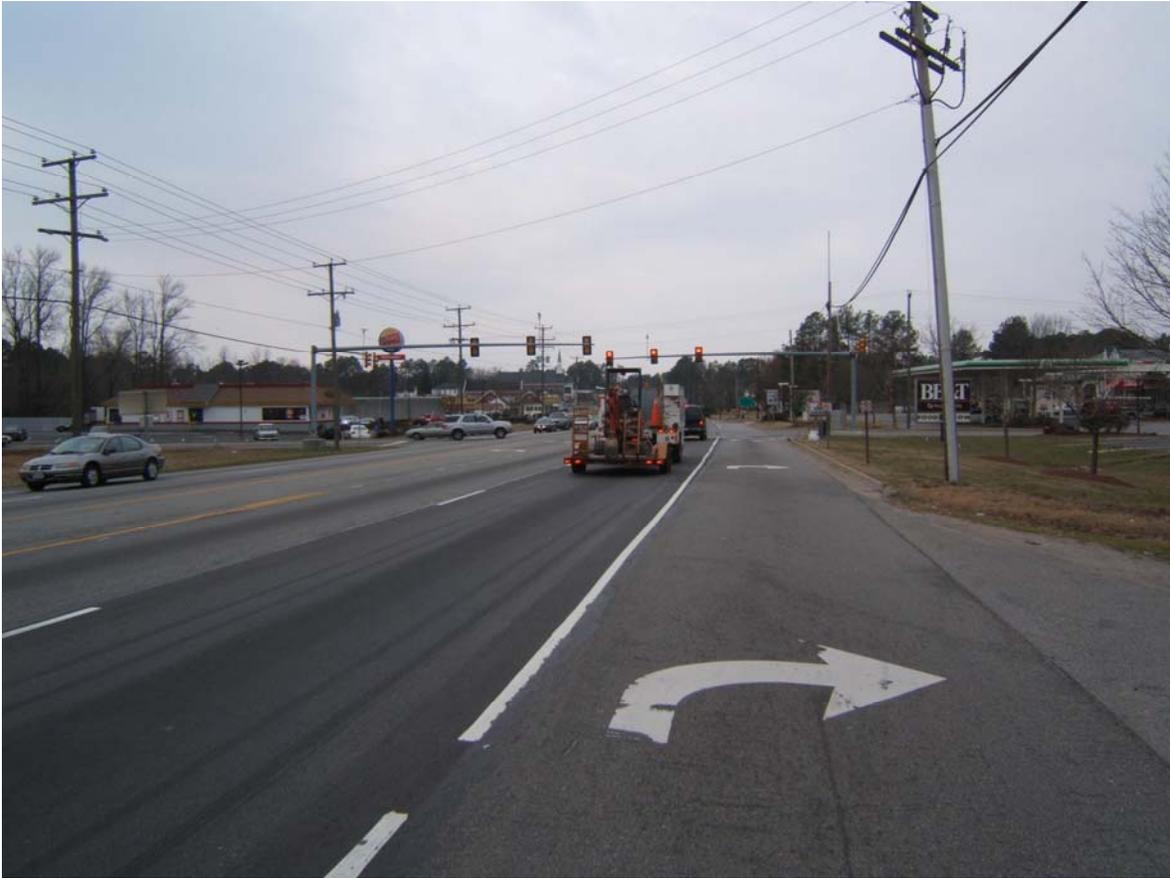
Photo #2: View facing westbound, in the direction tractor was traveling.

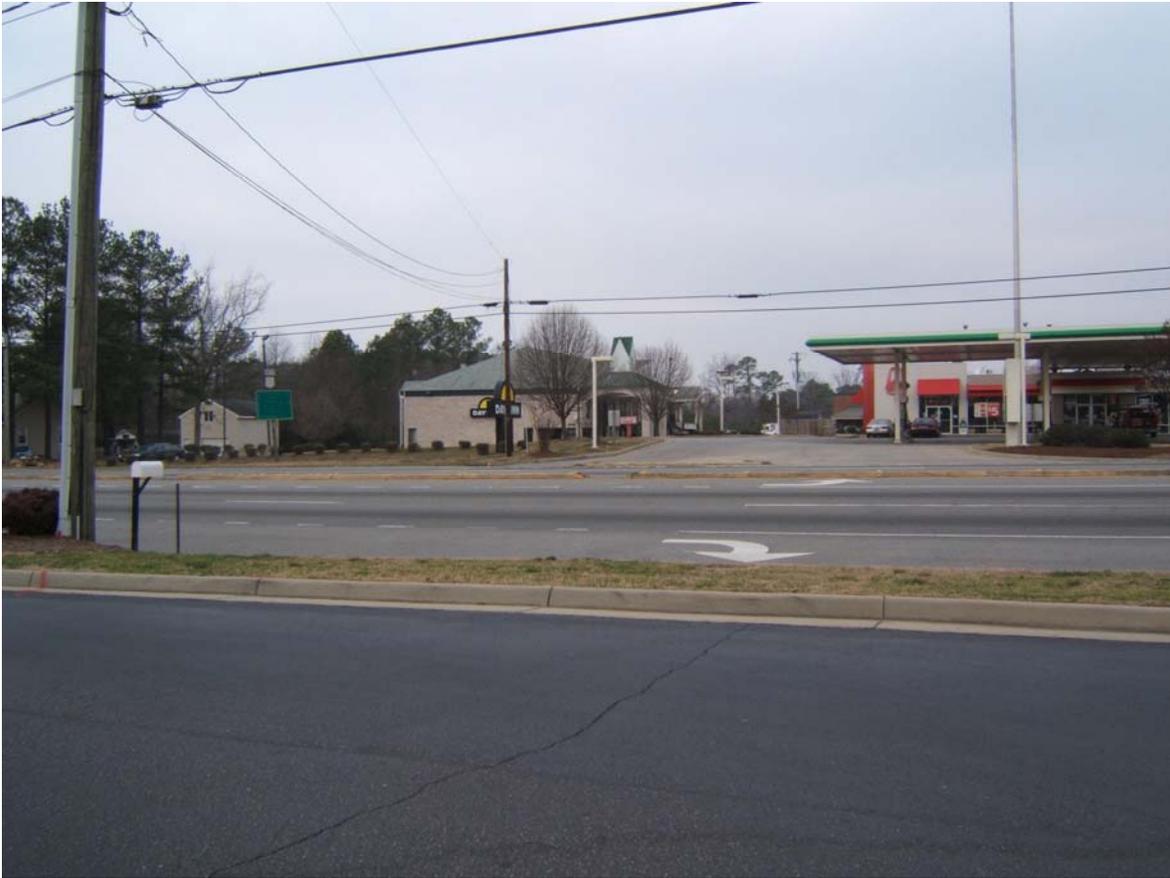
The fact that the couple chose to cross the busy primary road in the middle of the block was an issue of concern. Their hotel is located mid-block, directly across the busy primary highway from the parking lot behind the restaurant they had chosen for dinner. The intersection east of the couple's hotel is an active and potentially dangerous one. In addition to the four lanes of through travel for the primary legs of the intersection, the two approaches have both right and left turn lanes. The right turn lane on the westbound leg forms the entrance to a shopping center containing a grocery store and other retail outlets, including a fast food restaurant. At the front of the shopping center, on the southwest corner of the intersection, a gas station with entrances on both the primary and the secondary crossroad expose pedestrians to vehicles pulling in or out of the traffic flow. To reach the intersection from the motel, pedestrians must cross the gas station entrance. To then access the opposite side of the primary route, they must wait for the signals to stop traffic on the primary lanes and watch for vehicles turning left or right from the crossroad into their path of travel. There are no pedestrian pushbutton detectors or signal heads that would indicate when it is appropriate to walk, and the intersection is not marked to provide crosswalks and create a safe zone of passage. During an interview, the surviving pedestrian stated that they had crossed at the intersection on their way to dinner but that he had felt rushed. His discomfort led to the decision to cross mid-block on the return trip, where there were only two directions of vehicular movement to consider and navigate.

Photo #3: View across the primary highway in the area the pedestrians crossed to return to their hotel.

1. The city Department of Public Works should:
 - a. Repave and remark the road,
 - b. Install crosswalk lines at this intersection,
 - c. Install pedestrian signal heads and detectors,
 - d. Erect PEDESTRAIN CROSSING signs to direct them to the crosswalk,
 - e. Conduct an engineering study to determine if additional safety features are warranted; e.g. speed limit reduction, geometric changes, installation of sidewalks,
 - f. Install guardrail (westbound lane) in front of the motel. Although the lack of guardrail was not a factor in this crash, it would prevent vehicles from running into the deep drainage ditch just beyond the shoulder.

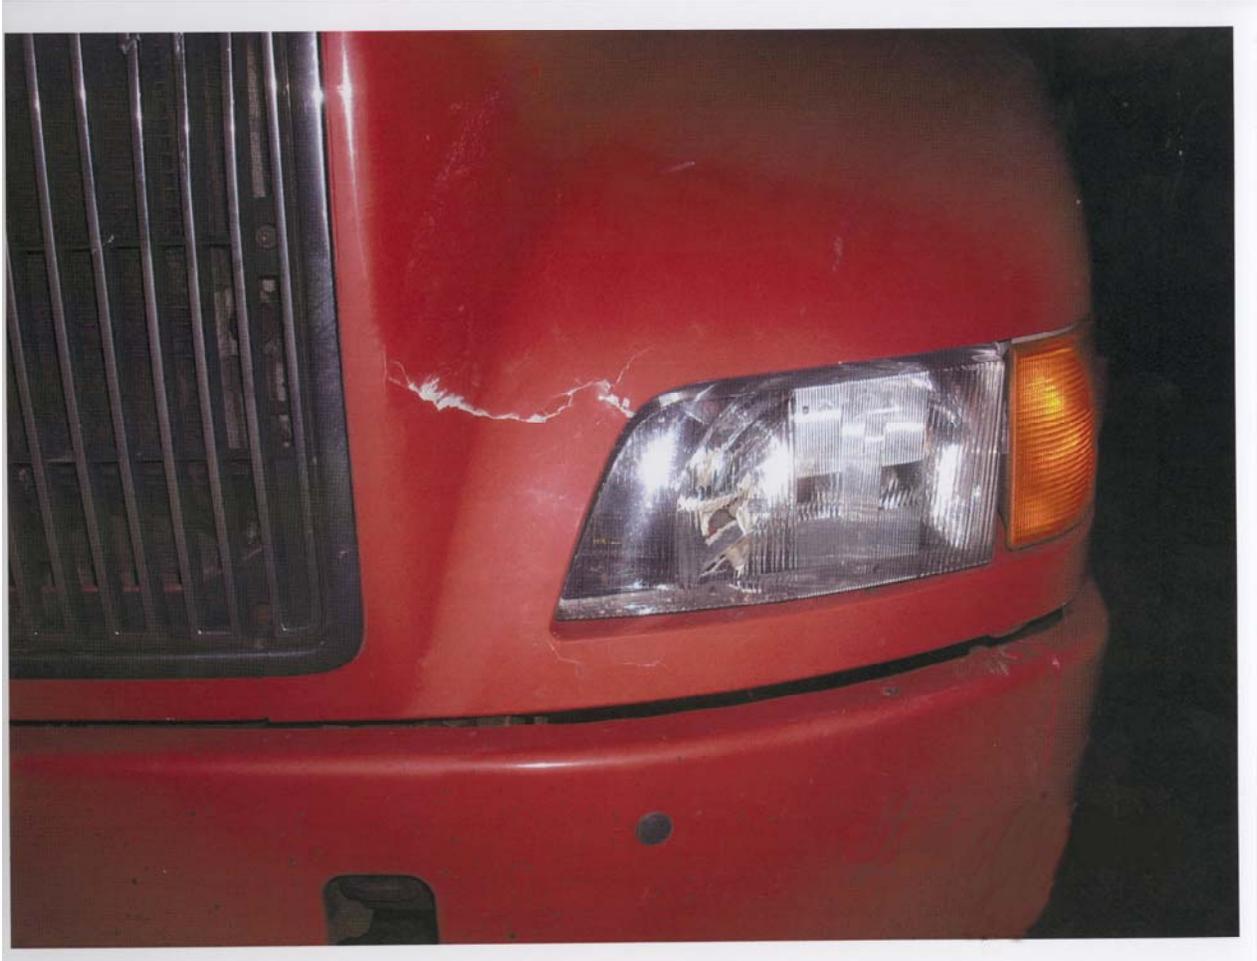
The tractor suffered little damage as a result of striking the pedestrian, as would be expected from the size and mass differences. Although the VMCIT was denied direct access to the vehicle, photographs taken at the scene revealed that the left front headlight was cracked and a portion of the lens was missing. In addition, there was slight damage to the left side of the grill and a crack on the front of the hood, between the grill and the left headlight. This damage was consistent with a pedestrian impact at that point on the vehicle. In addition, when the hood was

raised, one of the pedestrian's shoes was found lodged behind the left portion of the bumper. Her other shoe was located underneath the semi-trailer at final rest.

Photo #4: Left front bumper of tractor showing damage to headlight and hood.
