Virginia Commonwealth University
Transportation Safety Training Center
Virginia Multi-disciplinary Crash Investigation Team

Report Number 206 – September, 2008

Virginia Multi-Disciplinary
Crash Investigation Team
Report 206
1999 International School Bus
2005 Pontiac Minivan

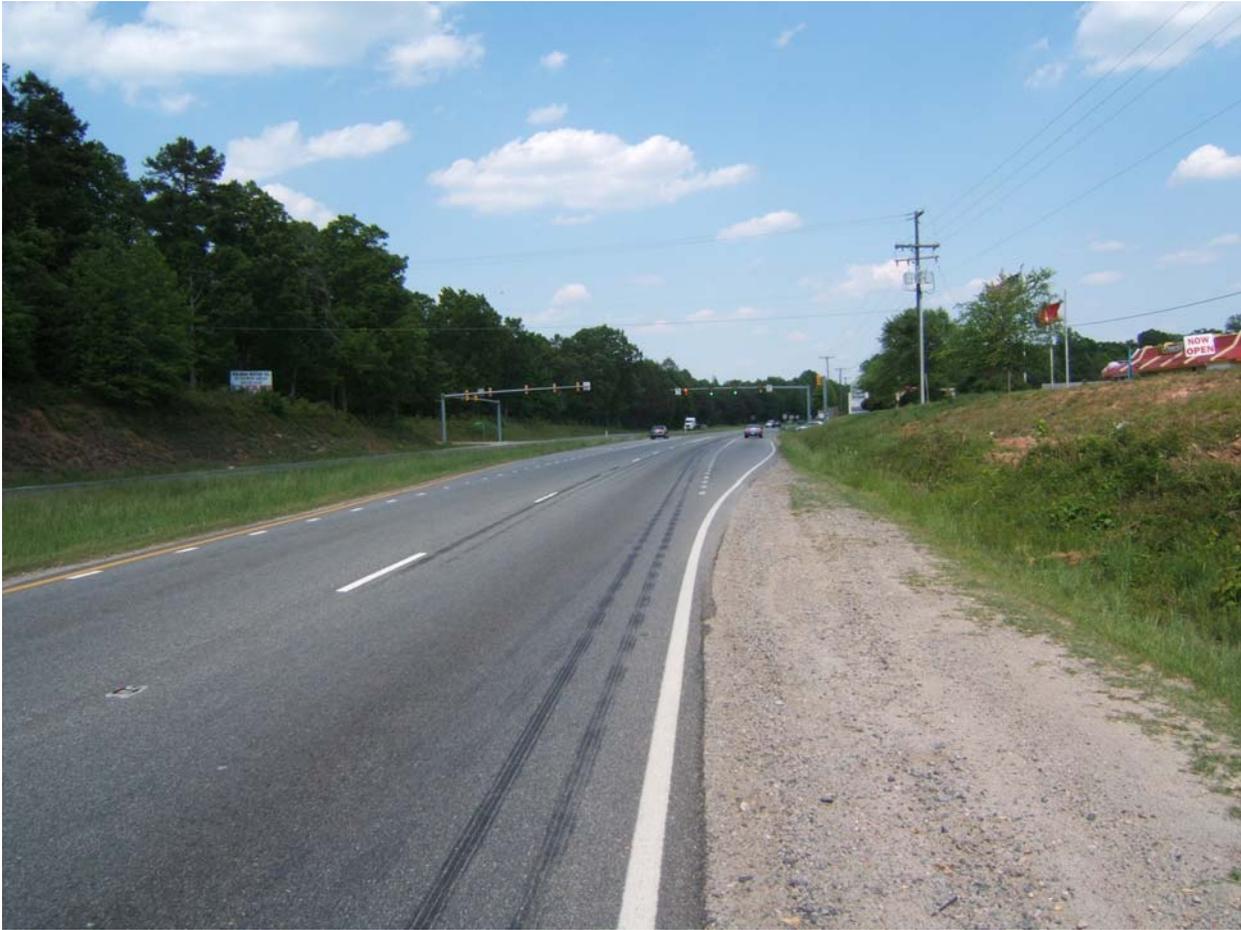
Photo #1: View facing east, direction both vehicles were travelling.

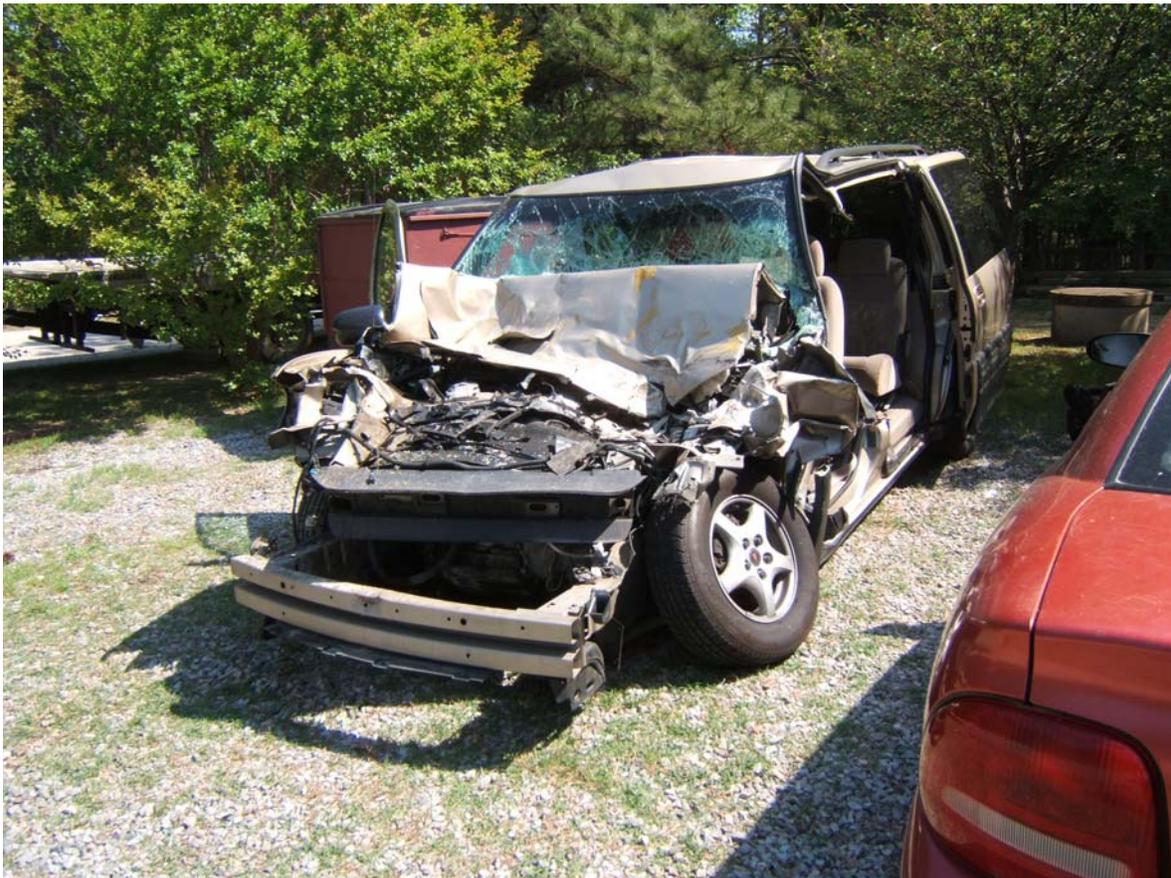
Photo #2: Front view of minivan showing underride damage.

The damage was angled with the deepest penetration on the driver's side of the van. Contact damage caused the roof of the vehicle to buckle inward and the doors to wrinkle. The engine, as a result of the crash, broke free of its mounts, as designed, and was pushed down and under the vehicle. The windshield was badly broken but still in place. The plastic bumper cover was torn free of the metal bumper, but the bumper itself, which connected directly to the frame, was mostly undamaged.

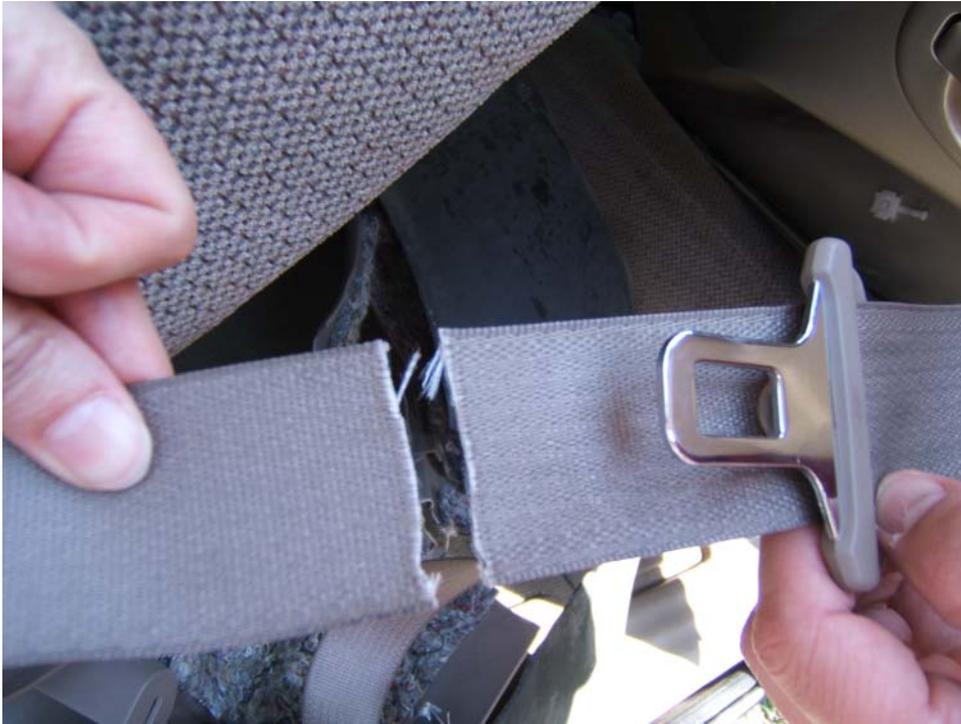
Initially, the driver was reported to have been wearing his lap/shoulder belt. This information was inconsistent with evidence from both the vehicle and the victim. The ACM download showed that the driver's seatbelt was unbuckled and the pretensioners did not fire. A seatbelt pretensioner is a device, in this case a pyrotechnic mechanism (see photo #4), that removes slack from a safety belt when activated by a vehicle's crash sensing system. A closer inspection of the driver's seat belt revealed that it had been cut in two places, with a 4 foot section removed in the middle. Usually a cut seatbelt is consistent with an occupant wearing the seatbelt and emergency personnel cutting it to allow removal. In this case, however, the door and "B" pillar were removed by the "Jaws of Life" to assist in extrication. The "B" pillar was cut near the base of the door, just above the seatbelt retractor. When the middle portion of the cut seatbelt was looped through the "D" ring and the cut ends brought down to the retractor and anchor point, the cut portions lined up perfectly with the cut made by the "Jaws of Life". The seat belt latch plate was still attached to the middle cut portion as well. Emergency personnel will usually leave the latch plate in the buckle after cutting the belt when removing an occupant. Inspection of the pyrotechnic seatbelt pretensioner showed that it did not fire during the crash, which is also consistent with the ACM report. With this model vehicle, the pretensioner, if working properly, will not fire unless the latch plate is inserted into the buckle.

Photo #3: Minivan driver's seat belt. Note that belt was cut but latch plate was not in buckle.

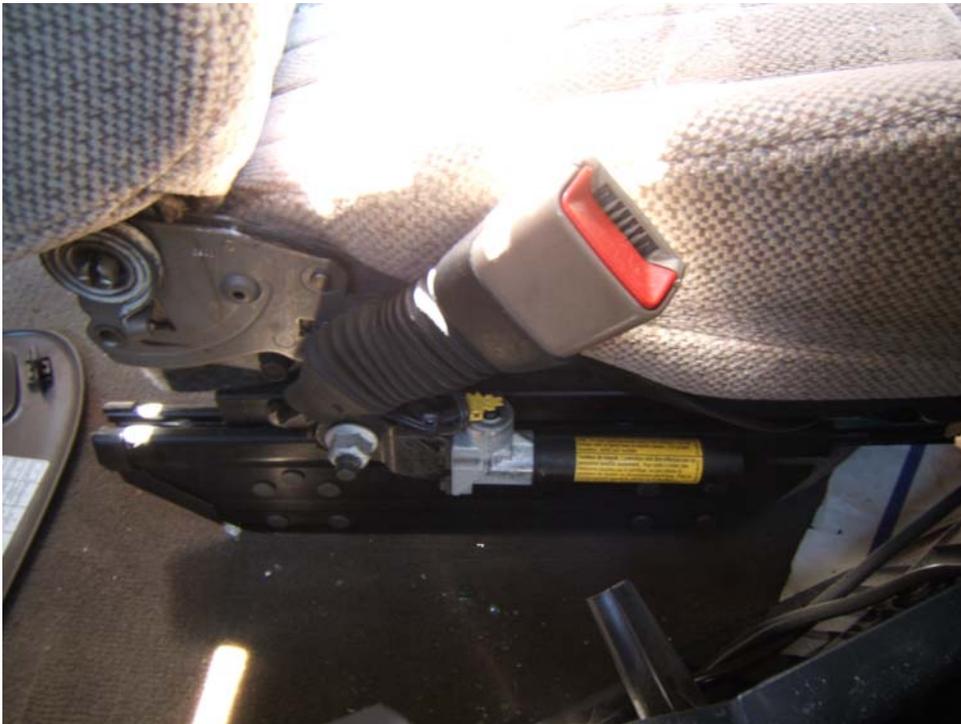
Photo #4: Pretensioner on driver's seatbelt buckle. The cartridge parallel to the seat base contains chemicals to fuel the pyrotechnic device. If the pretensioner had fired, the accordion pleats would be tightly compacted instead of expanded.

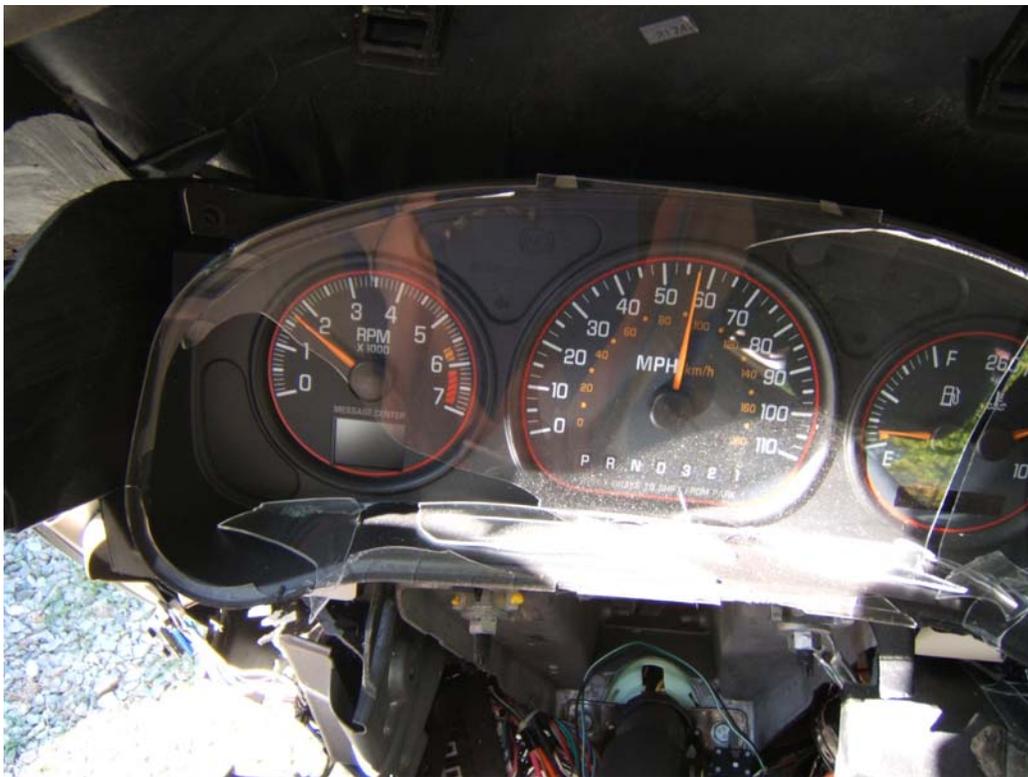
According to the ACM, the speed of the vehicle 5 seconds prior to impact was 88 mph. Over the next 4 seconds the driver activated his brakes and slowed his vehicle to 55 mph just before striking the rear of the school bus. With the lack of physical evidence on the roadway, the speed would normally be difficult to corroborate; however, the needle on the speedometer was pinned against the plastic covering due to damage at impact. The needle was locked slightly above the 55 mph dial reading. Although such information alone does not provide conclusive evidence, when considered along with the ACM download, it validates the van's recorded speed at impact.

Photo #5: Minivan speedometer with needle fixed between 55 and 60 mph.

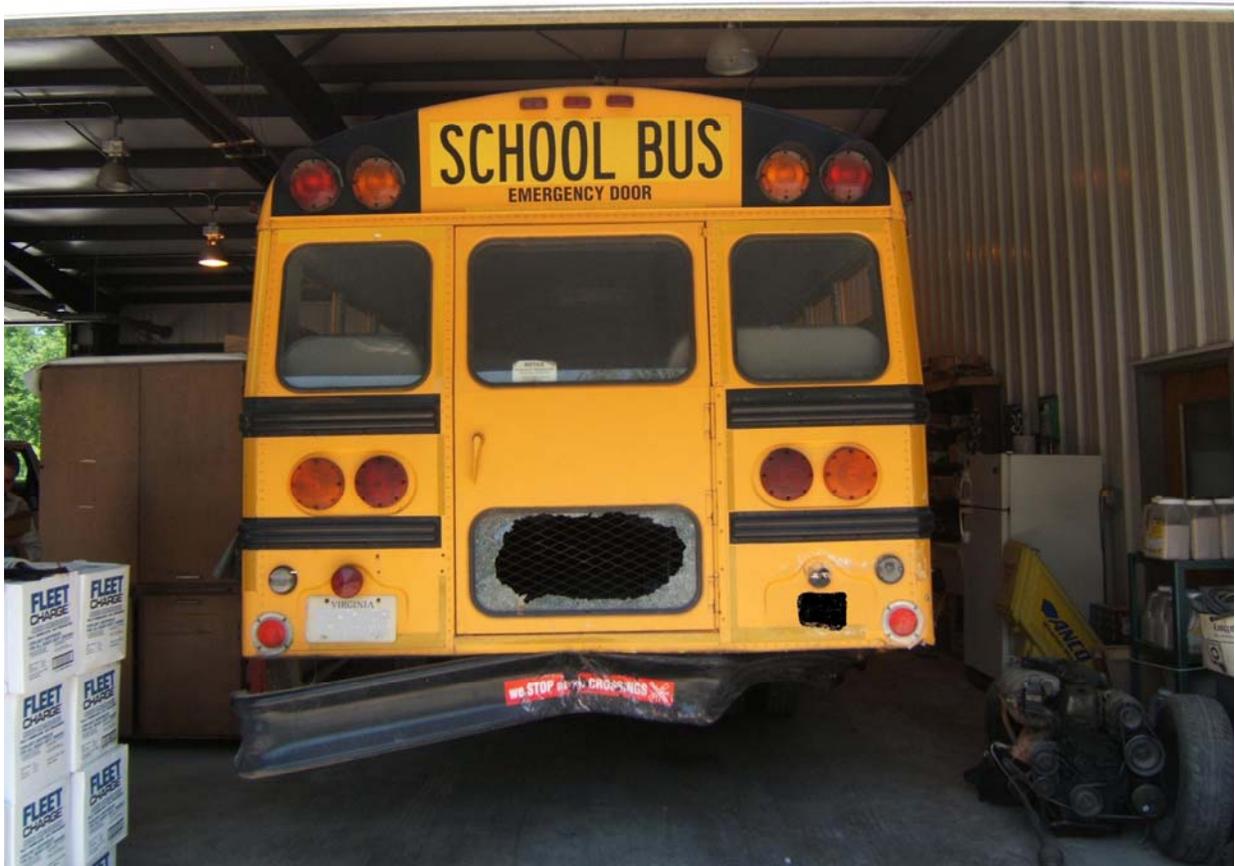
Damage to the school bus was limited to the bumper and the sheet metal just above bumper. The lower glass on the emergency exit door was also broken and missing as a result of the crash. Some minor scratches were also noted on the frame under the bus.

The bottom of the school bus bumper was measured by members of VMCIT at 25½ inches above the ground. Height measurements were also taken from the ground to the bottom and top of the 6 inch bumper on the minivan. The measurements were 12 ½ inches to the bottom and 17 ½ inches to the top of the nearly untouched bumper. The difference between the top of the minivan bumper and the bottom of the school bus bumper was 8 inches. During the investigation, VMCIT members measured the bumpers of several other school busses manufactured between 1999 and 2007. All of the bumpers measured on the busses had heights above the ground between 25 and 27 inches. This is where a potential problem exists.

Photo #6: Rear view of school bus. Note area of impact and underride on right.

4. The United States Department of Transportation should consider adopting Federal Motor Vehicle Safety Standard 223 and 224 for straight trucks and busses. If effects are consistent with the implementation of these standards in 1998, injuries and fatalities resulting from underride crashes could be reduced significantly.

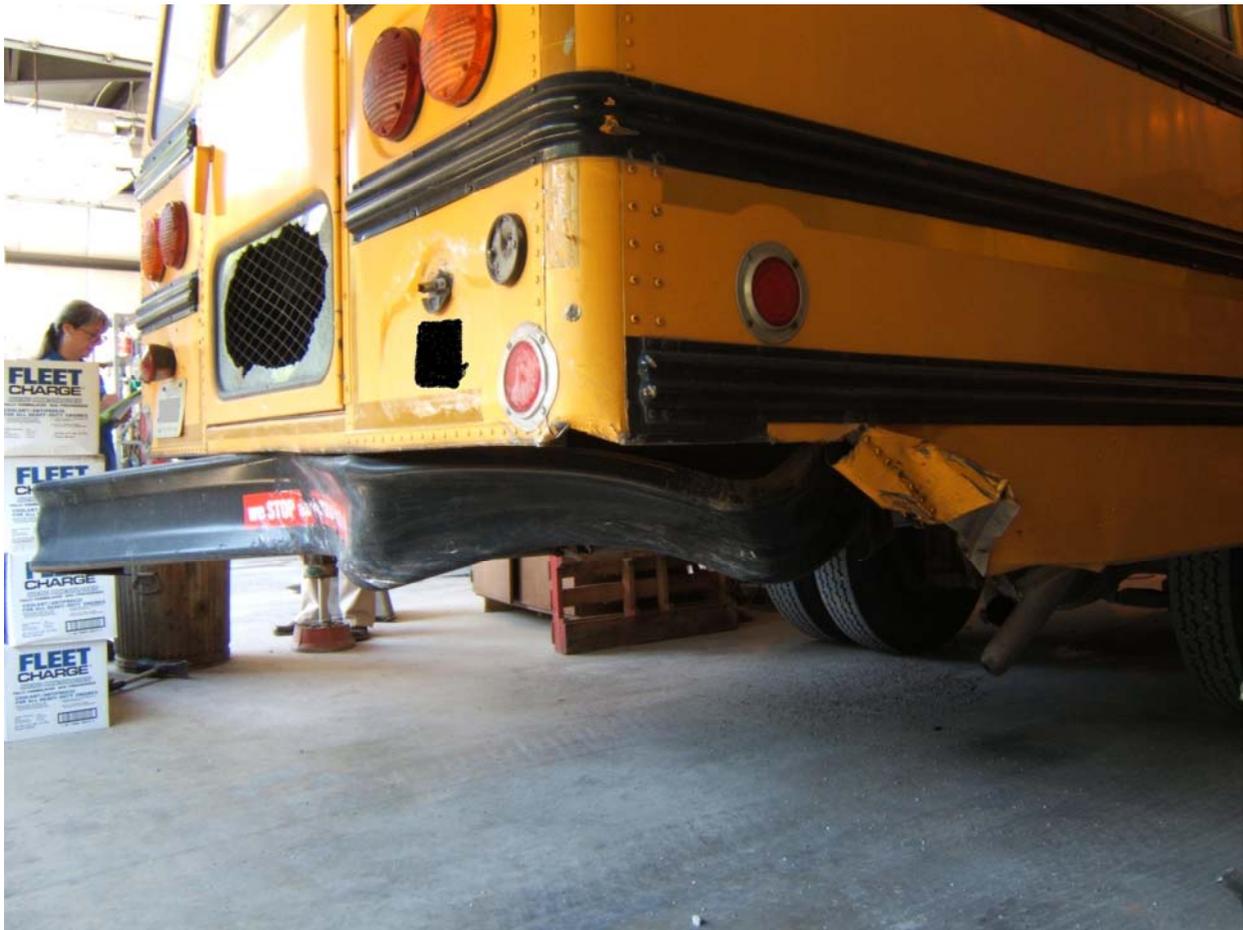
protection in the form of a drop down bumper to extend not more than 22 inches above the ground. The primary objective of a rear impact guard is to prevent an especially hazardous crash configuration known as "underride with passenger compartment intrusion (PCI)" that can occur when the front of a passenger vehicle contacts the rear of a truck trailer. The rigid structures in the front end of a small passenger car, such as the engine block, are often less than 30 inches above the ground, whereas the bed of the truck trailer is usually more than 45 inches off the ground. The passenger vehicle can underride the trailer, and the bed of the trailer will almost immediately intrude into the occupant compartment above and behind the hood, at great risk to occupants.

Photo #7: Right rear corner of bus. Note depth of intrusion damage to underside.
