Virginia Commonwealth University
Transportation Safety Training Center
Virginia Multi-disciplinary Crash Investigation Team

Report Number 209 – September, 2009

ABSTRACT

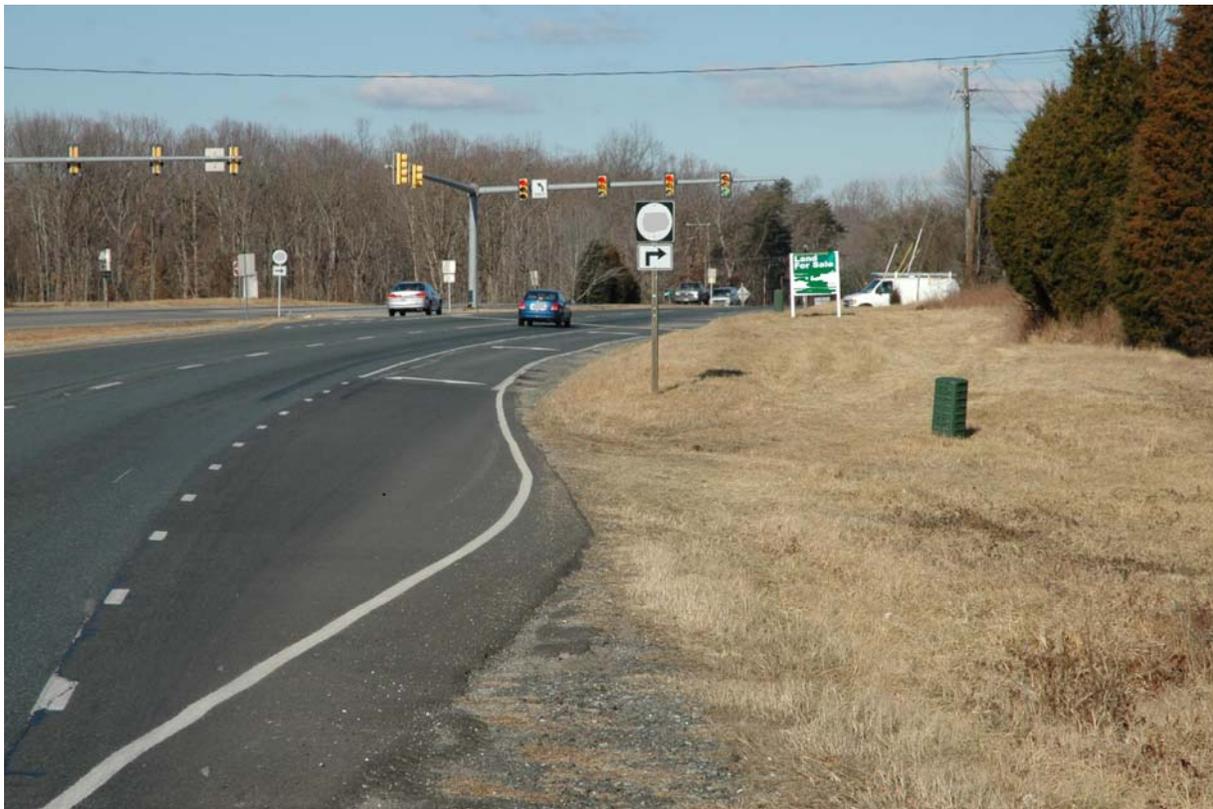
Four signal heads are mounted on a mast arm facing northbound traffic. The signals over the left turn lane and two through lanes were red. A green arrow point to the right was illuminated above the right turn lane. The traffic signal was green for the secondary road and

Photo #1: View of primary highway looking north, direction tractor was traveling. The right turn lane has a green arrow; all other lights are red.

and color identification during daylight conditions (Bullough, Boyce, Bierman, Conway, Huang, O'Rourke, Hunter & Nakata, 2000). When members of the VMCIT evaluated the site at the same time of day and under conditions similar to when the crash occurred, the red signals over the left turn lane and two through lanes were clearly visible from the maximum sight distance. The red and green colors were easily distinguishable and the lights were positioned correctly on the signal head, with the red light at the top and green at the bottom.

- (a) Remove trees on the VDOT right-of-way and prune the overhanging branches, opening up line of sight approaching the signal heads northbound lanes on the primary road.
- (b) Prohibit U-turns in each direction to reduce conflict points.
- (c) Close in 200 feet of skip lines on the northbound approach to discourage lane changes.
- (d) Install an advance set of "SIGNAL AHEAD" signs with distance plaques (1300 feet) in advance of the existing "SIGNAL AHEAD" signs and flashers.
- (e) Install 2 sets of rumble strips on the northbound approach—one set prior to the existing "SIGNAL AHEAD" message and another set 200 feet north of the message.
- (f) Upgrade and relocate warning signs on the secondary route approaching the signal and add "SIGNAL AHEAD" pavement message.

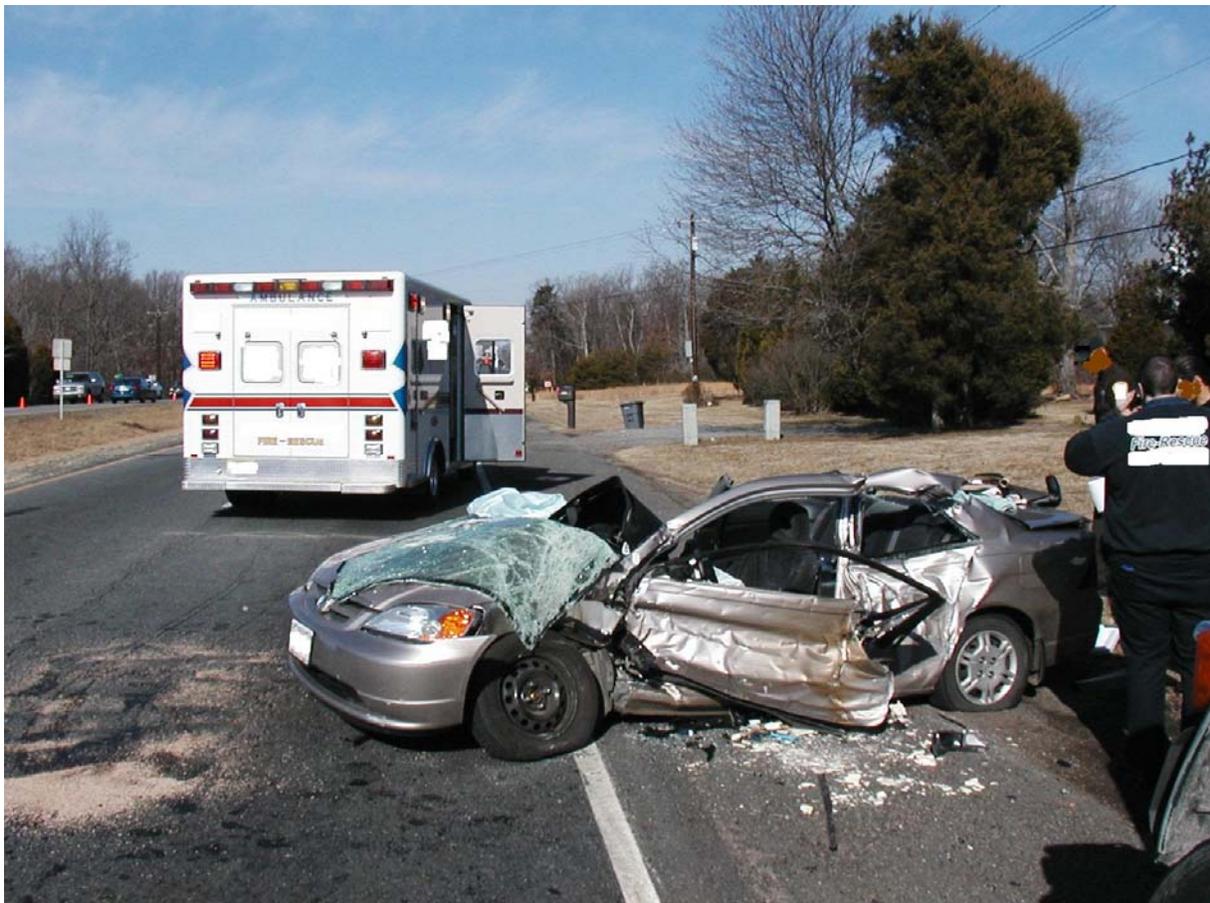
Photo #2: Honda at final rest.

Both vehicles showed damage consistent with a side impact crash. The Honda had significant damage to the driver's side. Several points along the door had as much 30 inches of crush into the occupant area. Paint transfers on the driver door matched the tractor license plate letters. Both front airbags deployed during the collision, even though the forces exerted in the car were all from the side. Due to its age, this vehicle did not have side airbags.

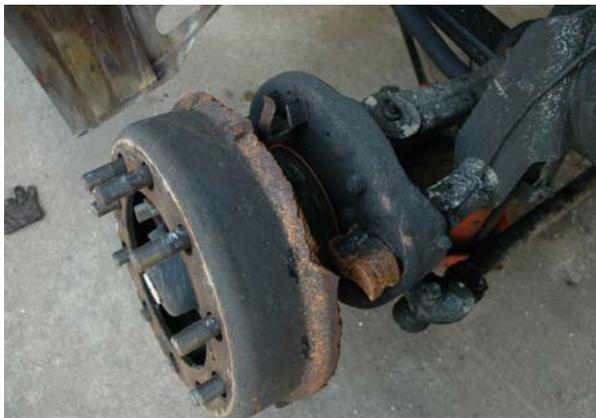
The tractor and semi-trailer, which was loaded with sand at the time of the crash, weighed approximately 83,000 pounds. Damage to the front of the tractor was obvious where it struck the Honda. Inspection of the power unit by local officers revealed problems with the brakes on the steering axle. A large section of the front brake drum on the driver's side of the vehicle had been broken and removed prior to this crash. The remainder of the brake components

on this side had been removed as well. The brakes on the passenger side had significant defects also. The brake shoe linings, both upper and lower, showed extreme wear and were no longer in compliance with U.S. Department of Transportation (DOT) regulations. The brakes on the remainder of the vehicle were in compliance. Despite the deficient braking system on the front of the tractor, however, the problem should have contributed very little to the crash. Based upon data which was compiled from skid tests conducted by the Institute of Police Traffic Management, the general “rule of thumb” for braking percentages on a tractor and semi-trailer front or “steer” axle is 10% (Transportation Safety Training Center, 1999). If all other aspects of the system were functional, as reported in the motor carrier inspections conducted by local and state officials, approximately 90% of the braking potential should have been available.

Photo #3: Driver's side front brake drum.

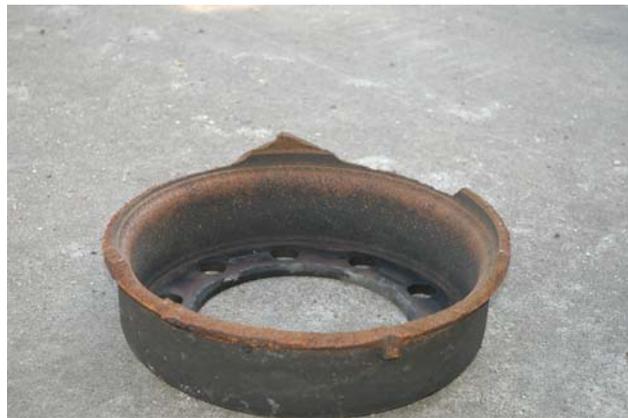
Photo #4: Driver's side front brake drum removed.

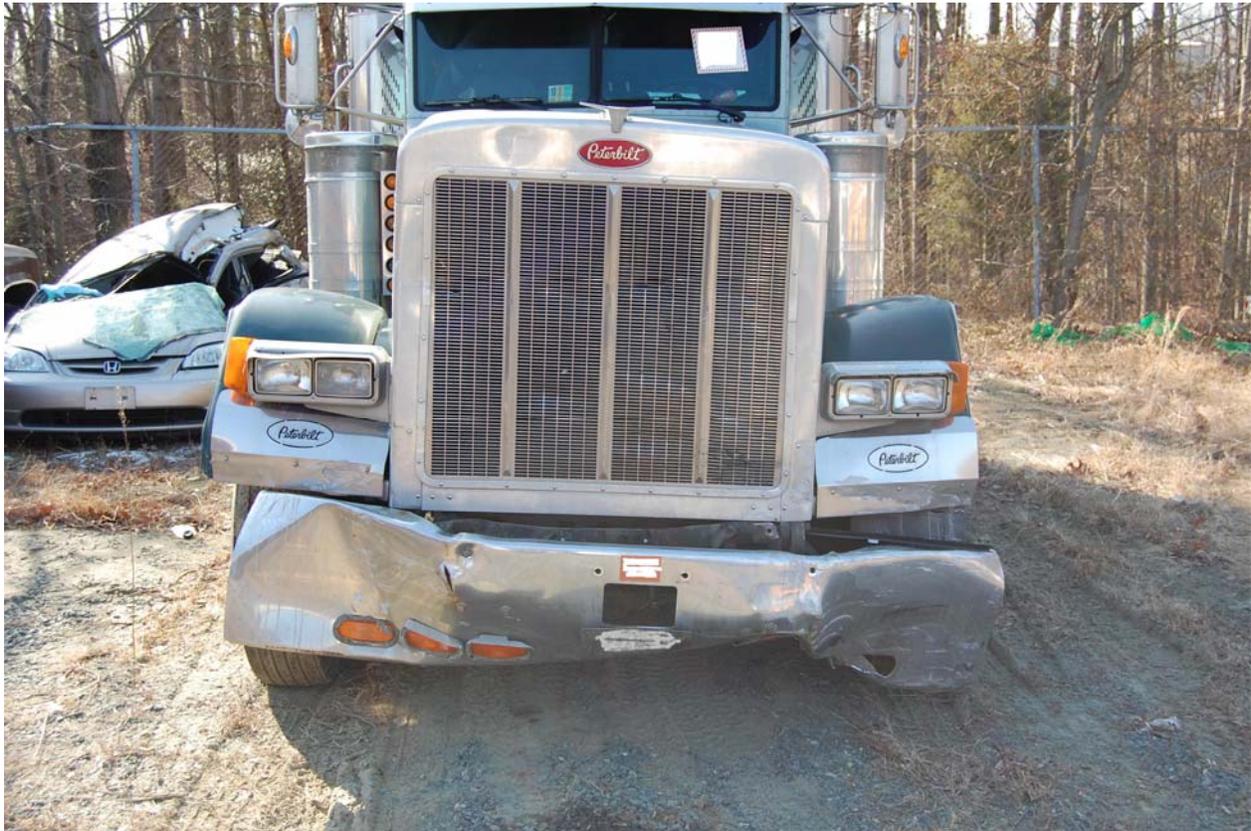
Photo #5: Damage to tractor. Honda is parked to left.
