Virginia Commonwealth University
Transportation Safety Training Center
Virginia Multi-disciplinary Crash Investigation Team

Report Number 210 – October, 2009

ABSTRACT

VIRGINIA MULT-DISCIPLINARY
CRASH INVESTIGATION TEAM
REPORT 210
2005 Harley Davidson FXSTDI
Motorcycle
2005 Harley Davidson FLHRCI
Motorcycle

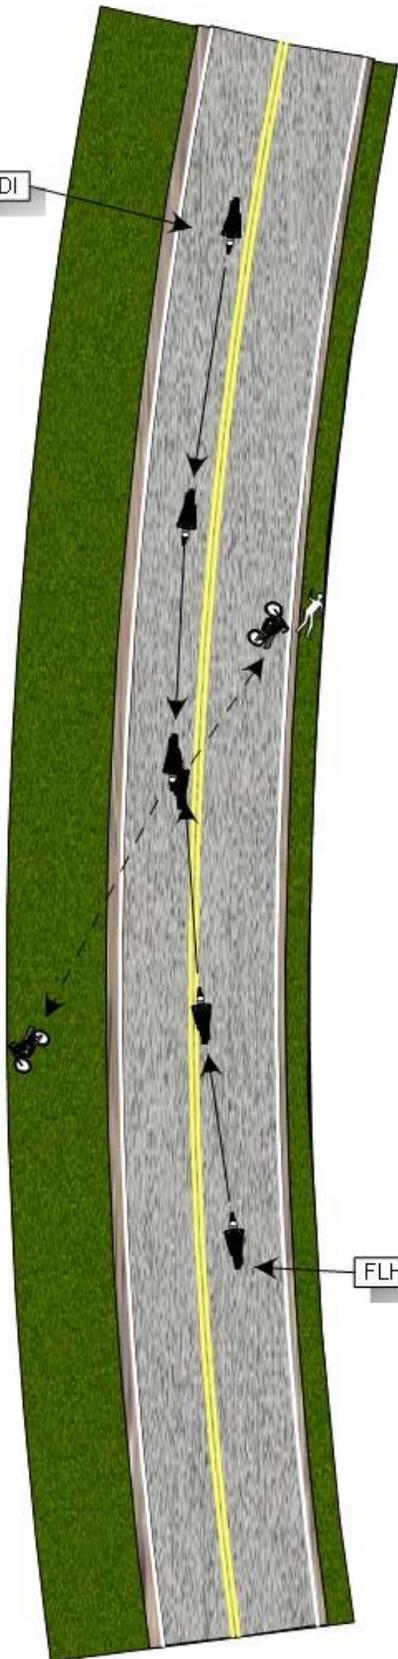
Summary: One motorcycle crossed the centerline and struck the second motorcycle in a slightly offset head on collision.

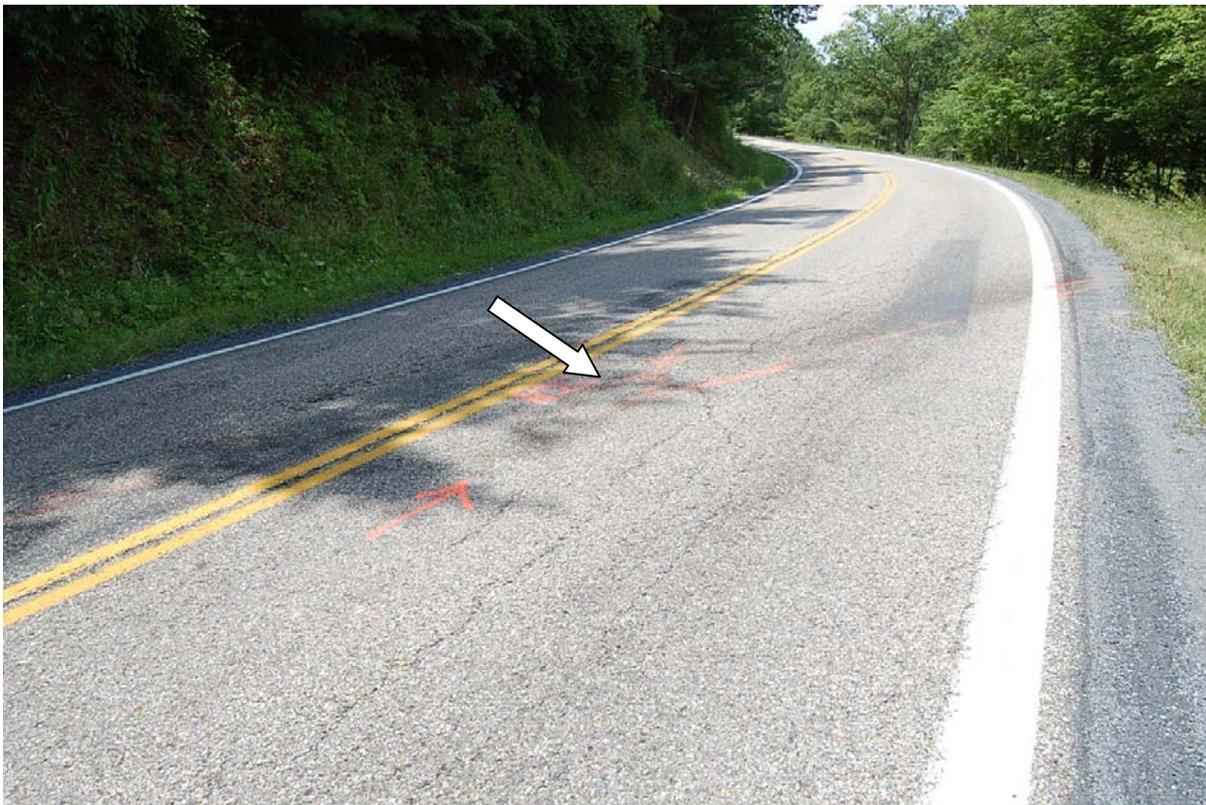
Photo #1: View looking west, direction Road King was traveling. Arrow points to area of impact, right of centerline.

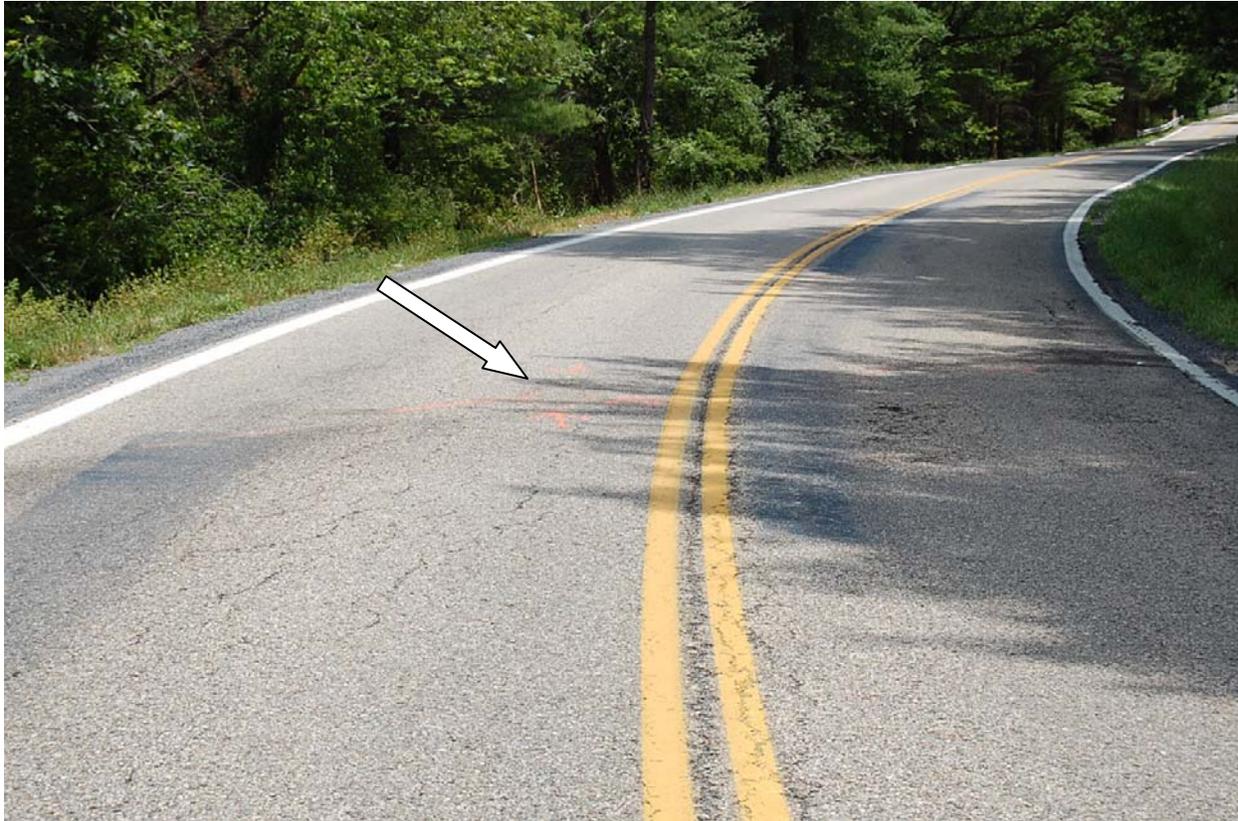
The road is a two lane east-west primary route located in a rural, mountainous area. The road is asphalt and in poor condition. The asphalt pavement is worn to the point the aggregate is exposed. There is a pothole near the centerline in the eastbound lane in the area of the crash. The eastbound lane is approximately 10 feet 5 inches wide and the westbound lane is approximately 9 feet 2 inches wide at the location of the crash site. There is a 1 foot gravel shoulder adjacent to the eastbound lane with a 3 foot grass shoulder adjacent to the gravel shoulder that slopes to a drainage ditch. This is bordered by a steep “cut” section (where the roadway was cut into the mountainside). The eastbound lane curves approximately four degrees to the right and has an approximately three percent downgrade at the location of the crash. The curve and cut section limits sight distance of approaching motorists. Adjacent to the westbound lane, there is a 2 foot gravel shoulder bordered by a 12 foot grass shoulder that slopes to a field. The lanes are separated by double solid yellow pavement markings. The road is controlled by pavement markings and signs. The signs are in good condition and the pavement markings are in fair condition. There is no overhead lighting. The speed limit is 55 miles per hour (MPH). In addition, there are horizontal alignment signs (indicating a winding road) with advisory speed plaques showing “45 MPH” in advance of the crash site for both directions of travel.

Photo#2: View facing eastbound. Arrow indicates area of impact.

5. Although the condition of the pavement does not appear to have played a role in the cause of this crash, the Virginia Department of Transportation should resurface this section of road and apply new pavement markings.

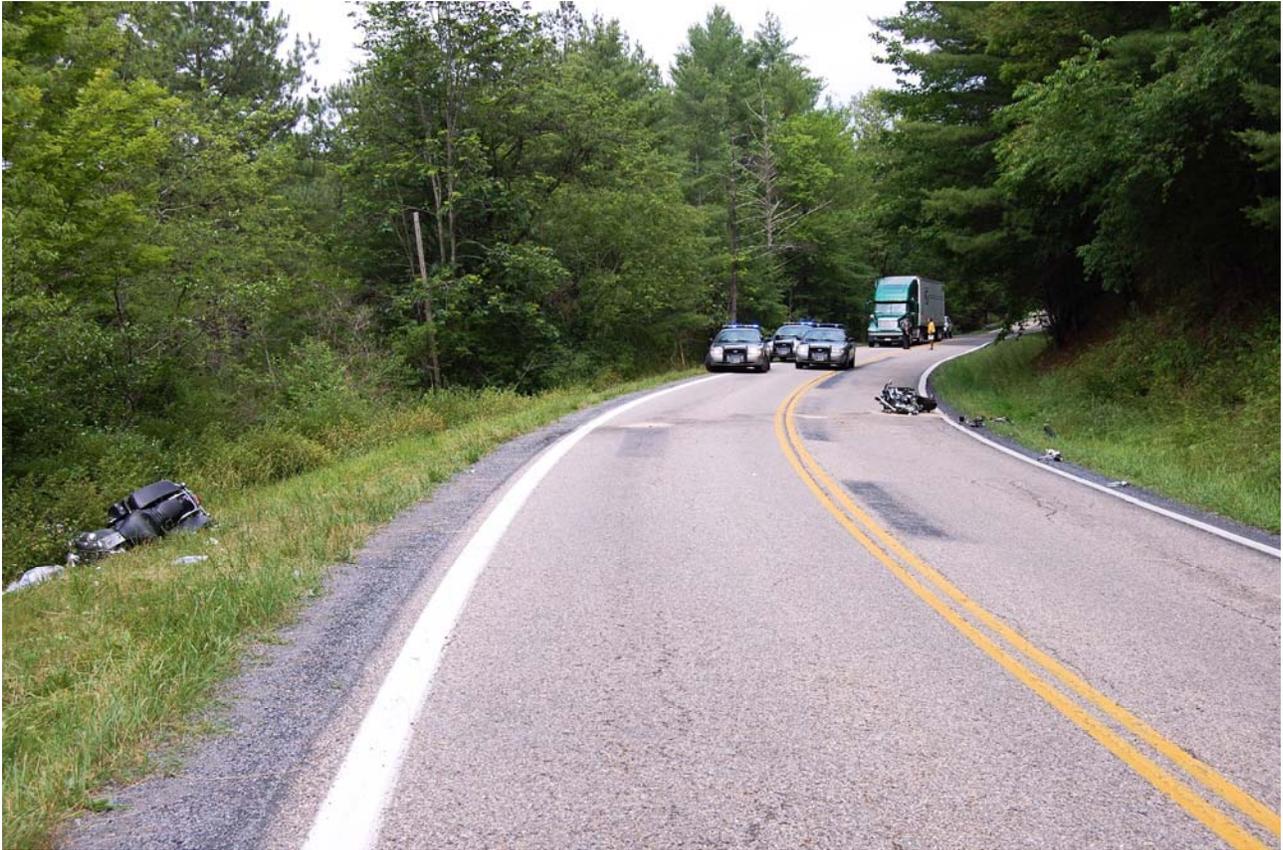
After maximum engagement, the Softail and its rider went to the right side of the eastbound lane. This motorcycle came to rest at the right edge of the roadway approximately 21½ feet northeast of the area of impact. The driver was found in the ditch line approximately five feet northeast of the motorcycle. He died instantly from head and chest injuries. The Road

King and its rider went to the right shoulder of the westbound lane after maximum engagement. The motorcycle came to rest in the grass shoulder approximately 39 feet southwest of the area of impact. The rider's final rest location was not documented in this crash.

Photo #3: View facing east, direction the Softail was traveling, showing final rest of both motorcycles.

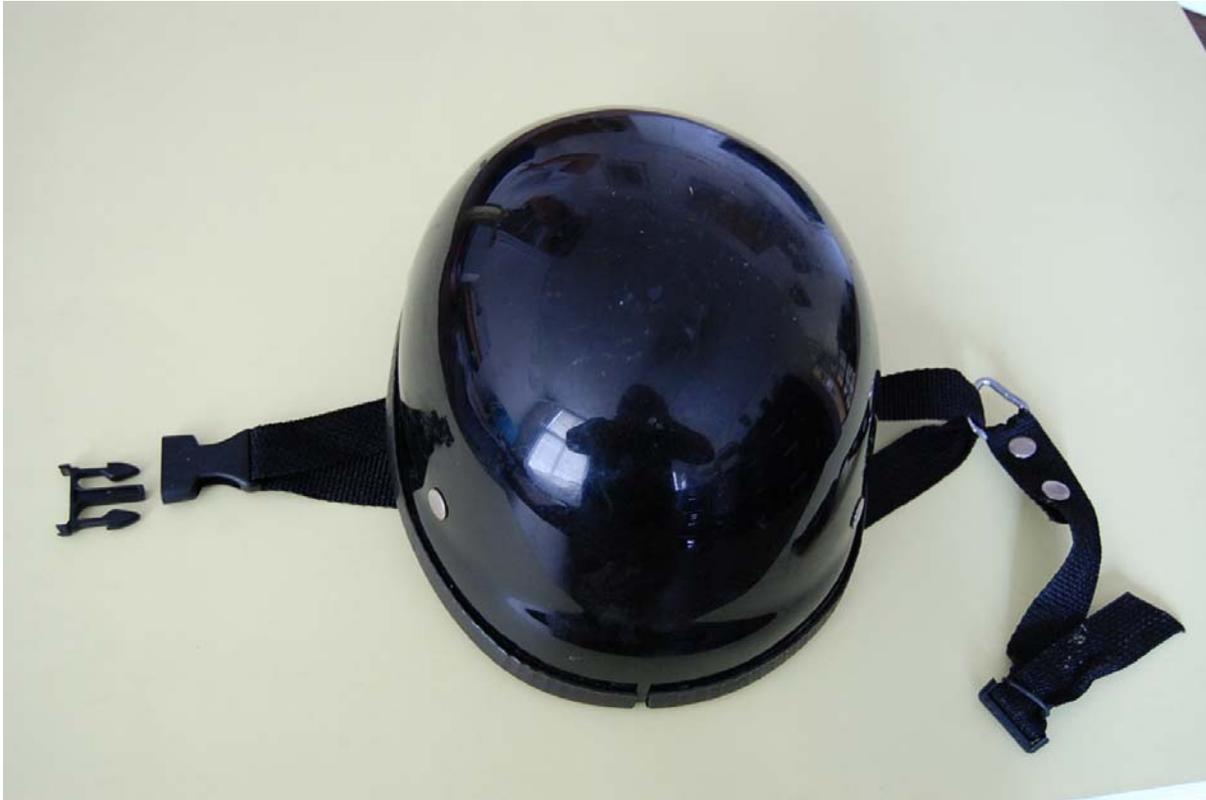
The Softail rider was wearing a helmet at the time of the crash that did not meet DOT standards. The retention system, a poor quality plastic clasp, failed, causing the helmet to come off of the rider and rendering it ineffective. The Federal Motor Vehicle Safety Standard regarding motorcycle helmets (§571.218) speaks to the Retention system and its testing requirements. The standard calls for a retention system (to include all of its components) that attains specific load standards specified without separation, and the adjustable portion of the system shall not move more than one inch (2.5 cm) measured from the preliminary and test load positions. The testing of the retention system requires applying a “static tensile load to the retention assembly of a complete helmet, which is mounted on a stationary test headform and by measuring the movement of the adjustable portion of the retention system test device under tension.” The preliminary test load of 50 pounds is applied to the retention assembly for 30 seconds and the measurement is taken. Then an additional 250 pounds test load is applied for 120 seconds and a second measurement is taken. If the retention system moves more than one inch, then the helmet retention system has failed the test.

In this helmet, the clasp broke, probably upon impact. There was minimal scarring on the shell of the helmet, due to the fact that it was thrown free of the driver's head before it struck the

ground. This is considered a catastrophic failure of the retention system. Had the retention system worked and the helmet stayed on, it would have offered little protection due to lack of a sufficient impact-attenuating liner and sturdy shell. However, even a helmet that met DOT standards may have made little difference in the outcome of this crash.

Photo #4: Helmet worn by Softail driver, showing broken clip for chinstrap.

4. Legislators and law enforcement officials should continue to work to strengthen the Virginia statutes on motorcycle helmet requirements (see *VMCIT Report Number 207*).

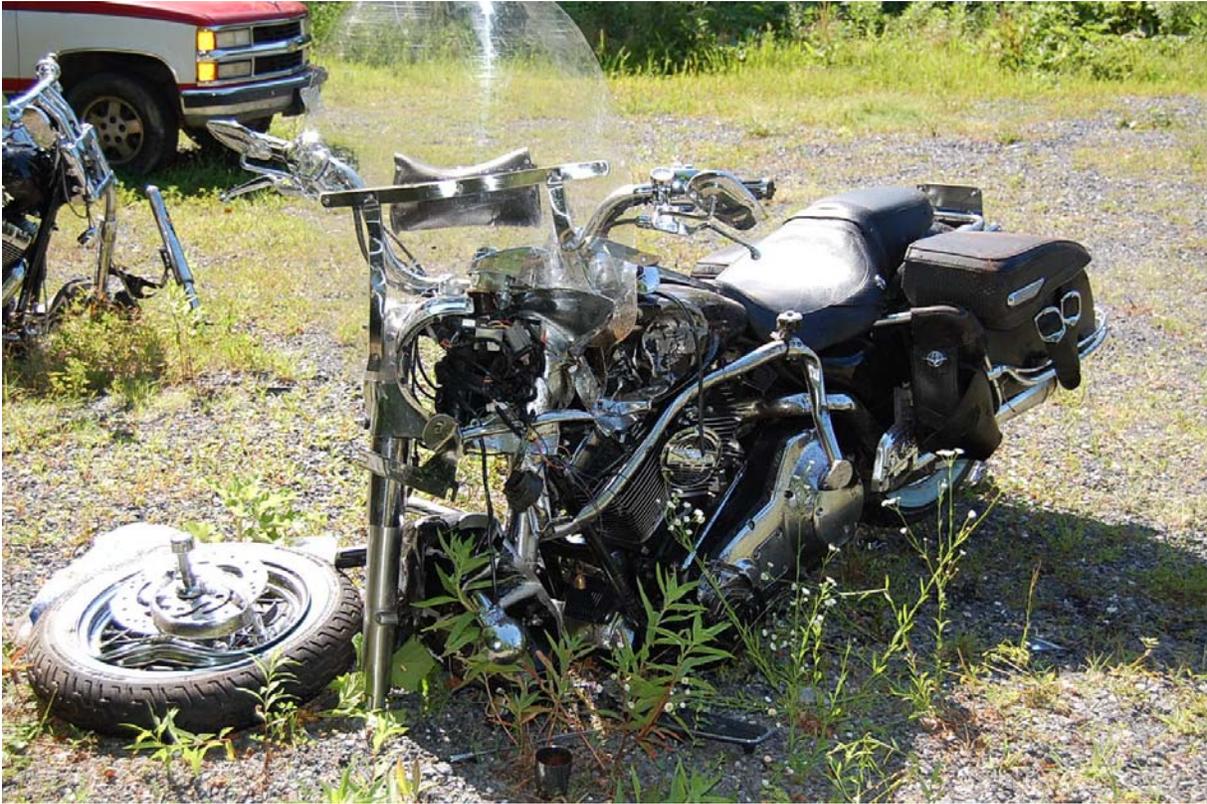
Photo #5: Harley Davidson Road King motorcycle.

The Road King displayed heavy front end contact damage. The front wheel and tire were detached from the motorcycle and the wheel was deformed. Both front forks were pushed rearward and displayed heavy damage. The left front corner of the gas tank displayed heavy damage from contact with the Softail. The right side of the gas tank displayed damage from contact with the rider's knee. Scratches, blood and tissue spatter, and induced damage were located throughout the remainder of the motorcycle. The Road King did not appear to have a state inspection (no sticker was found on the motorcycle), but a CARFAX report indicated a safety inspection was performed approximately 3 months prior to the crash. The report indicated mileage at that time of 12,589 miles. CARFAX reports did not indicate any other problems or

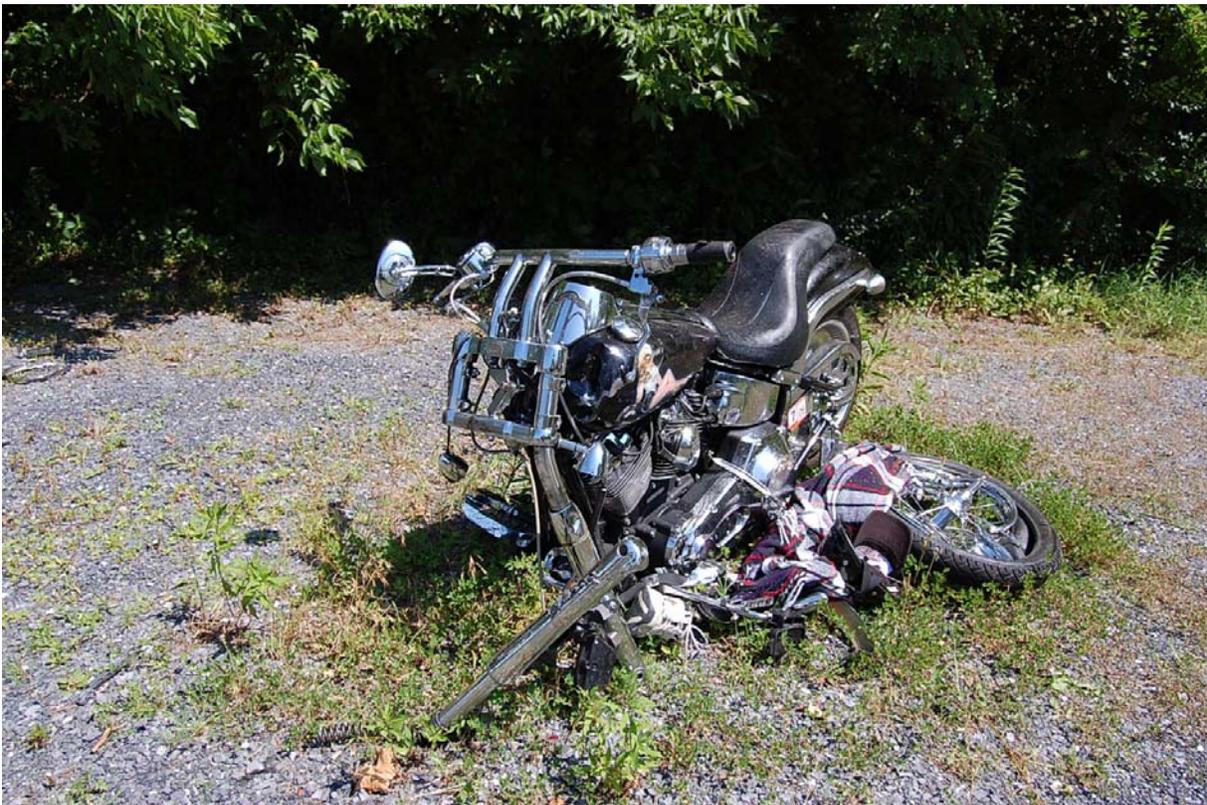
Photo #6: Harley Davidson Softail motorcycle.

Both motorcycles appeared to have been in good working order prior to the crash. The Softail had a current state inspection but was due for re-inspection in the month following the crash. The motorcycle displayed heavy front end contact damage; the front tire and wheel were detached from the motorcycle. The front wheel was heavily deformed and the brake rotors were broken and dislodged from their wheel connections. The right front fork was broken off of the triple tree (connection between the handle bars and front forks). The left front fork was bent toward the rear of the motorcycle, where it made contact with and damaged the left front corner of the gas tank. There was a dent on the left side of the tank from contact with the rider's knee during the collision. Scratches, blood and tissue spatter, and induced damage were located throughout the remainder of the motorcycle.
