Virginia Commonwealth University
Transportation Safety Training Center
Virginia Multi-disciplinary Crash Investigation Team

Report Number 212 – July, 2010

Vehicles Involved: 1996 Gillig Bus Model 35/102TBGCT Phantom

Summary: Bus was turning right, struck and then ran over pedestrian in crosswalk.

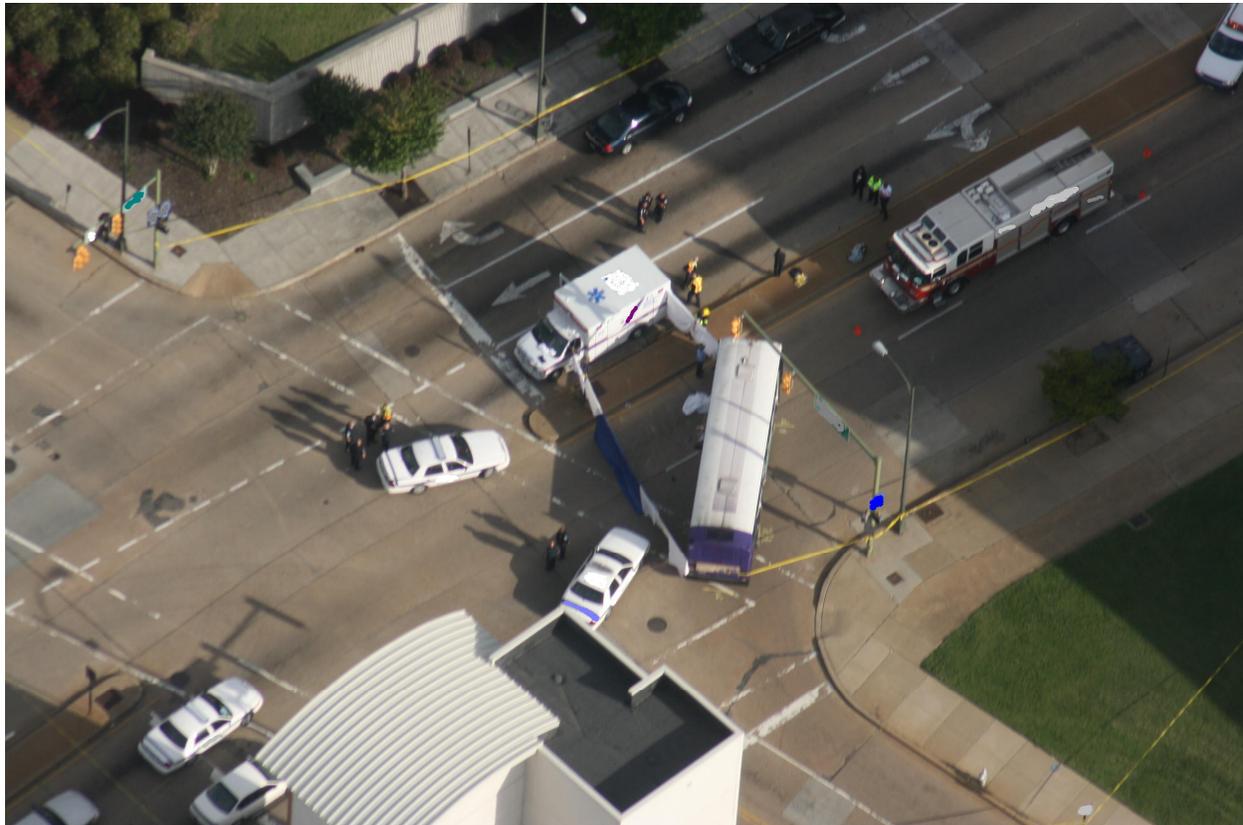
Photo #1: Aerial view of the crash scene with bus at final rest.

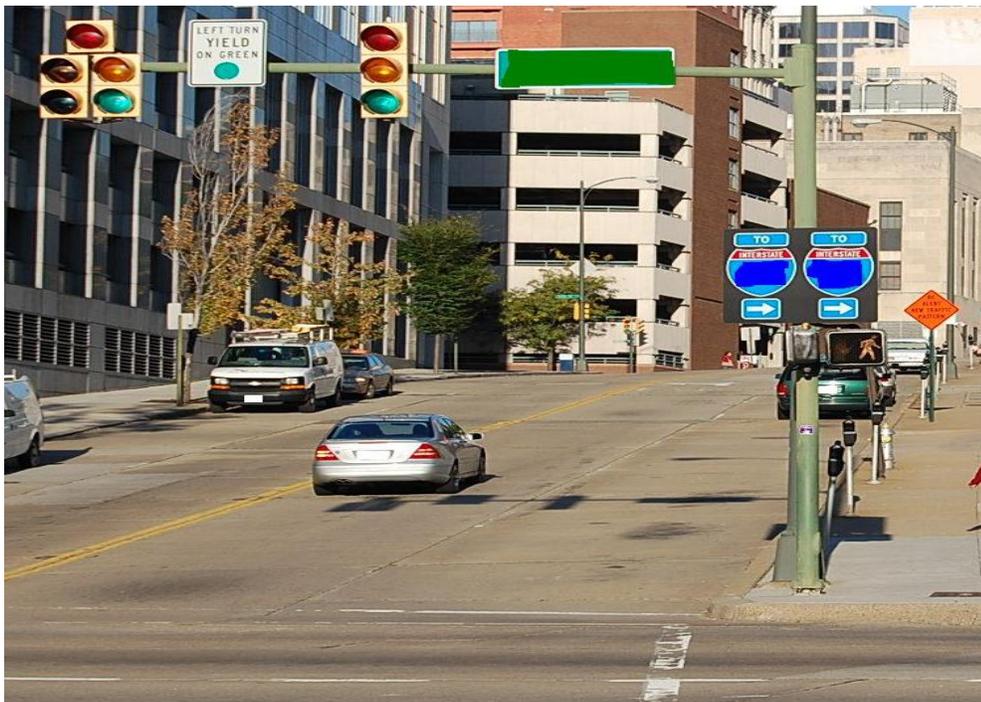
Photo #2: View of Traffic Signal and Pedestrian Walk Signal

When members of the VMCIT examined the crash site, the intersection did not appear to have any design deficiencies. However, pavement markings and crosswalk lines were in poor condition. The average daily traffic for this street is 12,000 vehicles (Virginia Department of Transportation, 2008). According to the crash history, between September 1, 2006 and September 30, 2009, 15 crashes were reported on this intersection. The crash types were: 6 angle collisions, 4 rear-end crashes, 3 side swipe (same direction) collisions, 1 head on collision, and 1 pedestrian fatality (this crash).

5. The city should review the markings and remark this intersection where appropriate.

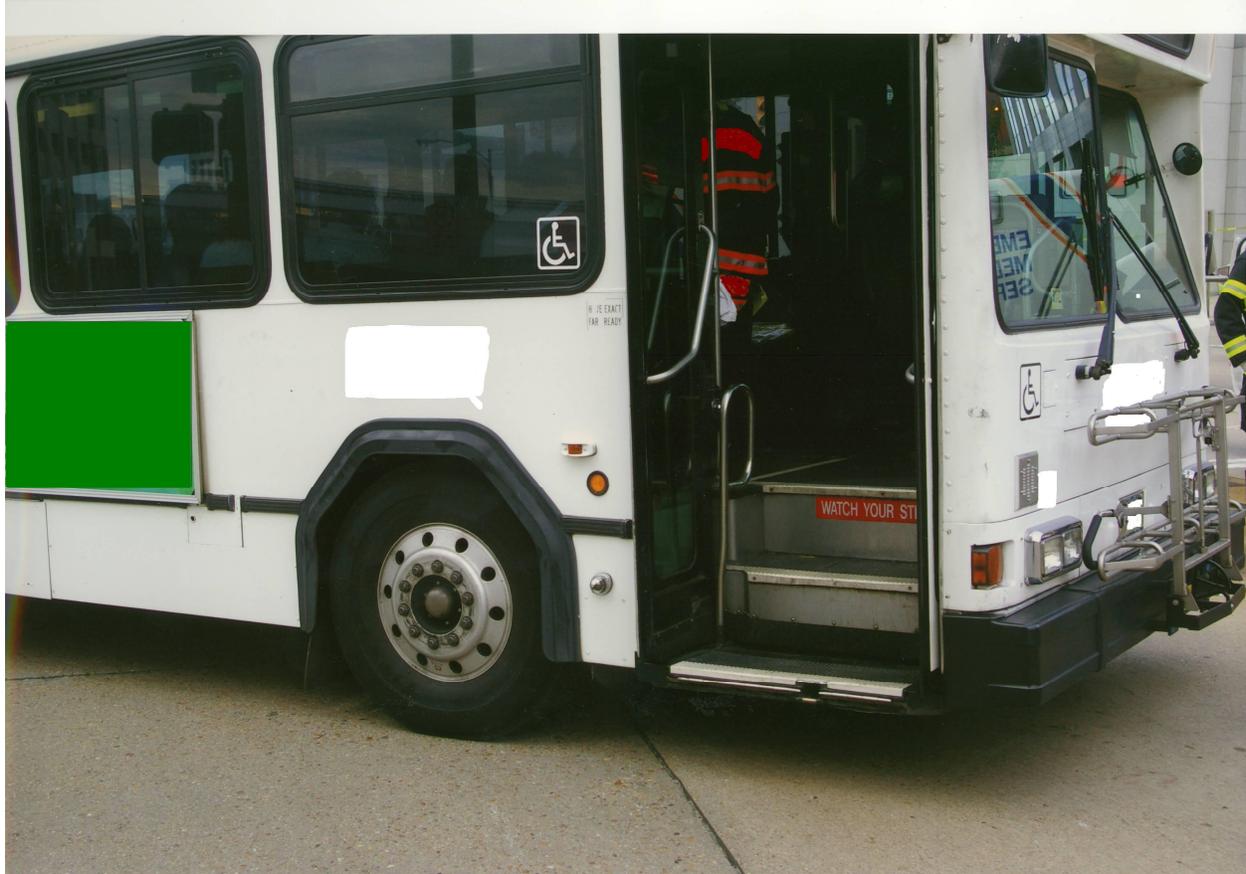
Photo # 3: Gillig transit bus, side view, at final rest. Pedestrian was initially struck with the front of the bus. Note that there is no damage to the vehicle.

This transit bus had a valid Virginia State inspection which was not due to expire for approximately six months. There were, however, some defective safety equipment parts on the bus at the time of the crash. A motor carrier safety inspection was conducted at the crash scene and it was found that the left front tire was less than 2/32 inch on the inside tread groove, the left rear brake was out of adjustment, and two top marker lights were inoperable. The bus was placed "Out of Service" by the motor carrier inspection officer of the local police department. Subsequent to this inspection, a second follow up inspection was conducted at the bus facility the next day by the local police department motor carrier inspection officer and an agent of the FMCSA. The motor carrier safety inspection report references an odometer reading of 20, 171.2 but states it is unlikely the actual mileage due to the vehicle age. A check of a recent maintenance report received a few days before the crash indicates the vehicle miles to be 410,337. During the secondary inspection, it was found that there was no windshield washer fluid, no fire extinguisher, and no safety triangles, there was an active leak around the transmission pan, and the speedometer was inoperable due to the cable being wrapped around the left front brake assembly and pulled apart. All of these vehicle defects should have been noted on a pre-trip safety inspection and repaired prior to the vehicle being placed into service to transport passengers. Despite these deficiencies, the safety equipment defects did not play a role.

The effective turn radius of this bus and the roadway configuration, however, may have been a contributing factor. This bus, according to manufacturer's specifications, has a turning radius of 36 feet. The transition radius of the turn from the westbound street to the northbound street is approximately 20 feet. This transition radius would require the bus to encroach into the left lane to complete the turn, instead of staying in the right lane as is required by law (§46.2-846). While this is not necessarily the cause of the crash, perhaps if the bus was able to stay in the right lane, the pedestrian might have moved past the bus or just been knocked down and not run over. If the driver had attempted to stay in the right lane, the bus' "offtracking" (the path of the vehicle's rear wheels tracking inside of the front wheels, which is far more exaggerated in a long vehicle such as a bus) would have caused the rear of the bus to run onto the sidewalk and possibly strike any pedestrian traffic, signs or lamp posts. This bus has an offtracking distance (calculated from the exemplar vehicle) of approximately 5.6 feet. This means the rear wheel path will track 5.6 feet inside of the front wheels. Bus drivers are trained to understand the
