Virginia Commonwealth University
Transportation Safety Training Center
Virginia Multi-disciplinary Crash Investigation Team

Report Number 213 – September 2010

Summary: A series of rear-end collisions resulted when the first tractor and semi-trailer slowed.

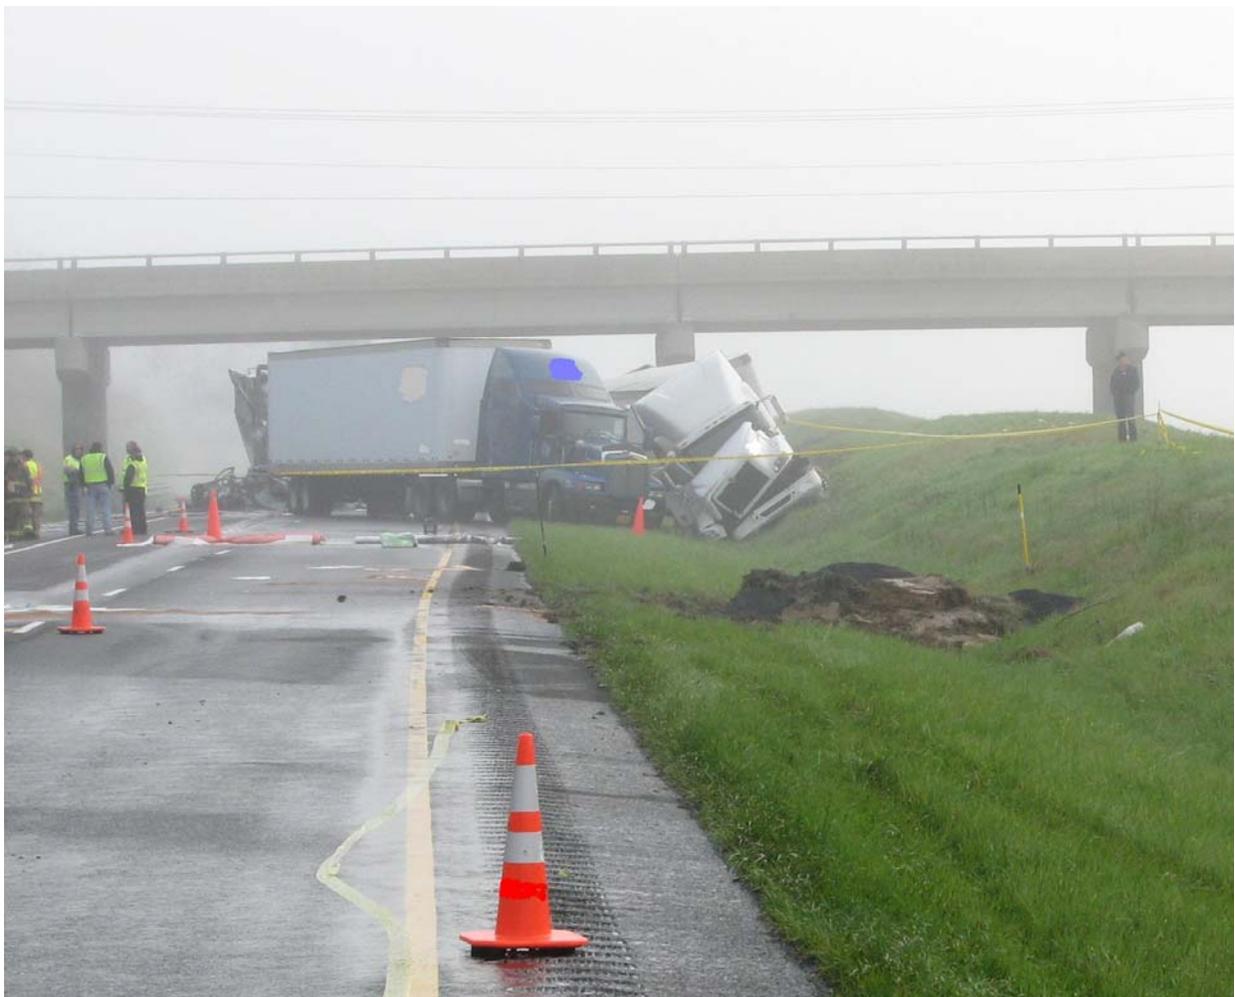
***Photo #1: Final rest of TT1(left) and TT2 in the southbound lanes.
Part of Trailer3 and the Hyundai are visible in the background.***

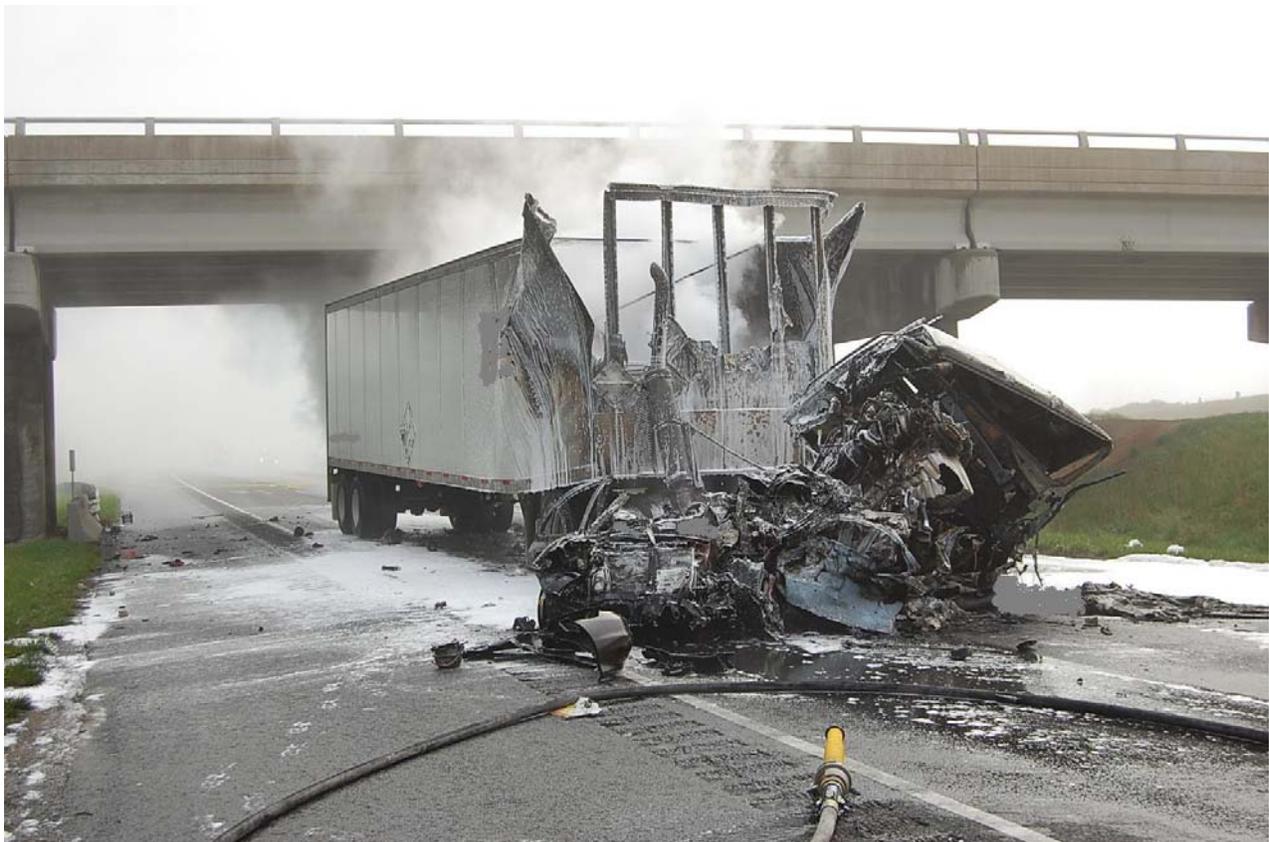
Photo #2: Hyundai and TT3 at final rest.

The Hyundai Elantra was completely destroyed by both contact damage and fire. The trunk was buckled forward and intruded into the rear passenger compartment. The engine compartment was pushed rearward and down, intruding into the front passenger compartment. The overall length of the vehicle was reduced by approximately 6 ½ feet from the manufacturer's original vehicle specifications. No inspection information was available for this vehicle due to the fire damage.

Damage to TT3 was extensive to the tractor and the front of the trailer. They were both damaged by contact damage and extensive fire damage. The tractor was destroyed by the fire, with the steer tires and first drive axle tires melted. The interior was burned extensively. The motor carrier trooper's post crash inspection of the tractor indicated the clamp brakes on the front drive axle (axle #2) were out-of-adjustment and the automatic airbrake adjustment system failed to compensate for wear. Both of these he indicated were not crash related. The front portion of the trailer was damaged by fire. This was where the hazardous materials had been

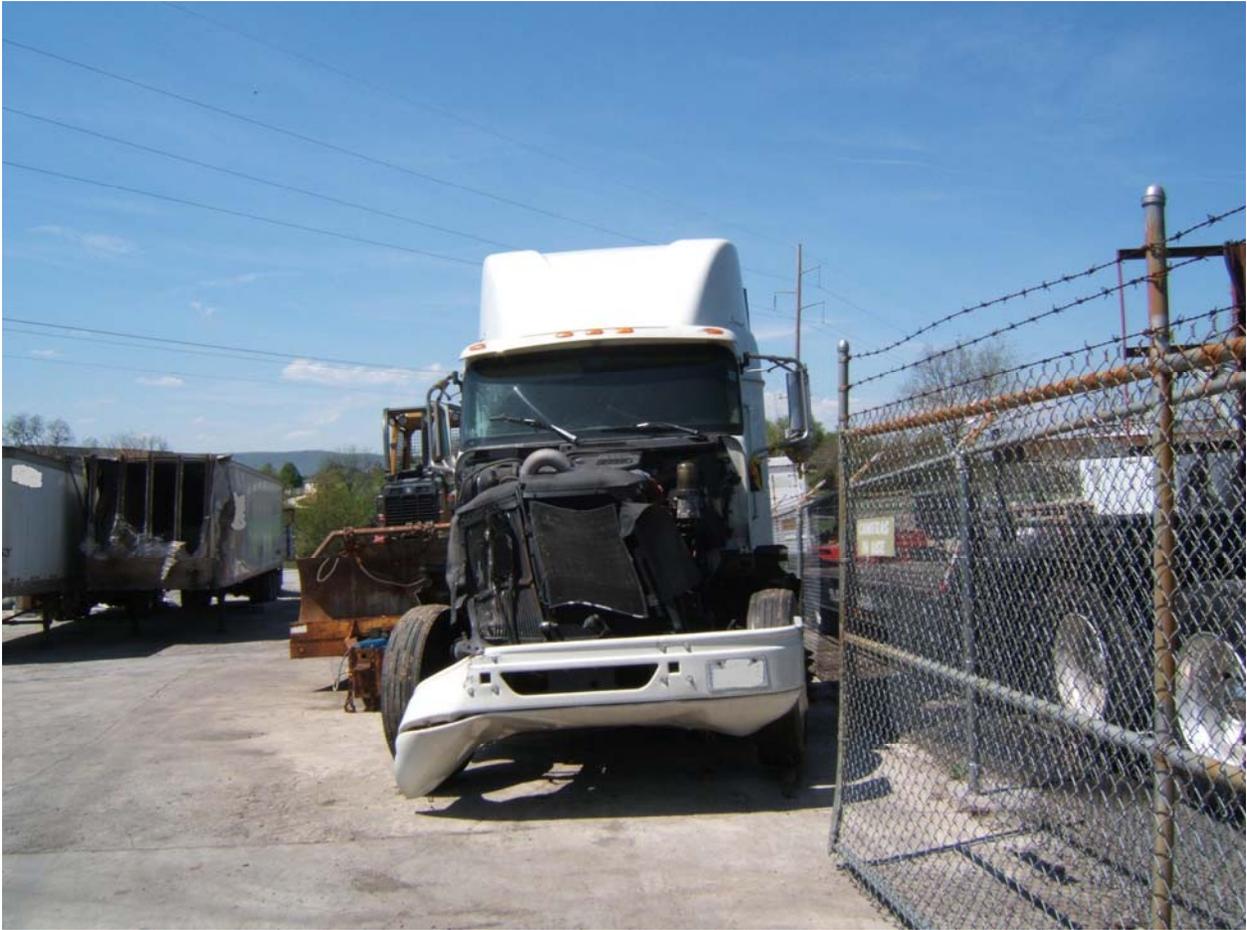
Damage to TT2 was extensive in nature. The rear of the trailer sustained major damage. The rear impact guard was pushed against the bottom floorboard of the trailer. The rear tandem axles were broken from the leaf assemblies and the brake chambers on the rear most axle were destroyed. The rear third of the trailer was torn and buckled at the top. The motor carrier trooper's post crash inspection of the trailer indicated that the left rear tail lights and both rear side marker lights were inoperable due to the crash. The tractor suffered contact damage to the right front half. The hood was broken and buckled. The motor carrier trooper's post crash inspection of the tractor indicated the right side windshield was broken (he did not attribute this to the crash), right side windshield wiper was inoperable, the left side front tire tread depth was less than 4/32nd of inch, the left Anti-lock Braking System (ABS) wire was cut, and there was an audible air leak coming from the air relief valve at the front drive axle (axle #2). He met with U.S. Postal workers the next day so that they could remove the mail from Trailer 2 and return it to the postal system.

Photo #3: Front view of Tractor 2, showing damage from collision with rear of Trailer 1. Burned remains of Trailer 3 are visible to the left.
