Crash Investigation Team Technical Alert: Number 14

Date: January, 2006

CRASH INVESTIGATION TEAM
Technical Alert Number 14
(Primary Highway)

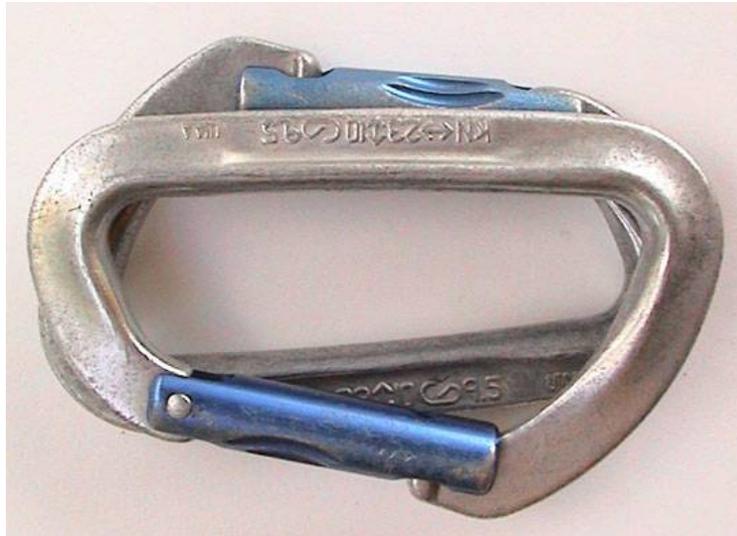
Exemplar Carabiner Clip

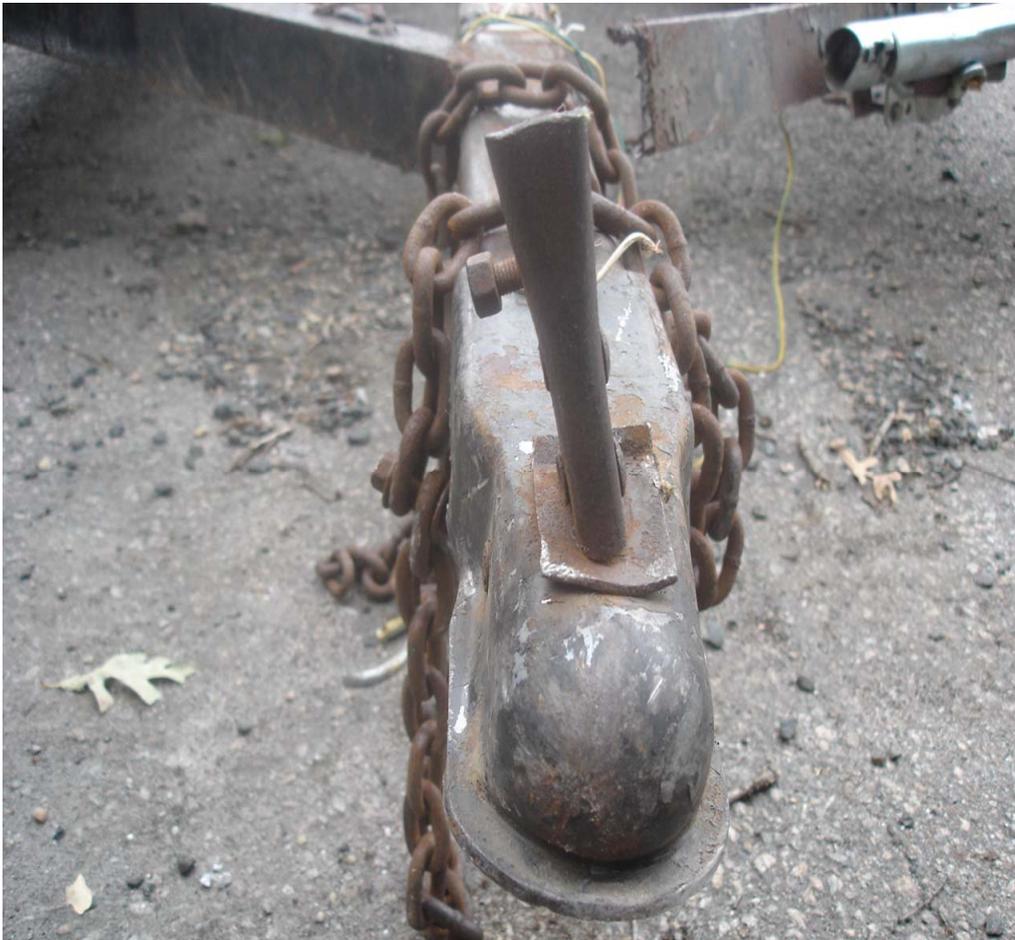
the trailer. Constructed in 1985, the steel trailer was composed of parts from a mechanical automobile lift and two axles from a mobile home. It had a flat bed without sidewalls or tailgate. The coupler on the trailer was compatible with the two-inch ball hitch on the truck; however, this latching mechanism was an older style. It consisted of a shallow concave rectangular metal plate that applied pressure to keep the ball securely seated in the coupler. This device was well worn and may have been defective prior to the crash. The lever on the coupling mechanism, which was bent and rendered the device defective after the crash, did not have a location to insert a locking pin to secure it in place.

Top view from the front of the trailer coupler and chains

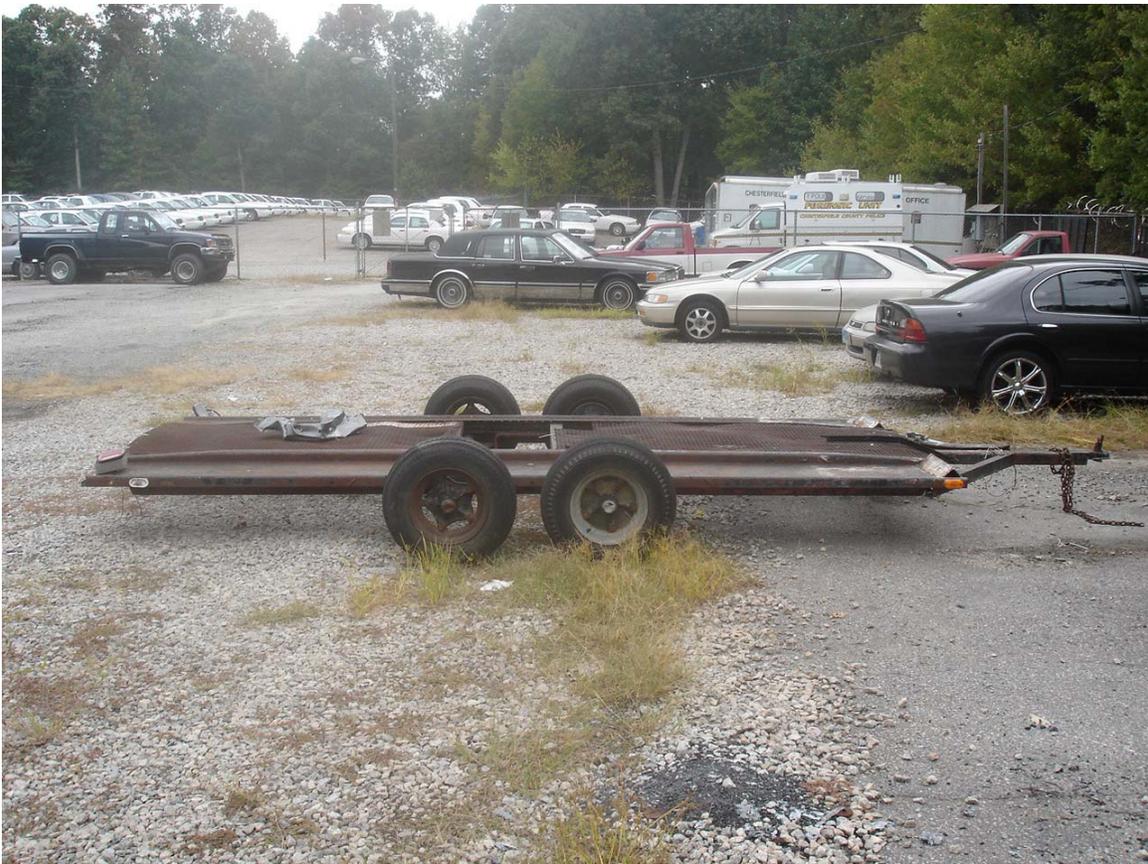
Drum brakes were installed on the trailer's front wheels; however, there were no wires connecting them to the electrical harness. Consequently, the brakes were present but not operational. Without the appropriate harness, the brakes could not be connected to a power unit. Thus, they could not be activated in the towing vehicle through application of the service brake pedal or with a hand-operated lever. Additionally there was no emergency breakaway system, as required by Virginia State Code and inspection rules and regulations, to activate the brakes should the trailer come loose from the towing vehicle. Such a system would have included a switch that trips when a trailer disconnects and a battery to power the braking mechanism when the switch is tripped. Since the trailer was equipped with brakes, by State Code the brakes were required to function and the trailer was therefore required to be inspected. This trailer had no inspection approval sticker on it.

View from right side of trailer: note absence of battery box and breakaway switch.

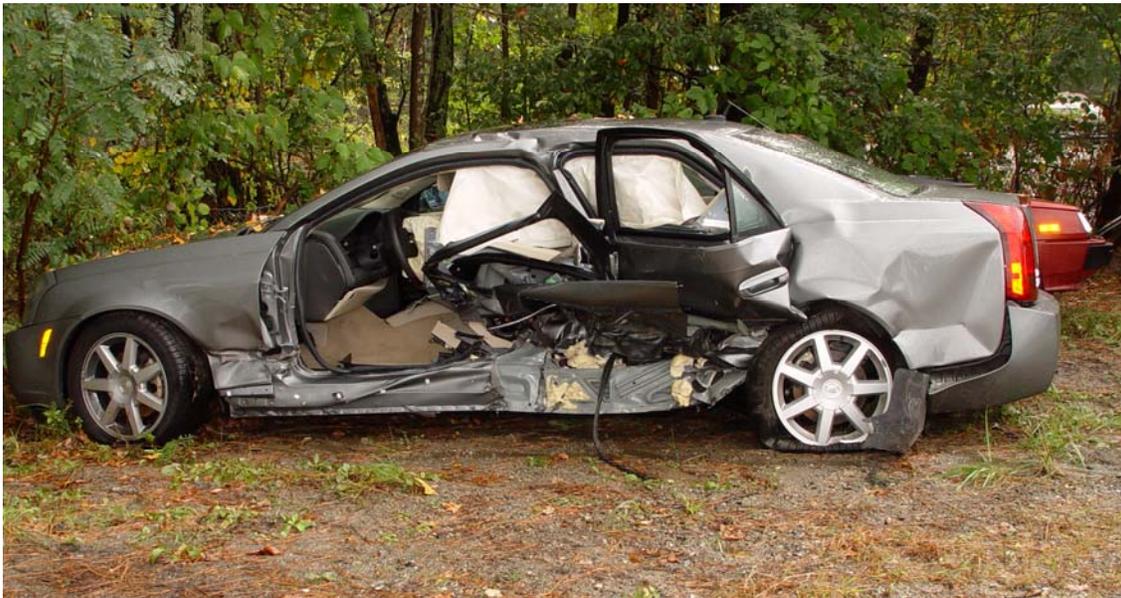
The trailer crossed the remaining turn lane, mounted the curb and rolled down the median’s slope, into the lanes of oncoming traffic. The driver of the van braked and swerved to the left into the median to avoid it. The trailer passed in front of his vehicle and its tongue struck the right side of the Cadillac just behind the left front tire. The tongue slid along the side of the car and then the left front corner of the trailer body impacted just below the window level of the “B” pillar behind the driver’s door. The tongue and trailer body intruded into the driver’s compartment, causing extensive damage and fatally injuring the driver. The trailer and the car began to rotate in a counter-clockwise motion, crossing the curb at the north shoulder. The car rotated approximately 90 degrees, and then came to rest facing south with its rear end against a utility post. The trailer came to rest facing 180 degrees from its original direction of travel, with the tongue embedded in the deflated left rear tire of the car. The webbing that anchored the aerator gave way and it flew off the trailer, crossed onto the shoulder east of the car and trailer, and struck the control box for the traffic signals. It severely damaged the box, knocking it loose from its concrete pad and thus disabling the traffic signals for the intersection. It came to rest on the shoulder near the northwest corner of the intersection.

Left side of Cadillac: note damage starts behind front wheel and deepens at “B” Pillar

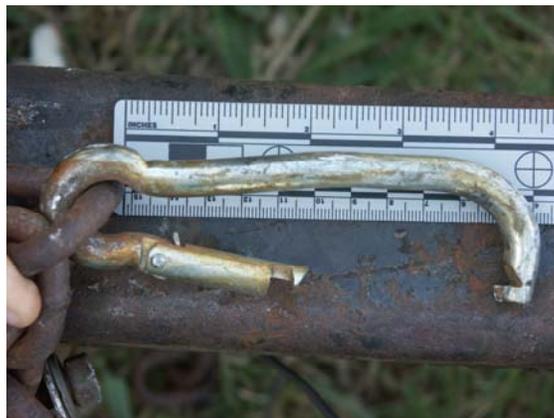
The run-away trailer was a key item of interest for the Crash Investigation Team. The question of how and why it broke away from the pickup was an initial concern. The high rise truck violated equipment specifications and, even with the drop-style hitch, was too high for a proper mount with the coupling mechanism. The nine-inch difference between the ball on the hitch and the receptacle on the trailer lifted the tongue of the trailer and forced the bed to slant downhill from front to back. With the bed no longer level, unnecessary stress was placed on the ties securing the aerator to the trailer. The lack of a level mount between the two vehicles may also have kept the latching device from locking completely into position. The pickup driver reported that he felt the trailer come loose when he hit a very slight dip in the road as he entered the left turn lane. The dip may have been enough to jar open the latch and uncouple the hitch, transferring the full weight of the trailer to the tow chain and the aluminum “carabiner” clip. A chain is only as strong as its weakest link, and this clip was not designed to support the weight of a trailer. It stretched open and broke, releasing the trailer.

Carabiner Clip from this crash.

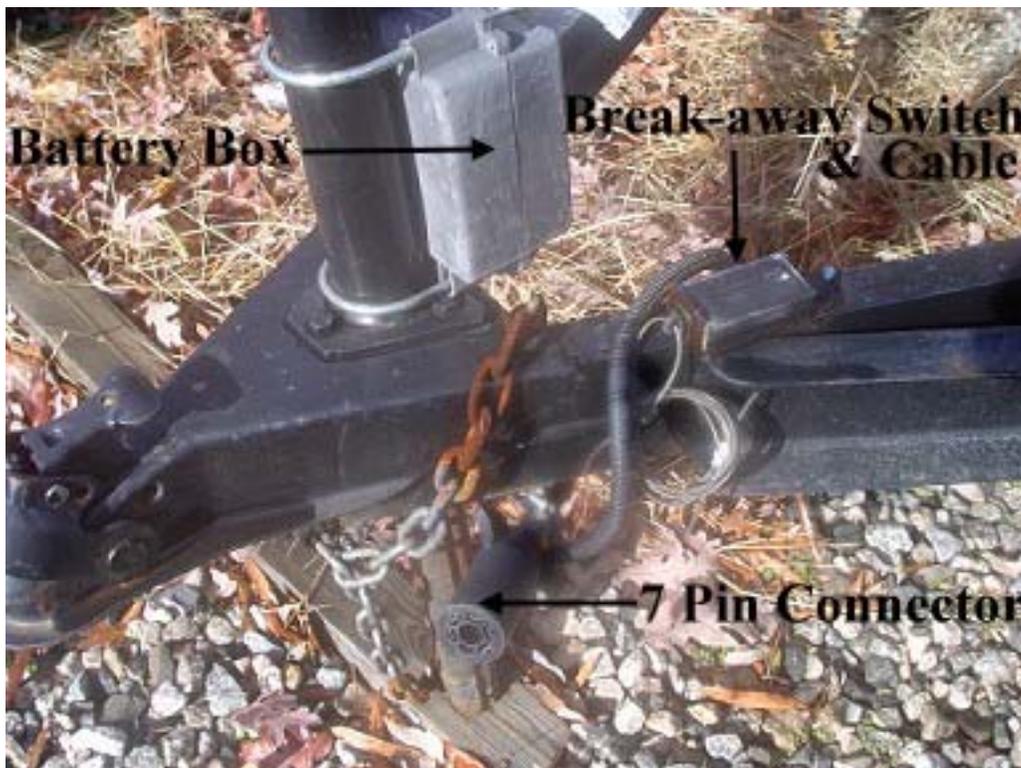
Example of trailer coupler with a seven-pin connector at bottom center, battery box at top center (attached with metal “U” bolts) and the breakaway switch and cable just right of center.
