## Virginia Multi-disciplinary Crash Investigation Team Technical Alert: Number 16

**Date: January, 2007**

VIRGINIA  
MULTI-DISCIPLINARY  
CRASH INVESTIGATION TEAM  
TECHNICAL ALERT NUMBER 16  
Rural Primary Road  
1999 Chevrolet Blazer  
1998 Dodge Ram Pickup

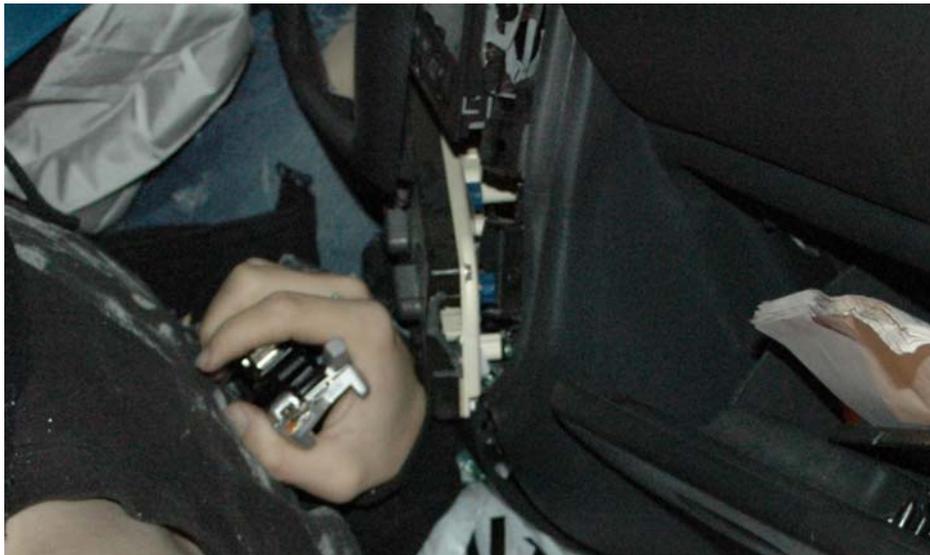
According to family members, this driver had just received a text message on his cell phone and was either reading it or responding to it when he crossed the median. Talking on a cell phone, once a call is in process, requires little visual effort or eye-hand coordination. When text messaging, however, the operator has to scan the message and/or locate and press various small buttons on the phone. These actions require the driver to take his eyes off the roadway. They also demand a higher level of mental

*Photo 1: Cell phone in deceased driver's hand at the scene of the crash.*
