**Virginia
Multi-disciplinary
Crash Investigation Team**

**Technical Alert: Number 17
Four Fatality Rear-end Collision at Intersection**

Date: January, 2008

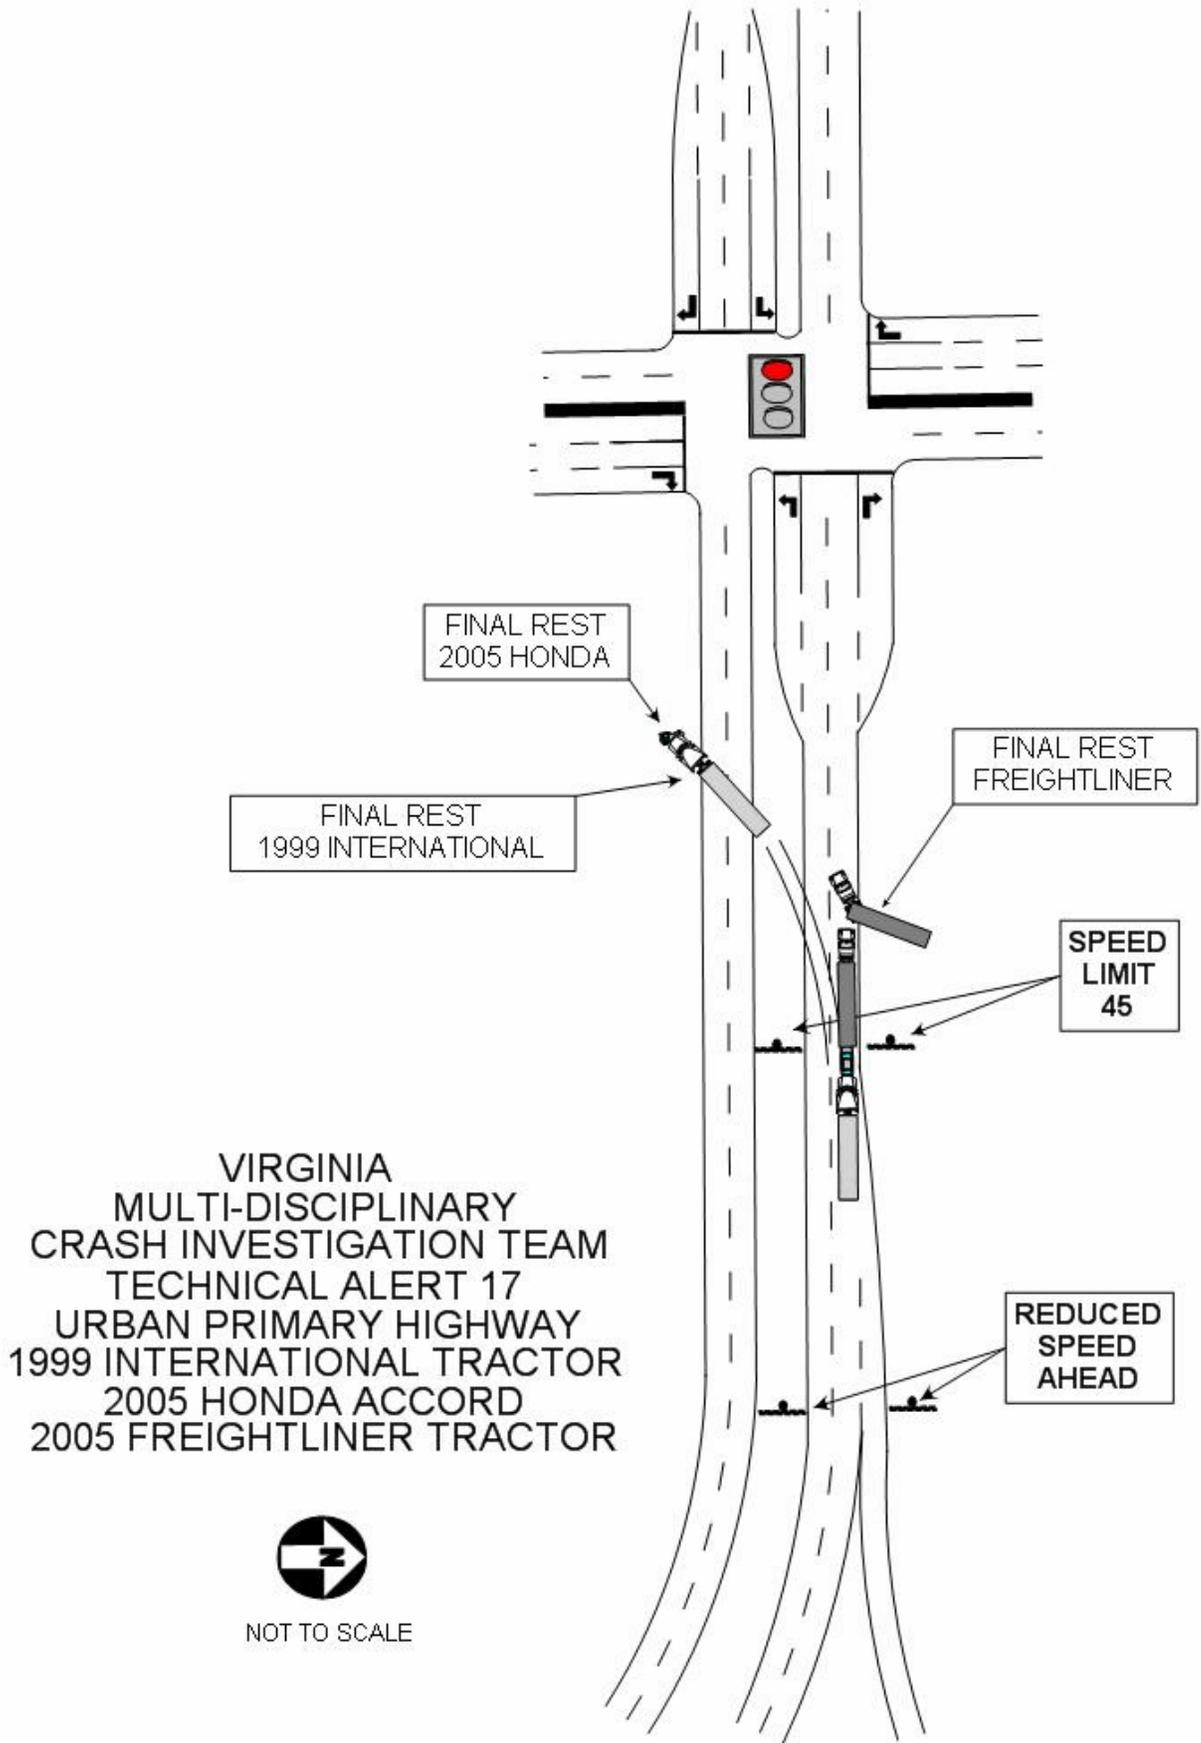
VIRGINIA
 MULTI-DISCIPLINARY
 CRASH INVESTIGATION TEAM
 TECHNICAL ALERT 17
 URBAN PRIMARY HIGHWAY
 1999 INTERNATIONAL TRACTOR
 2005 HONDA ACCORD
 2005 FREIGHTLINER TRACTOR

As the Honda approached the intersection, it slowed for traffic that was queuing at a red traffic light. A tractor-trailer was stopping immediately ahead, in the same lane. This vehicle, a 2005 Freightliner tractor pulling an empty semi-trailer, was operated by a 65 year old male, who was headed to a destination about 60 miles away in a neighboring state. A 36 year old male driving a 1999 International tractor and pulling an empty semi-trailer was also traveling in the right lane, behind the Honda. This driver had been working since 4 a.m., making pickups and deliveries. He was traveling home, about 30 miles away. He negotiated the long left curve on the downgrade and passed the entrance ramp from the southbound primary road.

The International tractor driver failed to note that the traffic was slowing and forming a queue. He stated that he saw the truck stop and “hit my brakes.” In a later interview, he stated that he was “tapping” his brakes, not pumping them. There were no marks on the road to indicate that his brakes were ever engaged enough to cause skidding. As his vehicle was almost even with the 45 mph speed limit sign posted beside the road, his tractor collided with the rear end of the Honda. The larger, heavier vehicle overrode the trunk area of the Honda and pushed the car forward, into the rear of the trailer preceding it. The Honda was crushed between the two, killing all four occupants instantly, in spite of the fact that the vehicle was equipped with eight airbags, all of which deployed. The impact

was of such force that it broke the tandems from beneath the first trailer and caused it to turn onto its side. The International tractor, with the Honda still entangled in its front engine area, disengaged from the Freightliner's trailer and slid across the left lane and through the grassy median. The tangled vehicles crossed both eastbound lanes and came to rest on the south shoulder of the roadway, still locked together.

In addition to the above changes, the VMCIT recommends that the 45 mph reduced speed zone be extended to prior to the overpass over the north/south primary road. The signs should be minimum expressway sizes (Manual on Uniform Traffic Control Devices for Streets and Highways, 2003) and installed on both sides of the roadway. Consideration should be given to installing warning beacons on the “REDUCED SPEED AHEAD” signs. These engineering changes, in addition to the ones already implemented, will help improve
