**Virginia
Multi-disciplinary
Crash Investigation Team**

**Technical Alert Number 18:
Six Fatality Two Vehicle Crash**

Date: February, 2008

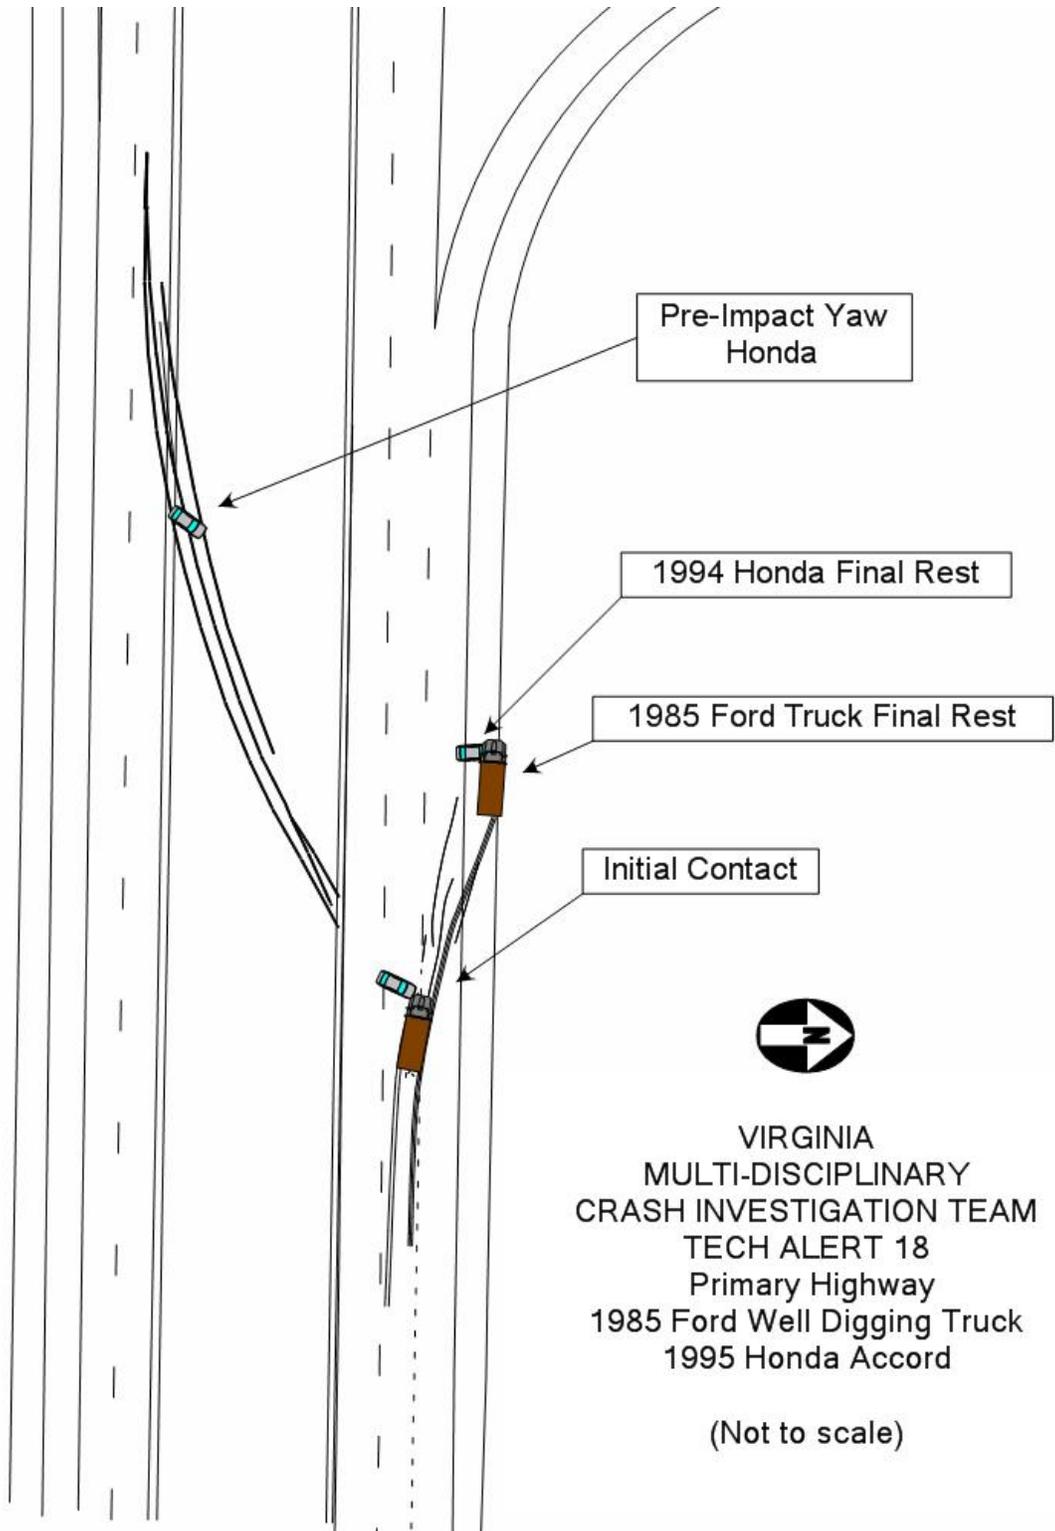
The Accord ran off the left edge of the pavement, across the rumble strips and a few feet into the grass median. The driver swerved to the right to regain the roadway, lost control and continued several hundred feet down the road, swerving from lane to lane. The driver finally swerved left sharply enough that the vehicle rotated counter-clockwise and slid into and through the median, furrowing the grass and dirt along its path. The vehicle then entered the westbound lanes and encroached upon the path of the oncoming truck. The truck driver applied brakes and his vehicle slid approximately 75 feet to impact with the car. The Accord slammed into the truck's left saddle (fuel) tank at an angle as the vehicles engaged. They remained entangled as the heavier, equipment-laden truck pushed the smaller car to the west, gouging and scratching the road surface as they slid across the right travel lane and the deceleration lane. The 13 year old boy was ejected through one of the left side windows of the Honda. Fire erupted and completely consumed the Accord and partially burned the truck. At final rest, the vehicles were still attached, with part of the truck atop the car. The truck straddled the edge of the right shoulder, its right wheels off the roadway, and the back end of the car extended into the right travel lane.
