**Virginia
Multi-disciplinary
Crash Investigation Team**

**Technical Alert: Number 19
Five Fatality Single Vehicle Crash**

Date: November, 2008

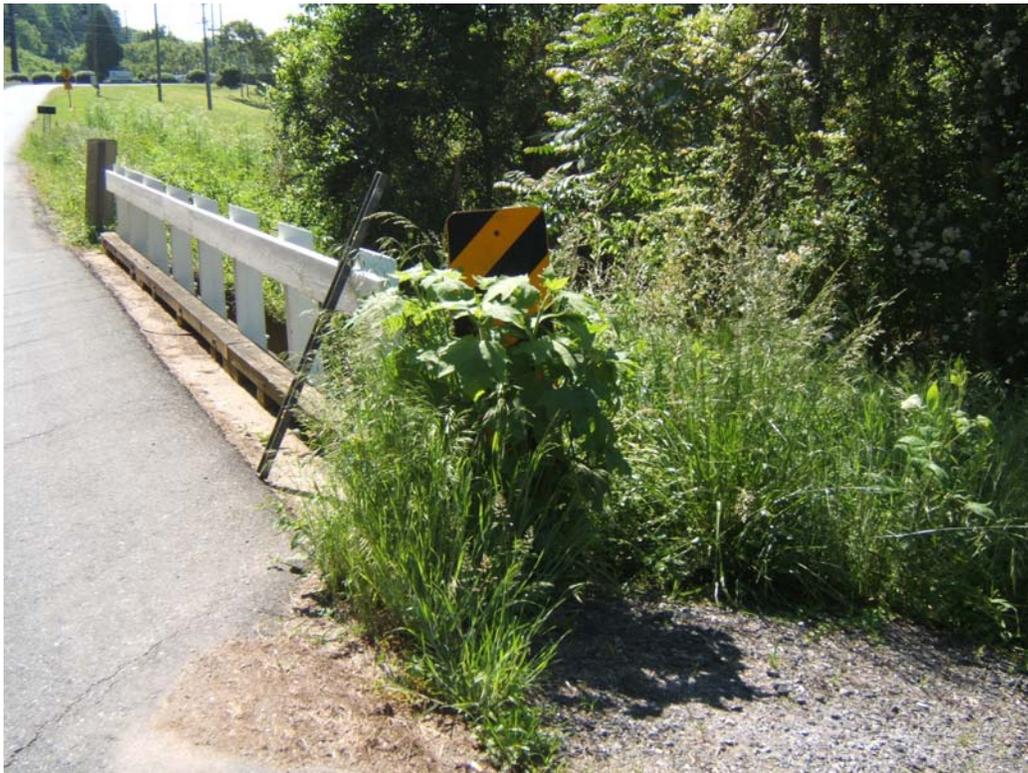
This two lane highway, a north-south route, is approximately 18 feet wide. A long straight segment leads to a curve to the right that is approximately 13 degrees just prior to the crash site. A creek runs beneath a bridge at the north end of the curve and the road is bordered by grass and trees. Vegetation obscured the object markers (diagonally-striped vertical rectangular signs) mounted on posts at the beginning of the bridge. (*This should be trimmed by the Virginia Department of Transportation (VDOT) in order to provide better visibility of the markers.*) The pavement is asphalt and in good condition.

Photo #1 Vegetation blocking view of object marker for bridge

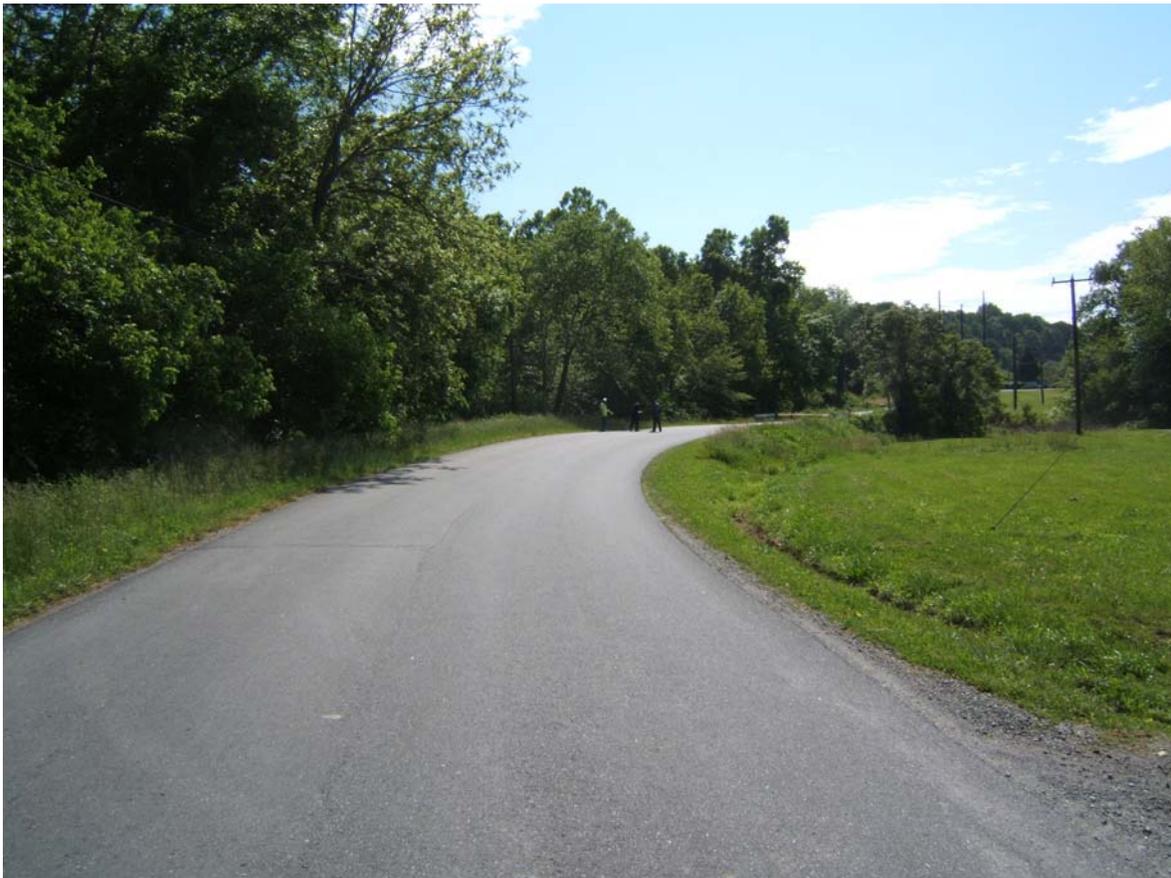
There is no overhead lighting. Furthermore, the road is unmarked approximately one half mile prior to the location of the crash site and the absence of edge lines means that drivers have less perceptual information to help them navigate the road, especially at night. There are no delineators or chevron alignment signs (W1-8) on this section of road to indicate a curve. *(VDOT should consider installing the appropriate delineators/chevron alignment signs in order to provide positive guidance for the motorist. VDOT should conduct an engineering study on this road to determine if additional safety features are warranted, such as guardrail, additional signing, and/or pavement markings.)*

Photo #2: View of the road facing north, in the direction the Mazda was traveling.

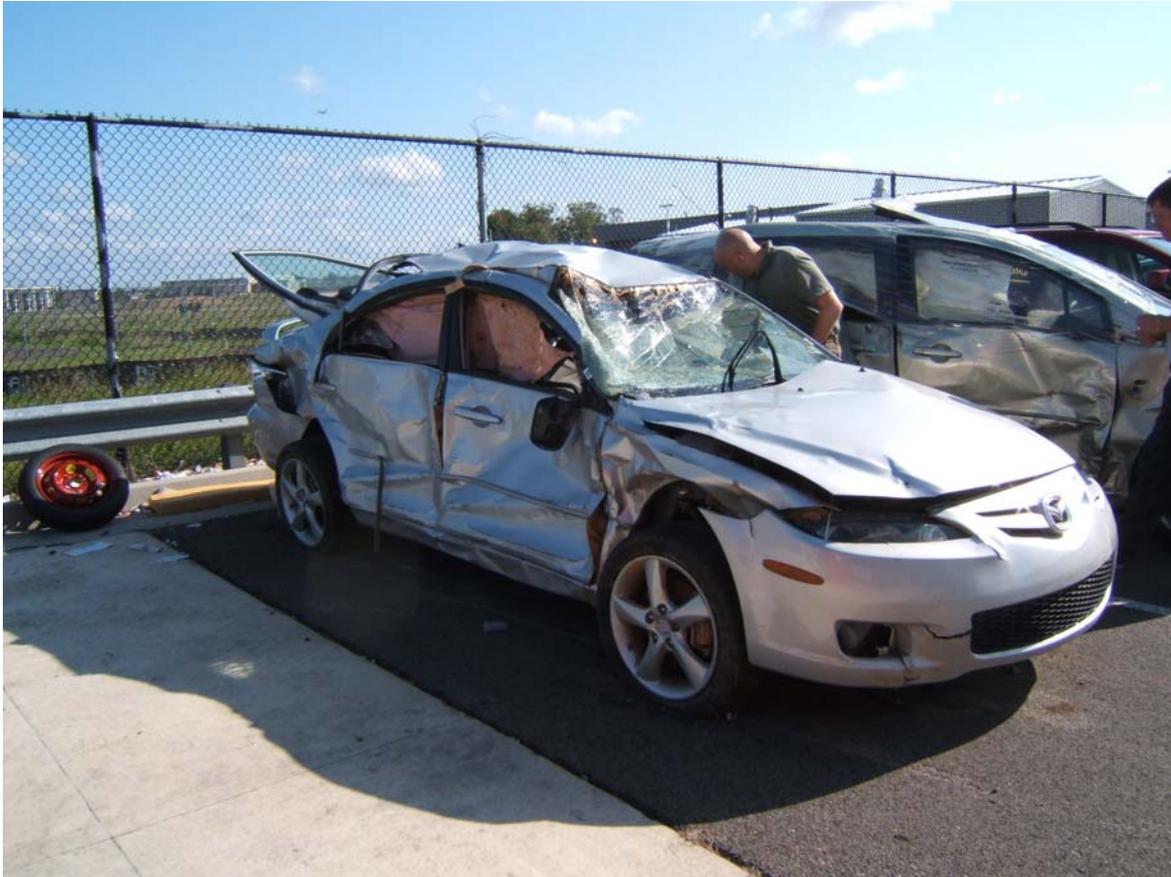
The vehicle sustained the majority of damage when the vehicle tripped and landed on the passenger side. Both passenger side tires were deflated and unseated from the rims. The rims showed scarring and were embedded with dirt and grass. Damaged areas of the vehicle intruded into the occupant compartment as much as 13 inches. The roof on the passenger side was buckled upward and torn free from its supports. The passenger side curtain airbags and side torso bags deployed in conjunction with the driver and passenger front airbags. As a result of the hard impact, the driver's seat was bent toward the passenger's door. The deformation measured 8 inches from its original position and crushed the center console. Despite the damage listed above, the occupant compartment held up very well. It is possible that this would have been a survivable crash for most of the occupants if they had been using restraints at the time of the crash.

***Photo #3: View of the Mazda showing area of most severe damage.
Note that both right side curtain airbags deployed.***
