**Virginia
Multi-disciplinary
Crash Investigation Team**

**Technical Alert: Number 20
Two Fatality Single Vehicle Crash**

September, 2009

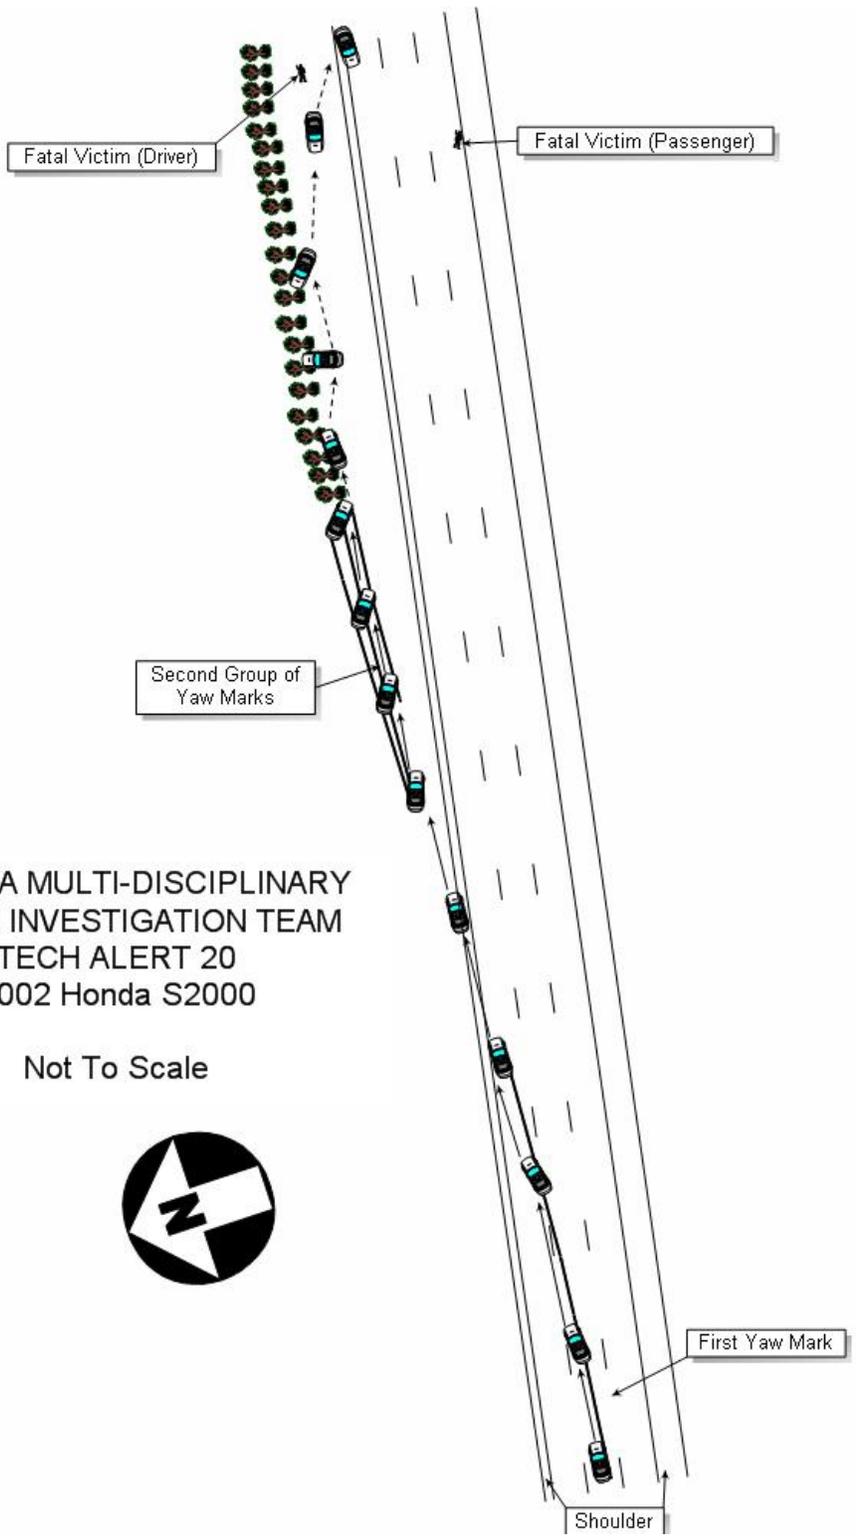
VIRGINIA MULTI-DISCIPLINARY
 CRASH INVESTIGATION TEAM
 TECH ALERT 20
 2002 Honda S2000

Witness statements indicated that the Honda was traveling at a high rate of speed in the left travel lane in moderately heavy traffic. According to the “AVERAGE DAILY TRAFFIC VOLUMES with VEHICLE CLASSIFICATION DATA ON INTERSTATE ARTERIAL AND PRIMARY ROUTES” (Commonwealth of Virginia Department of Transportation, 2008), the average daily traffic is 25,000 vehicles for this section of roadway. As the driver approached a slower moving vehicle in the same lane, he changed lanes to the middle lane to pass. After passing the slower moving vehicle, the driver attempted to steer back to the left lane. This maneuver caused the rear wheels of the Honda to begin slipping sideways and the vehicle yawed counterclockwise towards the median on the left. The driver attempted to regain control by overcorrecting to the right, but his momentum had already carried him off the left edge of the roadway and into the grass median. The Honda furrowed through the median until the left front impacted

the first of the treelike shrubs. The vehicle then spun throughout the median, contacting the shrubbery several more times in different locations along the body of the Honda.

The unbelted front seat passenger was ejected from the vehicle and came to rest in the right travel lane adjacent to the right emergency shoulder. The unbelted driver was also ejected from the vehicle and found in the median near the final rest of the Honda, which was partially in the left travel lane facing the opposite direction of travel. A nitrous oxide bottle was also found in the median, adjacent to the Honda at final rest.
