**Virginia Commonwealth University**  
**Transportation Safety Training Center**  
**Virginia Multi-disciplinary Crash Investigation Team**

Report Number 214 – February 2011

**CASE STUDY ONE: SYNOPSIS**

**CASE STUDY 2: SYNOPSIS**

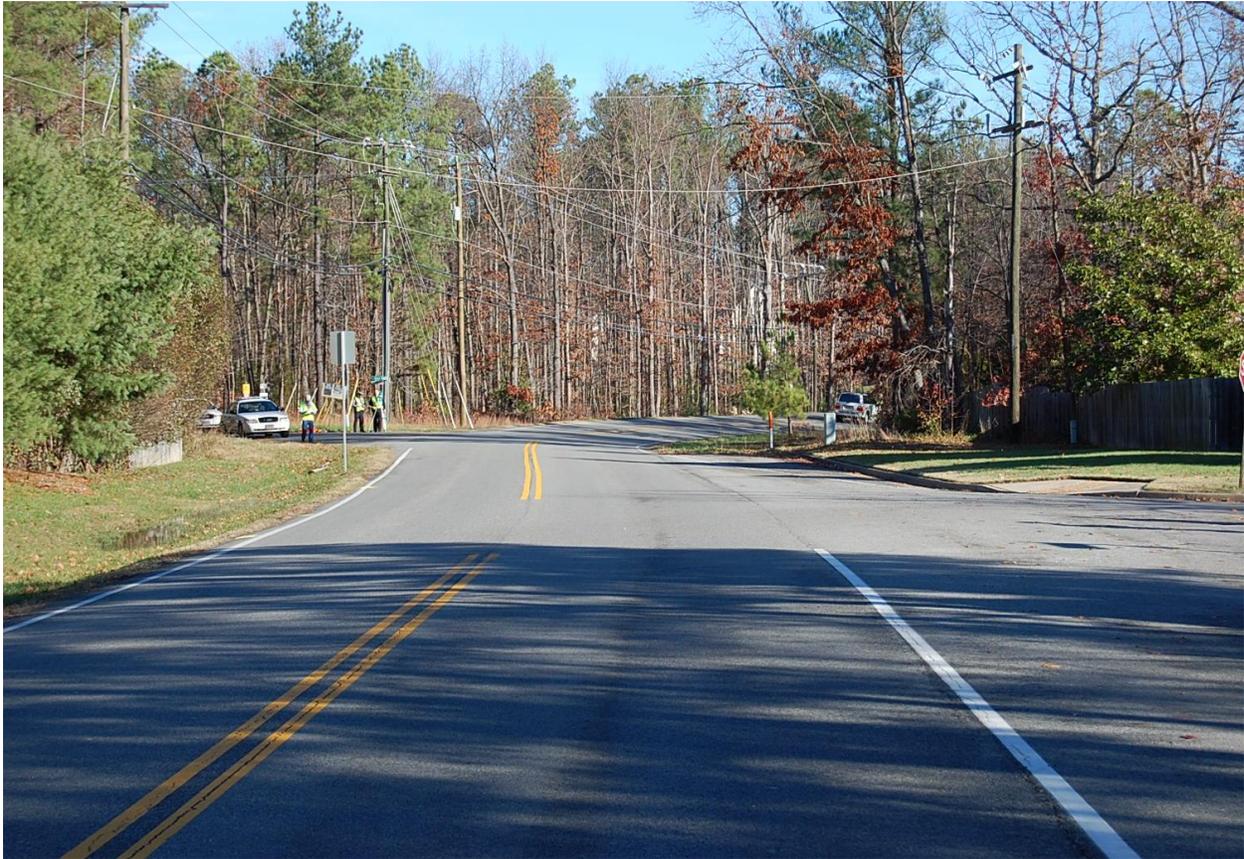
*Photo #1: View looking northbound, approaching “S” curve.*

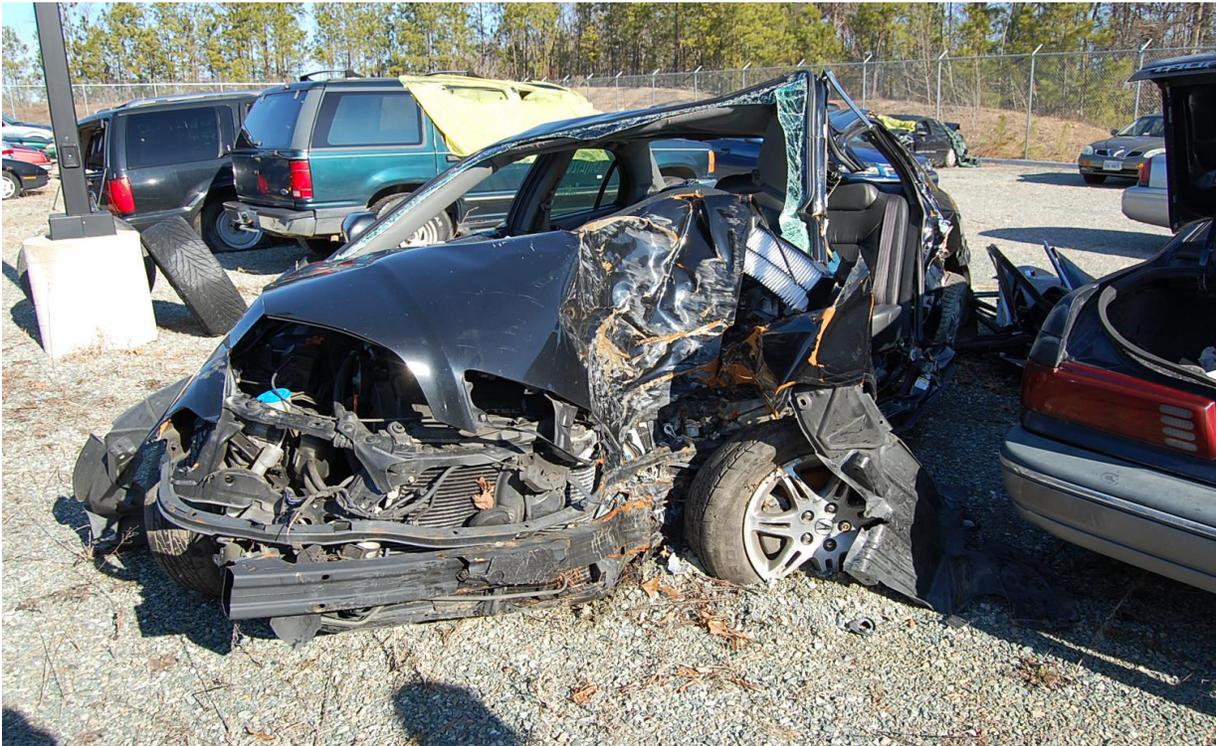
Members of the Virginia Multi-disciplinary Crash Investigation Team (VMCIT) examined the Acura at a police storage facility. This vehicle was registered to the driver and had current inspection and registration stickers. The odometer was not readable after the crash, but the car had 135,544 miles reported at its last inspection, about ten months prior. The tread on the tires was in good condition, although the left front and right rear tires were deflated as a result of the crash. The Acura's front end was extensively damaged when it struck the tree. The left side of the hood, grill and engine compartment collapsed toward the occupant compartment, deforming the front end of the frame.

*Photo #2: Front/Side view of Acura, showing collision damage from impact with the tree.*

Measurements of the Acura post crash found the wheelbase to be 85 inches on the left side and 107 inches on the right side, compared to the manufacturer's specifications of 108.1 inches. The overall length of the vehicle post crash measured 172 inches on the left side and 174 inches on the right side versus the vehicle specifications of 192.9 inches. The width of the vehicle was also measured post crash: 61 inches at the front and 64 inches at the rear, compared to specifications of 70.3 inches. The left front axle was damaged as the left front tire folded toward the center of the vehicle. The right side of the hood buckled upward. As the left "A"

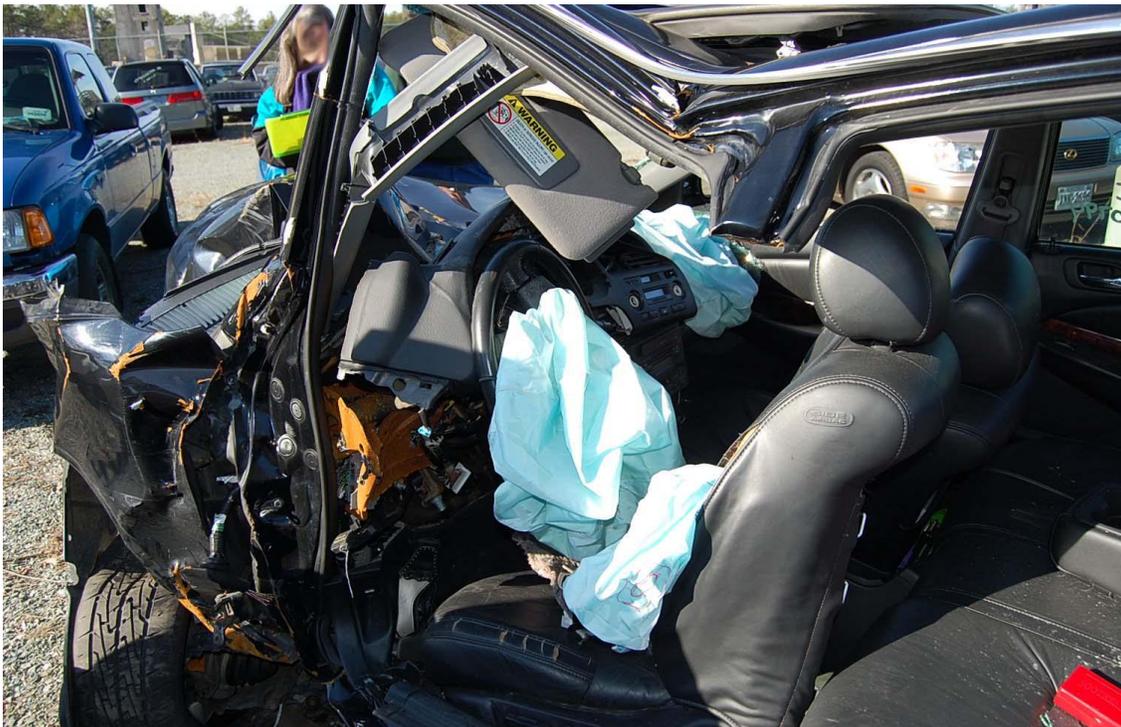
pillar was forced back and upward, the left side of the roof buckled upwards as well, in the area above the driver's head, peaking approximately half the distance between the "A" and "B" pillars. This in turn induced the roof area just behind the peak to buckle downward, several inches below the normal line of the roof. The front windshield shattered and glass fell into the vehicle interior. Inside the occupant compartment, the floor pan and dash areas intruded into the driver's space, leaving only 10 inches between the steering wheel and the front of the driver's seat. The entire driver's seat was also pushed rearward until the left side of the seat back came into contact with the bottom front portion of the rear bench seat.

***Photo #3: Side view of Acura, showing the upward buckling of the "A" pillar and occupant compartment damage/intrusion.***

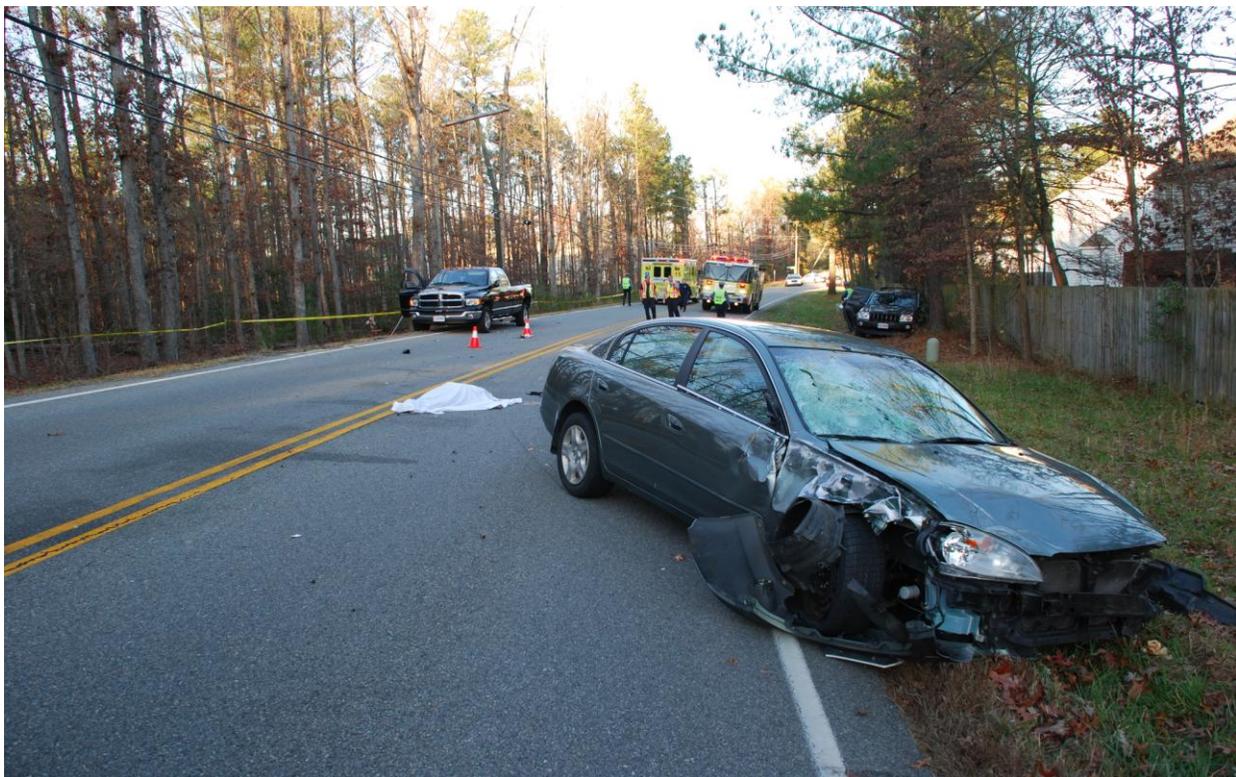
***Photo #4: Vehicles and victim at final rest.***

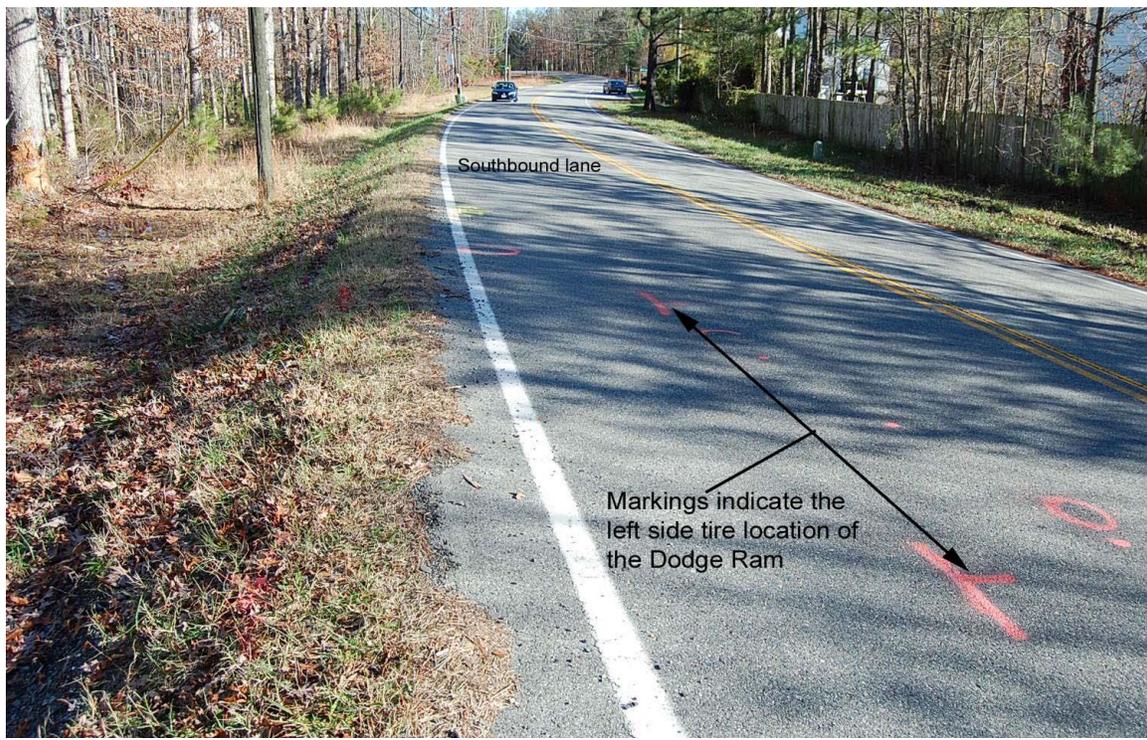
When the female passenger stepped out of the pickup, she fell down the steep slope. Her husband exited the pickup, walked to her side and assisted her back up the slope. According to statements he made to investigating officers, he told his wife to wait behind the pickup while he walked around to the driver's door and got in to move it. He reported that he had intended to move the truck off the roadway and into a more protected area approximately 220 feet away, near the intersection with a private road. As he walked alongside his pickup toward the driver's

***Photo # 5: Area where the Dodge pickup parked.  
View of southbound lane, the Nissan direction of travel.***

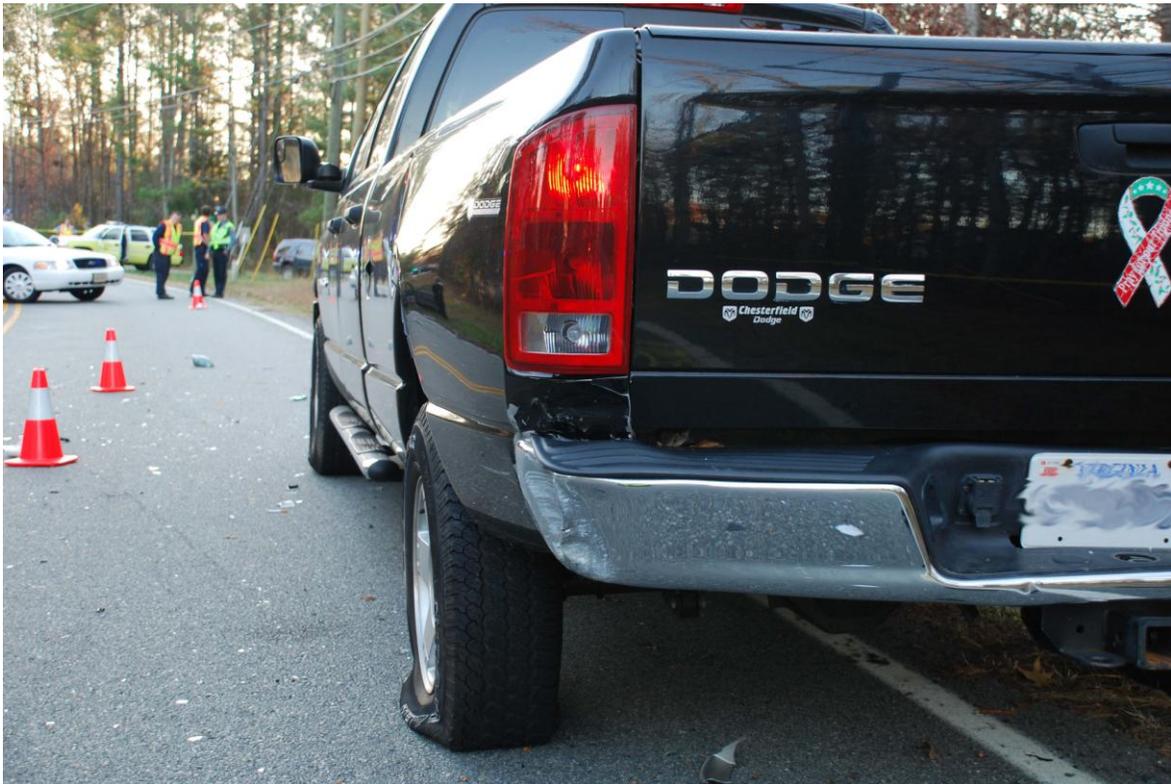
headlamp, right front fender and sheared off the right side mirror. The right front tire was deflated. Damage to the black, 4 door 2004 Dodge Ram 1500 pickup, which was registered to the male pedestrian, consisted of slight crushing to the left corner of the rear bumper and cracking in the area under the left tail light. The left rear tire was deflated. Photographs showed that the left rear tail light cover was not damaged.

***Photo #6: Damage to the Dodge Ram.***

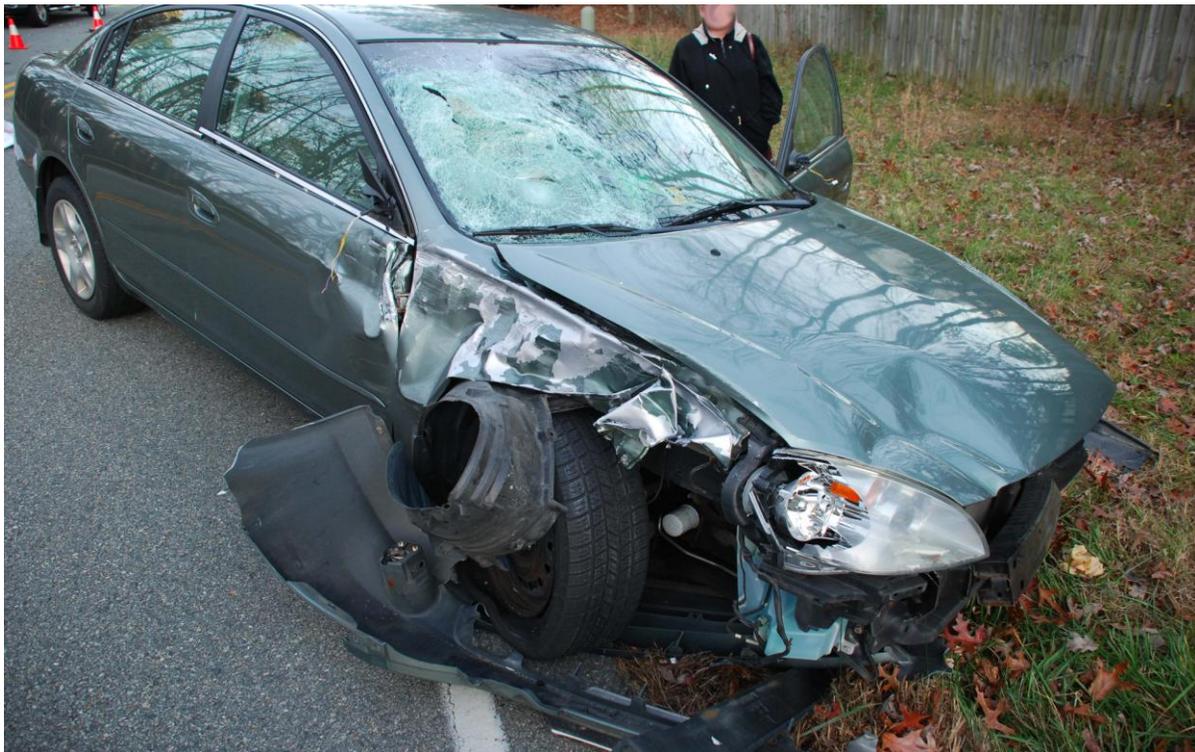
The right front corner of the light green, 4 door 2002 Nissan Altima struck the pickup in the left rear corner. Photographic evidence shows that this first collision damaged the car's right

*Photo # 7: Damage to right side of the Nissan.*

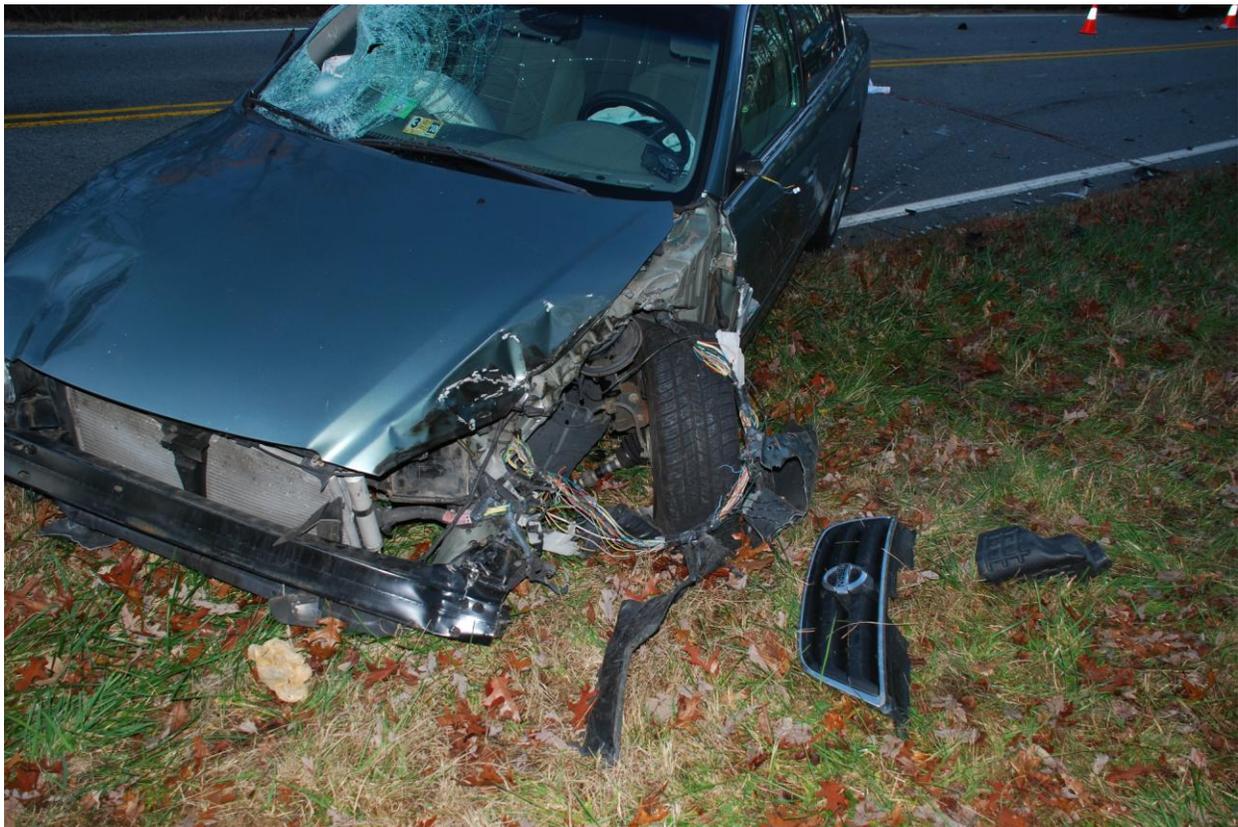
After the pedestrians had separated from the Nissan, it continued across the roadway into the northbound travel lanes, where it struck the Jeep in a small overlap head-on/sideswipe configuration. During this collision, the Nissan sustained damage to its left front fender, from the front of the bumper to the driver's door. The left front axle was severely damaged and the tire was turned outward. Less photographic evidence was available for the black 2005 Jeep Grand Cherokee Sport Utility Vehicle (SUV), although it appeared that the damage was of a sideswipe nature along the left side, from the left front wheel well to the driver's door. This vehicle was registered to a person with the same last name, but not the same address, as the driver.

*Photo #8: Damage to left side of the Nissan.*

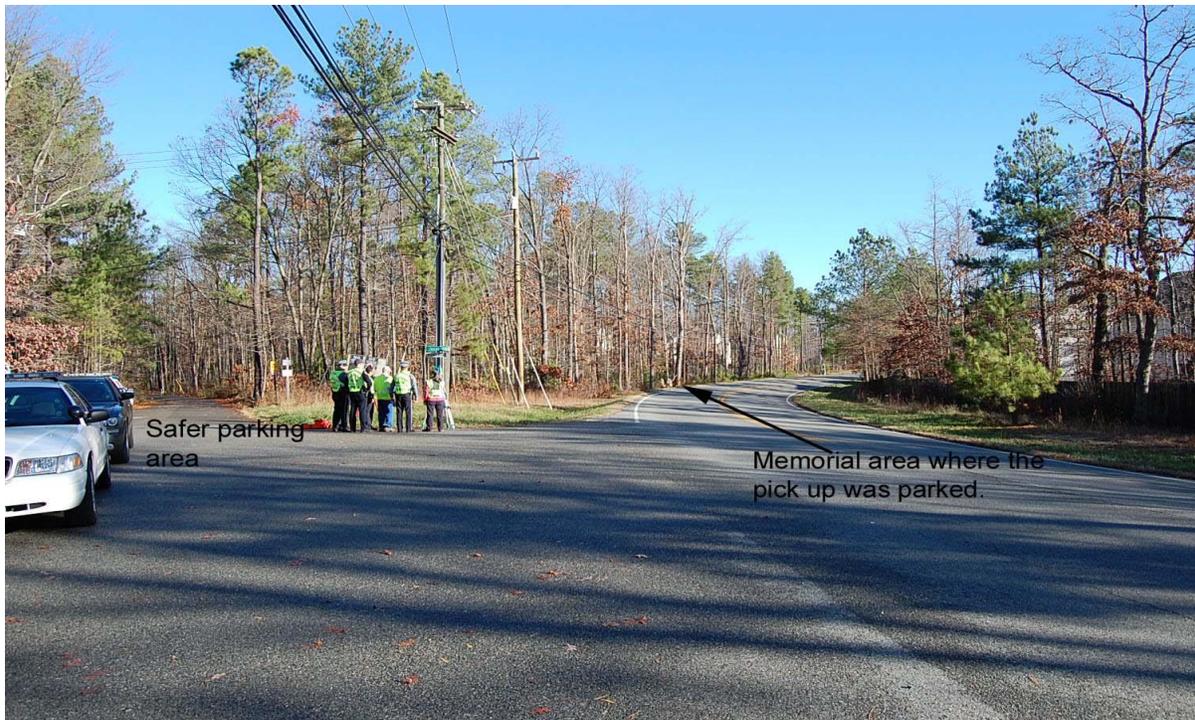
*Photo # 9: View of safer parking area.*
