**Virginia Commonwealth University  
Transportation Safety Training Center  
Crash Investigation Team**

Report Number 190 - May 2003

**SYNOPSIS-Case Study Number One**

**SYNOPSIS-Case Study Number Two**

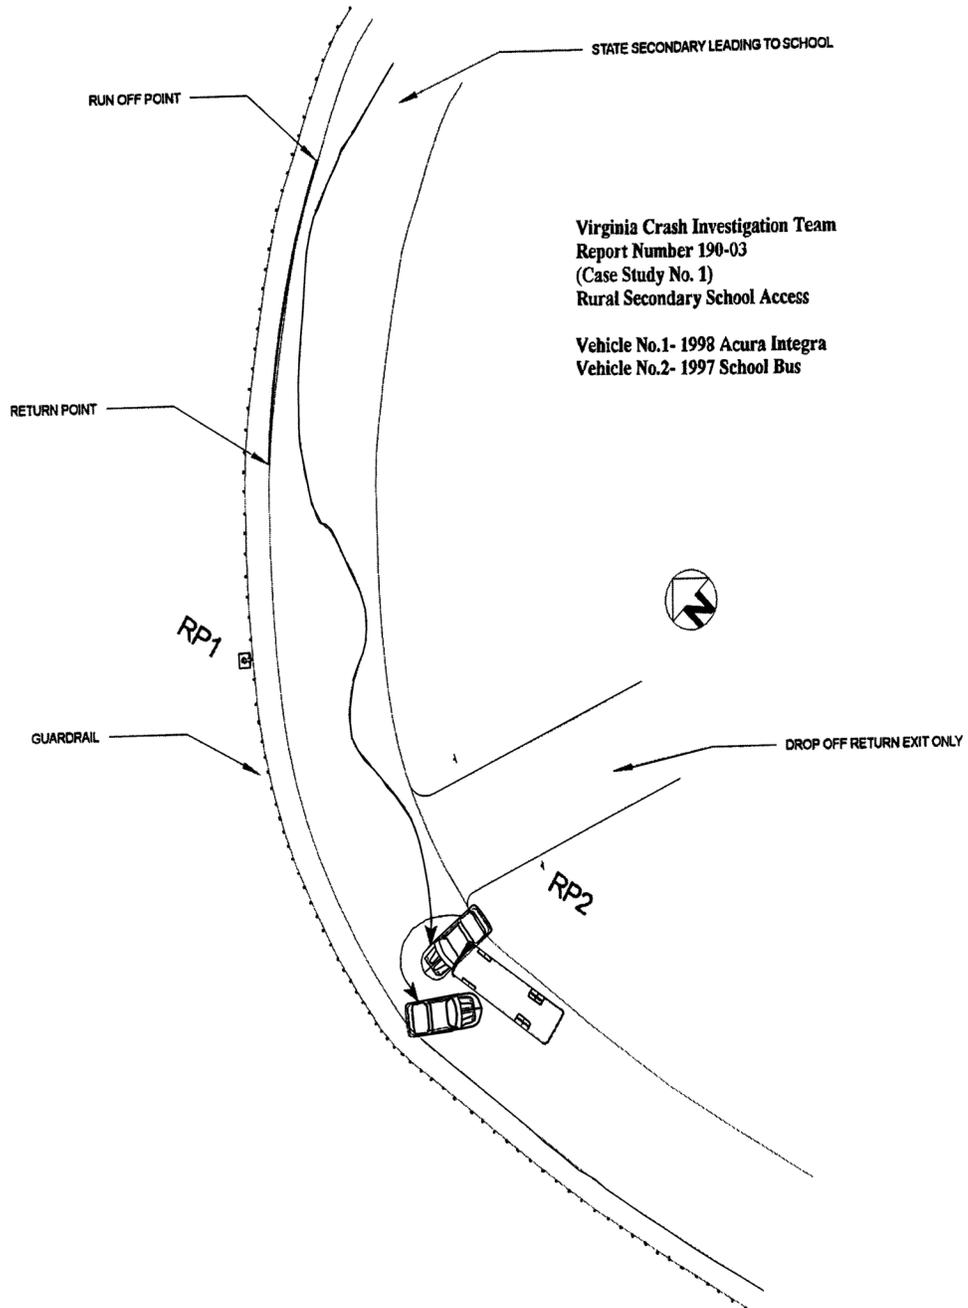
**Summary:** The Acura ran partially off the right side of the road, over corrected, came back onto the roadway and struck the front of a stopped school bus broadside.

**Probable Cause:** The 16-year-old driver, in a rush to arrive at his destination, was exceeding the posted speed limit and was distracted by interaction with his two teen passengers.

**Significant Points:** Driver distraction; speed too fast for road and weather conditions; lack of safety belt use; younger inexperienced driver; violation of teen driving laws; driver over-correction and safety aspects of larger school buses.

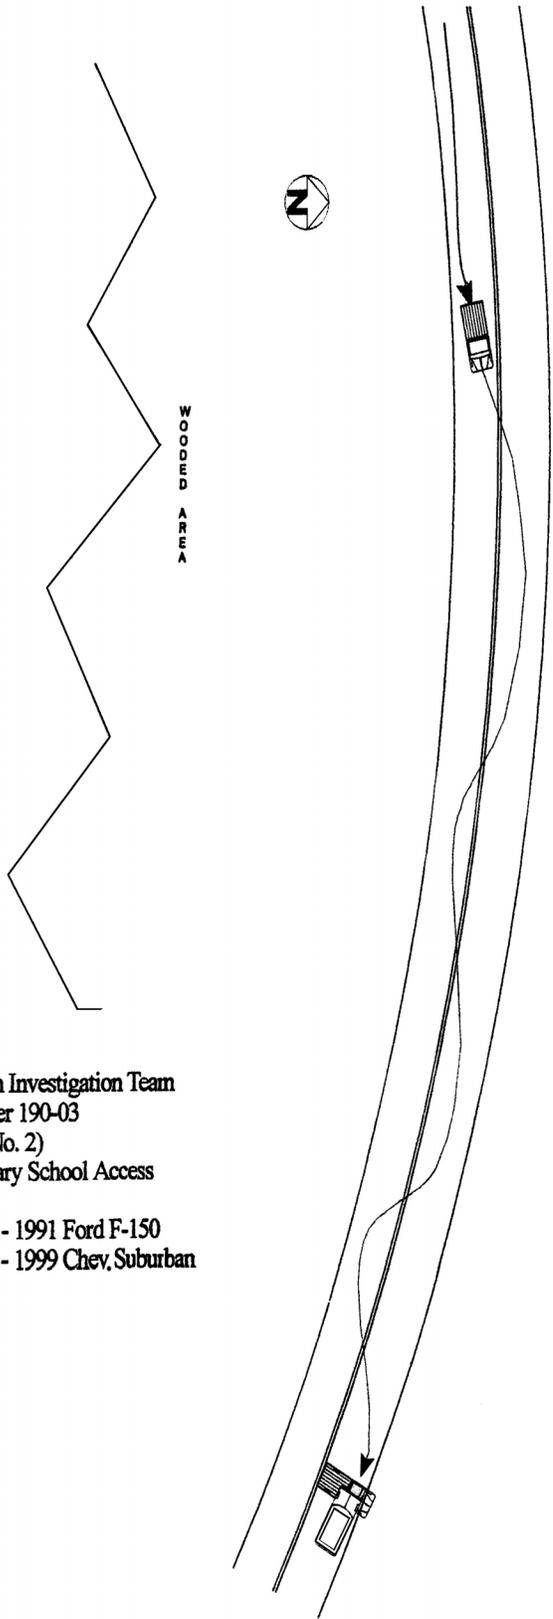
Virginia Crash Investigation Team  
Report Number 190-03  
(Case Study No. 2)  
Rural Secondary School Access

**Probable Cause:** The 17-year-old driver was exceeding the posted speed limit, was traveling at a speed too fast for weather conditions and, as a result, lost control of his vehicle on the wet road.

**Significant Points:** Speed too fast for roadway/weather conditions; driver lost control of the vehicle and over-corrected; younger, inexperienced driver; driver partially sliding out of safety belt: proper safety belt use and Event Data Recorders (“black boxes”) in selected vehicles.

Vehicle No. 1 - 1991 Ford F-150  
Vehicle No. 2 - 1999 Chev. Suburban
