**Virginia Commonwealth University
Transportation Safety Training Center
Virginia Multi-disciplinary Crash Investigation Team**

Report Number 198 – December 2006

VIRGINIA
MULTI-DISCIPLINARY
CRASH INVESTIGATION TEAM
REPORT NUMBER 198
Urban Primary Road
1990 Ford Ranger
2005 Mercury Sable
1999 Plymouth Voyager

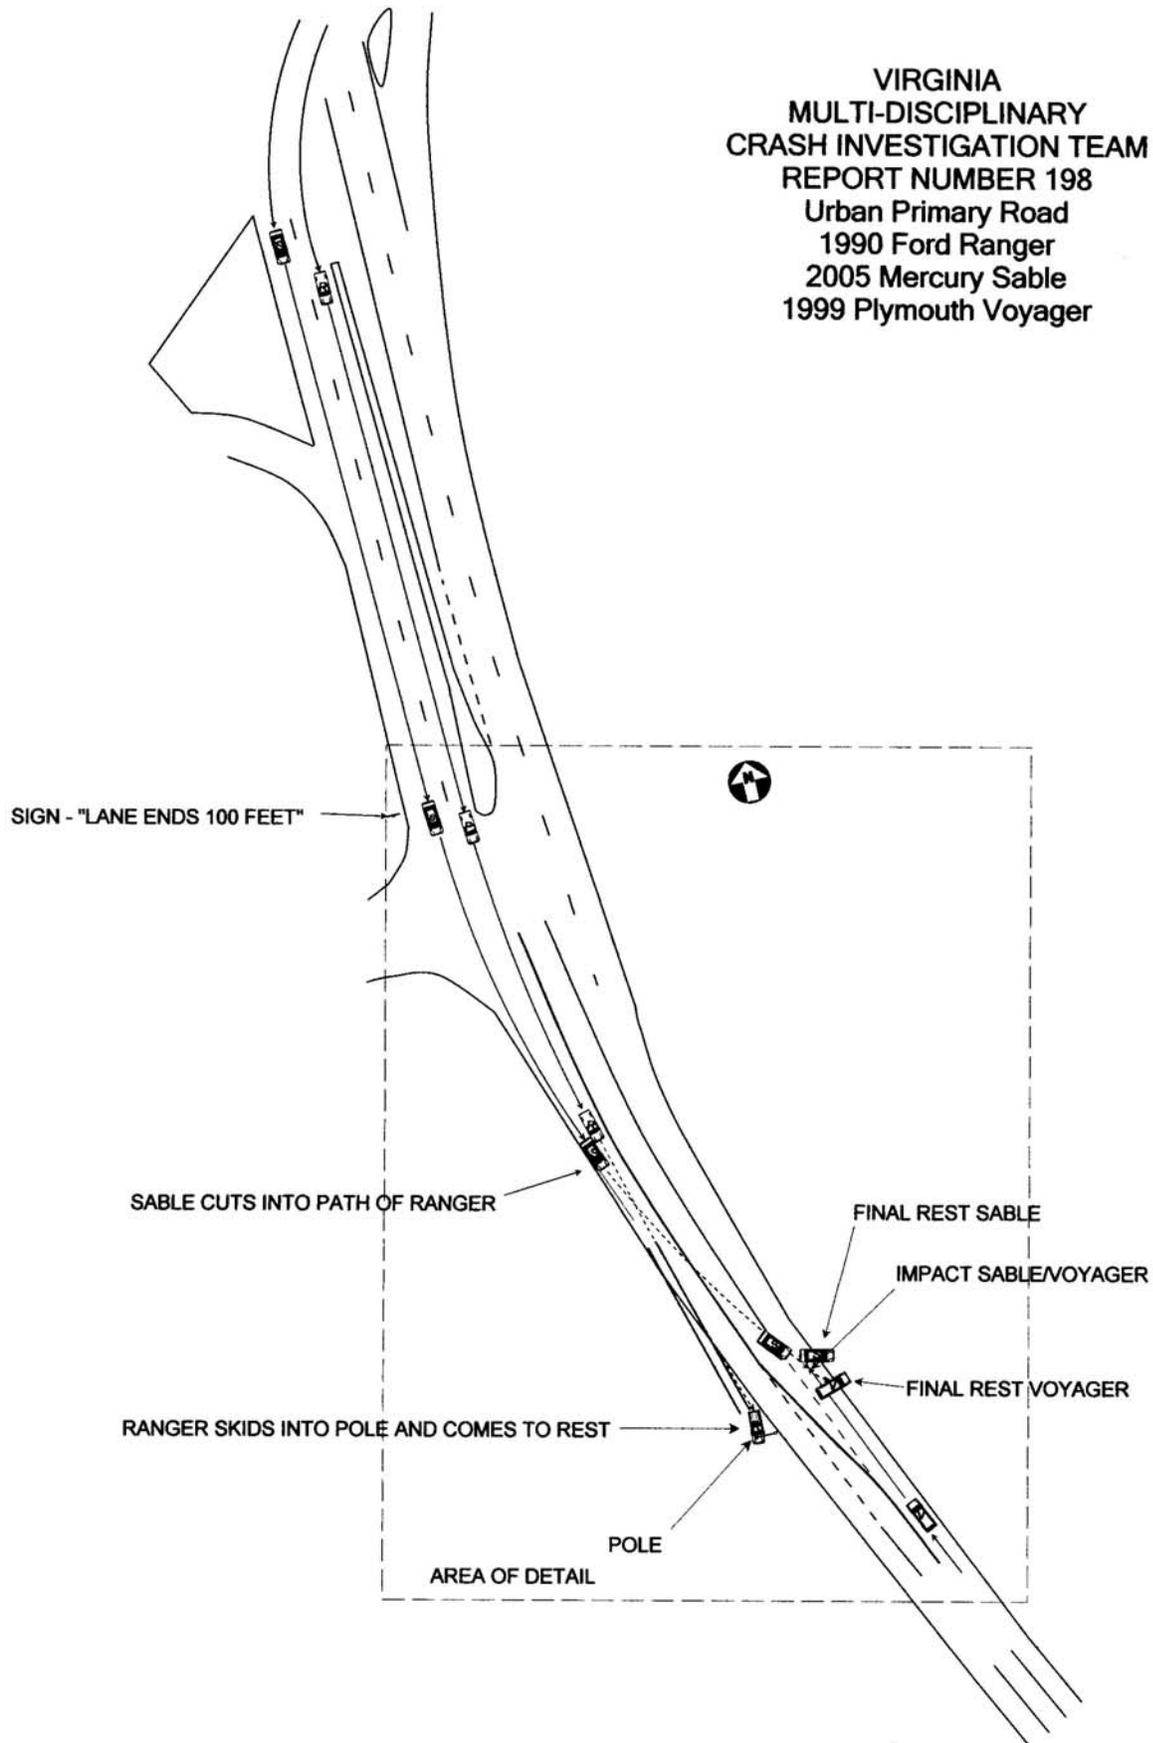
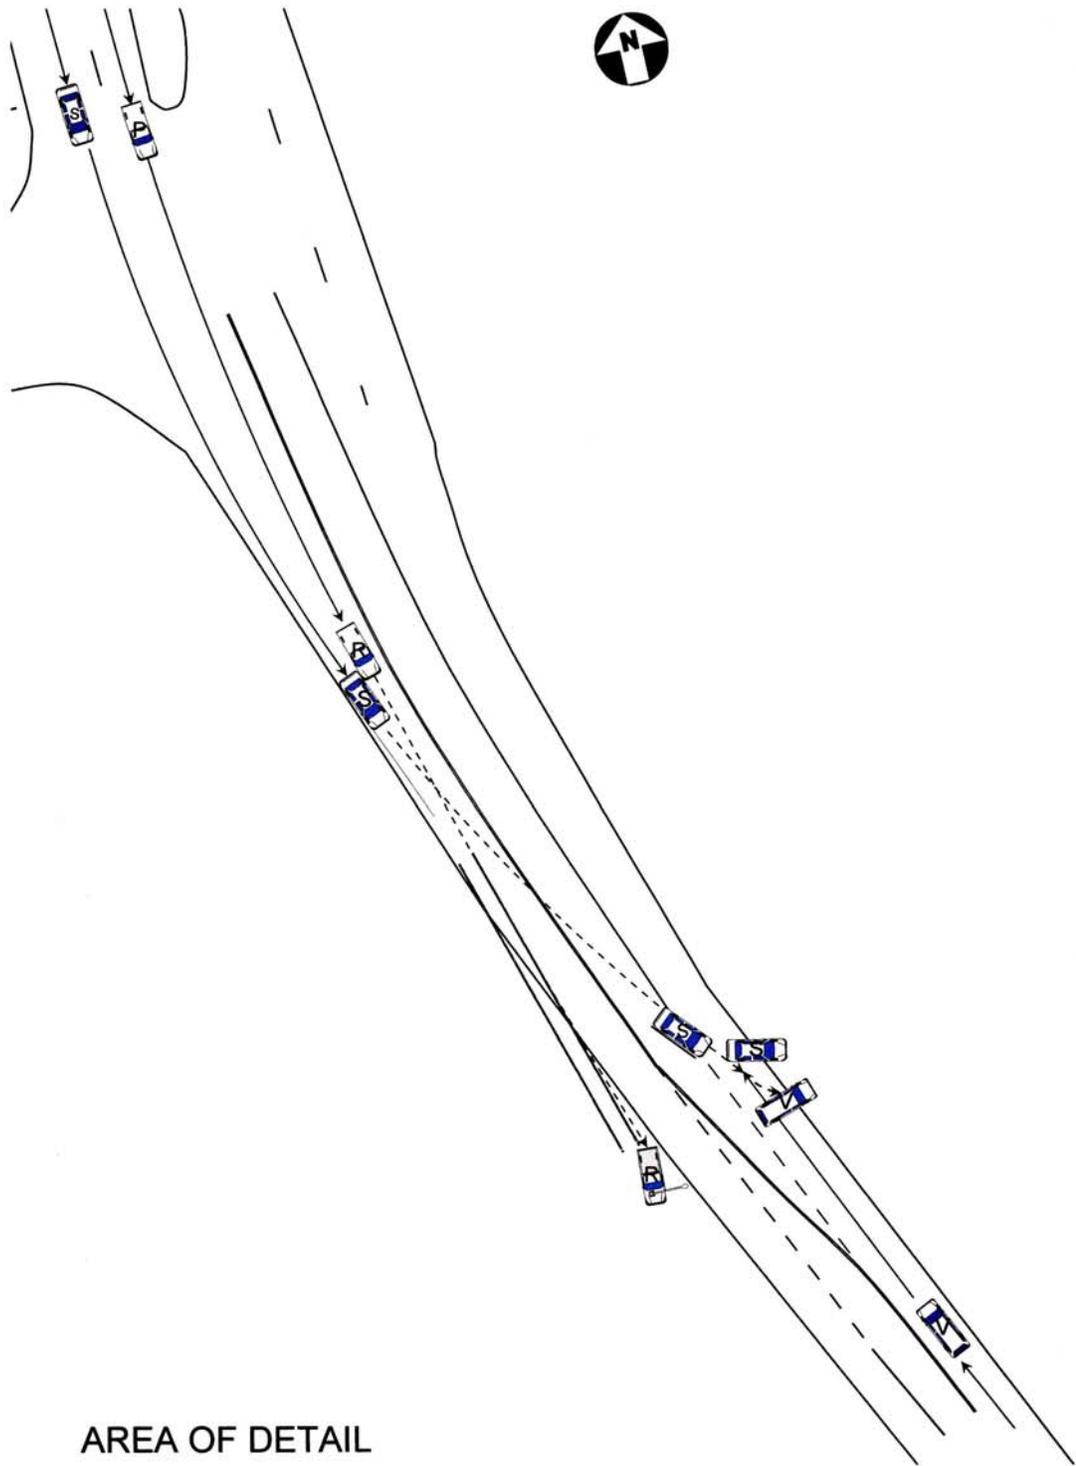
AREA OF DETAIL

When the signal changed for these vehicles to move, both drivers took off quickly in an attempt to gain the lead position. The vehicles accelerated heavily, creating enough noise to attract the attention of two witnesses who were washing a vehicle in front of their place of employment. The Sable in the right lane was in the process of passing the Ranger and, as the rear of her car came even with the front of the Ranger, she began cutting to the left as the pavement narrowed. The left rear corner of the Sable and the right front corner of the Ranger collided, sending both out of control. The Ranger skidded off the right edge of the pavement, struck and severed a light pole and came to rest atop the base of the pole. The Sable started to rotate counter clockwise and crossed the center lines of the road.

As the Sable and the Ranger were making the left turn onto the business primary road, a 77 year old male was driving his 1999 Plymouth Voyager minivan northbound on the same road, on his way to a local restaurant where he often went for lunch. He was wearing his lap/shoulder belt. He had just completed a left curve at the top of the hill and was traveling downhill in the opposite direction of the other two vehicles. After the first collision, the Sable entered the Voyager's lane of travel while rotating counter-clockwise. The car driver steered to her right to correct for the rotation, attempting to keep it facing southbound as she crossed into the northbound lane of travel. These two vehicles struck front to front with the Sable at a slight angle. There was slightly heavier damage to the right front of the car and the right front of the minivan. After maximum engagement, they separated. The Sable rotated counter-clockwise toward the shoulder, with both front tires on the east shoulder and both rear tires in the northbound lane. The minivan rotated clockwise and ended up in a similar position approximately 10 feet south of the car.
