Virginia Commonwealth University
Transportation Safety Training Center
Virginia Multi-disciplinary Crash Investigation Team

Report Number 205 – August, 2008

VIRGINIA
MULTI-DISCIPLINARY
CRASH INVESTIGATION
TEAM
REPORT 205
2003 VOLVO TRACTOR
TRAILER VS PEDESTRIAN

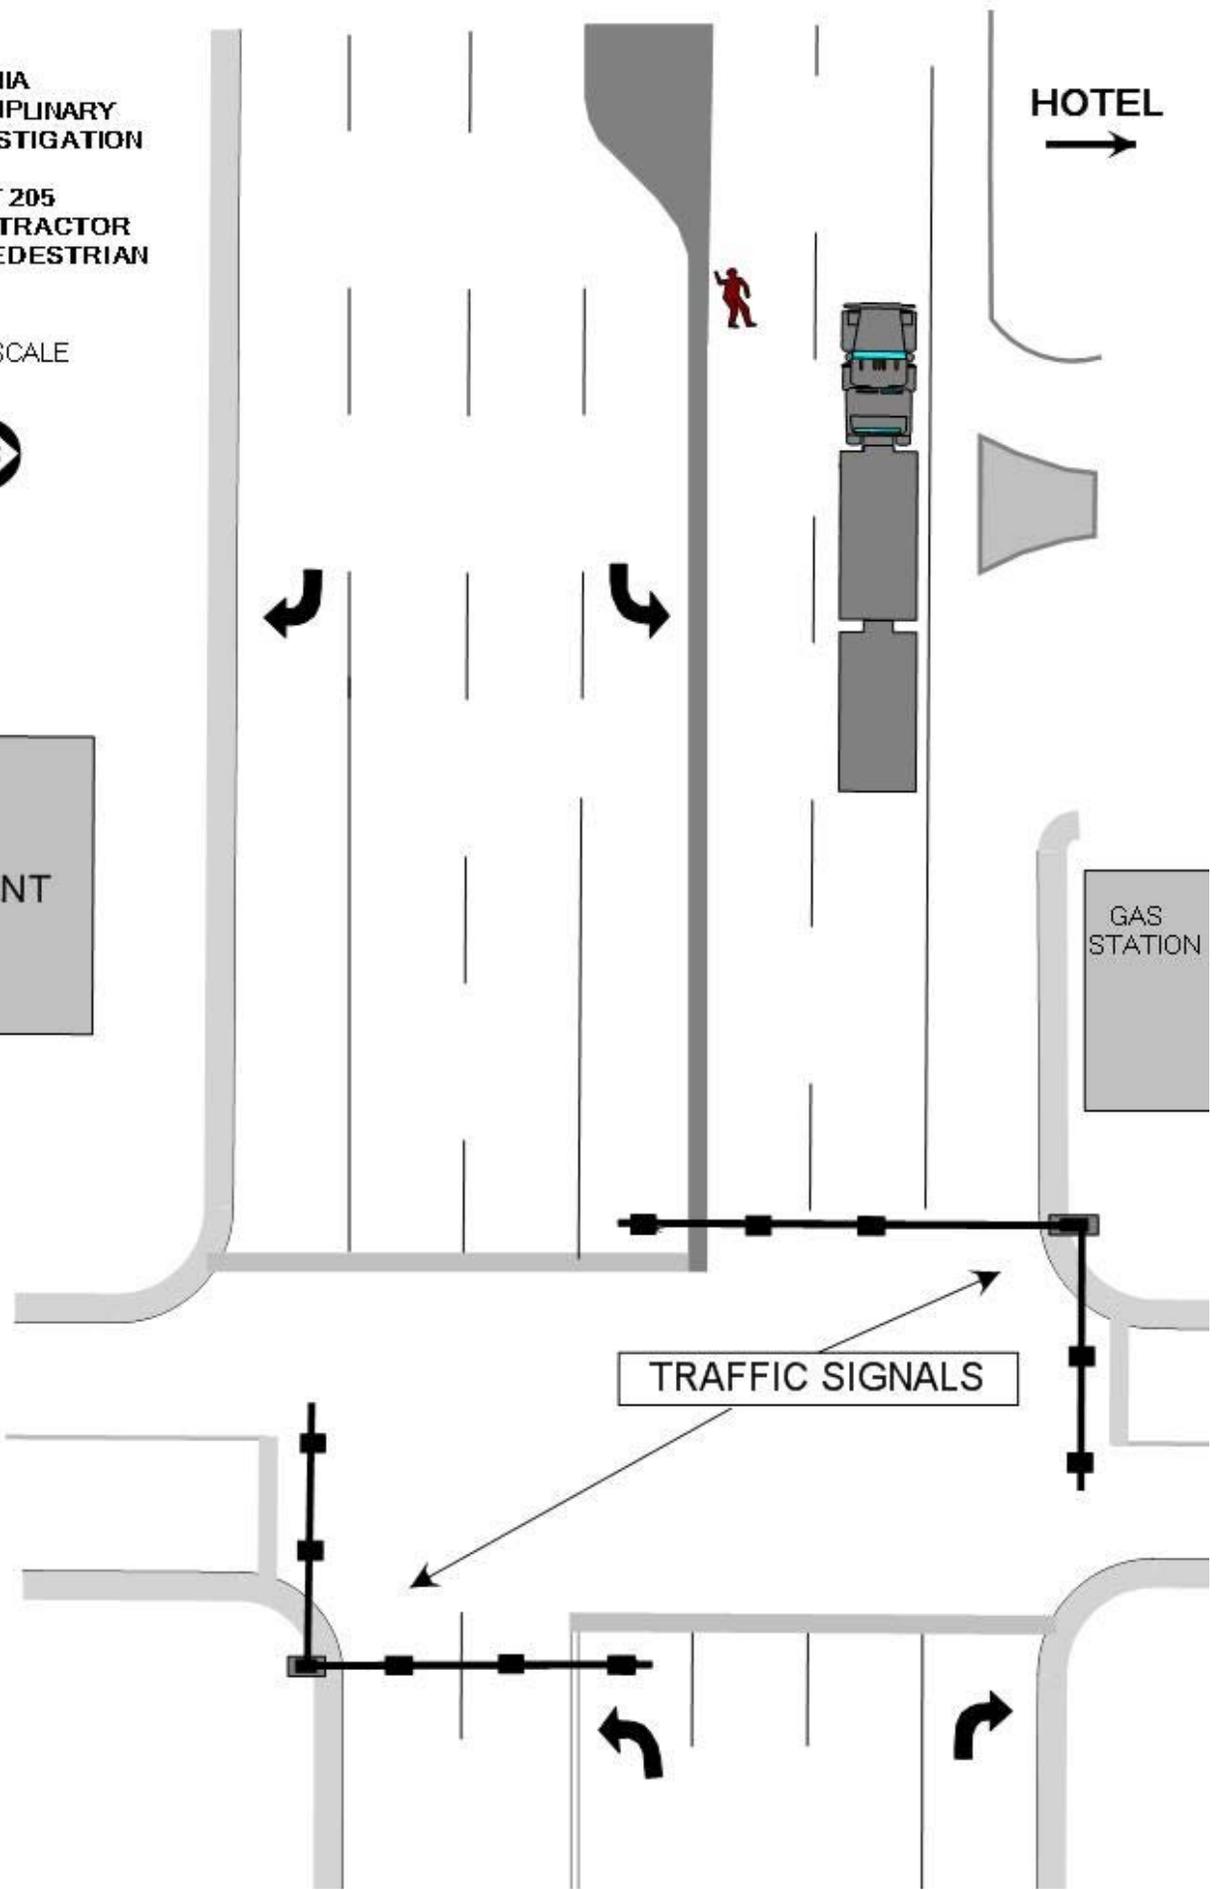
Summary: Pedestrian stepped from median into the path of the tractor.

As he continued forward, the tractor driver looked forward and saw the woman in the road, directly in his path. He braked hard, but was unable to avoid striking her with the left front corner of the tractor. The pedestrian was propelled into the left lane, landing near the median. The truck skidded to a stop, with minor damage to its left headlight and grill area. The exact

location of the first contact was not known—the trailer came to rest over that area of the roadway and no identifying marks were noted when it was moved.
