Crash Investigation Team Technical Alert: Number 14

Date: January, 2006

CRASH INVESTIGATION TEAM
Technical Alert Number 14
(Primary Highway)

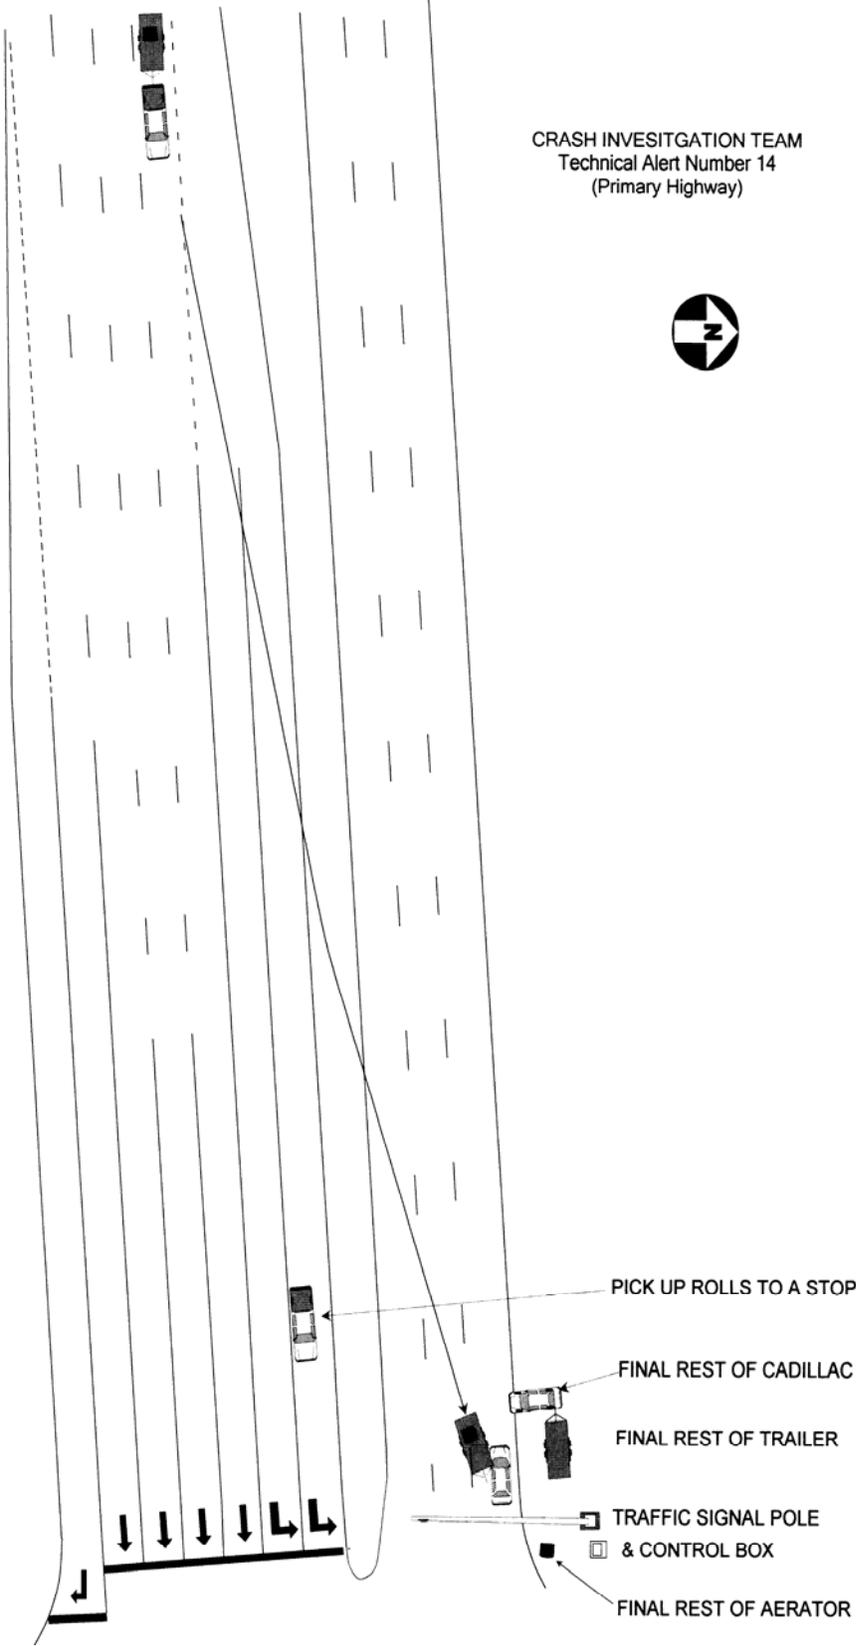
The pick-up and trailer had been traveling in the center lane, but moved to the left lane, then into the adjacent turn lane as it approached the intersection. On the opposite side of the road, signals for westbound traffic had just turned green. Several vehicles, including a 2000 Honda Odyssey minivan followed by a gray 2005 Cadillac CTS four-door sedan, began traversing the intersection. The driver of the Cadillac, a 51-year-old female with a valid Virginia license and a clean driving record, wore her lap and shoulder belt and was alone. Her sedan displayed valid state registration and inspection stickers and had only about 6000 miles on the odometer. As the truck slowed, the hitch and coupler separated, transferring the weight of the trailer onto the “carabiner” type clip and the emergency chain. The clip failed, releasing the chains and allowing the trailer to become a freewheeling, uncontrolled projectile.

The trailer crossed the remaining turn lane, mounted the curb and rolled down the median’s slope, into the lanes of oncoming traffic. The driver of the van braked and swerved to the left into the median to avoid it. The trailer passed in front of his vehicle and its tongue struck the right side of the Cadillac just behind the left front tire. The tongue slid along the side of the car and then the left front corner of the trailer body impacted just below the window level of the “B” pillar behind the driver’s door. The tongue and trailer body intruded into the driver’s compartment, causing extensive damage and fatally injuring the driver. The trailer and the car began to rotate in a counter-clockwise motion, crossing the curb at the north shoulder. The car rotated approximately 90 degrees, and then came to rest facing south with its rear end against a utility post. The trailer came to rest facing 180 degrees from its original direction of travel, with the tongue embedded in the deflated left rear tire of the car. The webbing that anchored the aerator gave way and it flew off the trailer, crossed onto the shoulder east of the car and trailer, and struck the control box for the traffic signals. It severely damaged the box, knocking it loose from its concrete pad and thus disabling the traffic signals for the intersection. It came to rest on the shoulder near the northwest corner of the intersection.
