## Virginia Multi-disciplinary Crash Investigation Team Technical Alert: Number 16

**Date: January, 2007**

VIRGINIA  
MULTI-DISCIPLINARY  
CRASH INVESTIGATION TEAM  
TECHNICAL ALERT NUMBER 16  
Rural Primary Road  
1999 Chevrolet Blazer  
1998 Dodge Ram Pickup

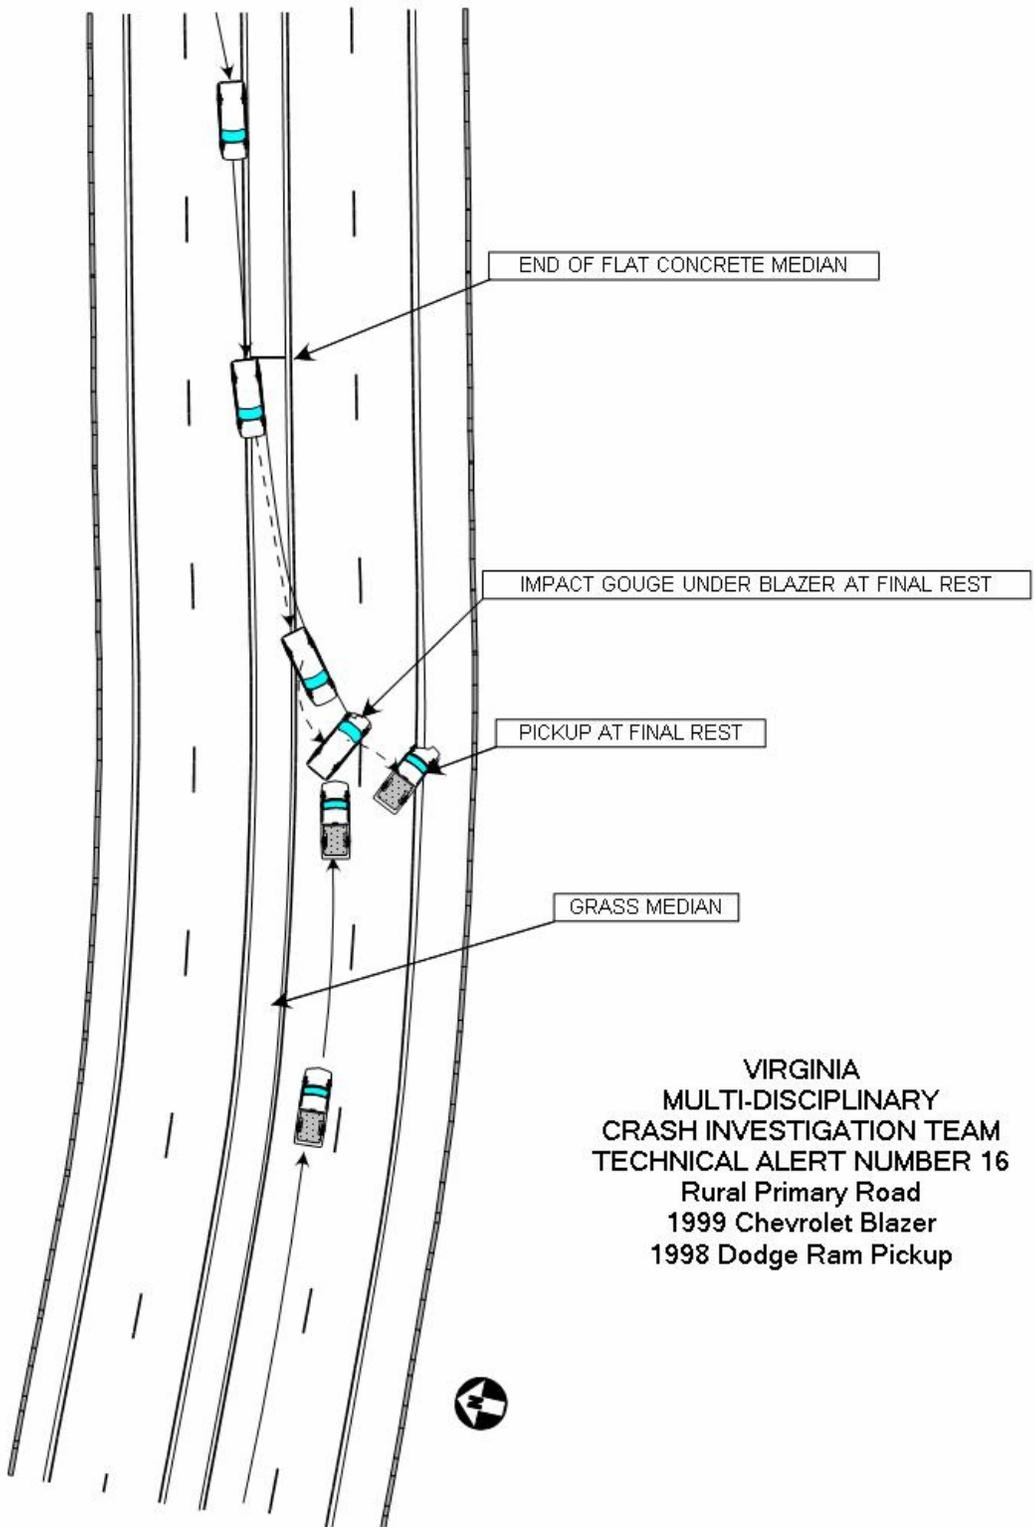
braking, when his SUV mounted the five inch concrete curb. The SUV crossed the median and entered the westbound lanes at an attitude of approximately 30 degrees and struck the right front corner of the pickup with its full front. The two vehicles slammed into one another, crushing the engine compartments back toward their respective occupant areas. This induced buckling type damage to the vehicles' roofs and sides, jamming the doors. The entire front end of the Blazer was crushed over 3.75 feet on the left and over 2 feet on the right. The Dodge pickup suffered the most damage to the driver's side, which was crushed inward over 2.5 feet. This caused the driver's door to buckle outward and the driver's seat to twist toward the window. The right front collapsed backward just over one foot. After the vehicles reached maximum engagement in the westbound left lane, they separated. The pickup came to rest in the right travel lane approximately 40 degrees to the right of its' original direction, facing southwest, with its right front wheel on the paved shoulder. The SUV spun counterclockwise approximately 110 degrees and came to rest also facing southwest in the left lane for westbound traffic with its right front wheel on the dashed lane line. A gouge mark from the impact was located in the left lane beneath the SUV.
